TOWN OF HAMPDEN Fire Department Conditions Assessment & Expansion Options Report

Phase 1

July 14, 2020

Mitchell Associates Architects, PLLC
29 Thacher Park Road, Voorheesville, NY 12186
518 765-4571 www.mitchell-architects.com

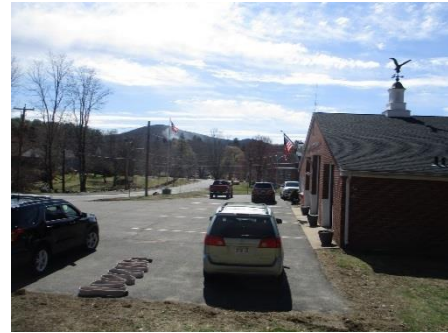
Image-008

The site has asphalt surfacing wrapping around the building on three sides - to the east, south and west - and was replaced approximately 6 years ago by Department of Public Works (DPW) personnel. Overall, the asphalt is in good condition although areas of settling are developing primarily on the southeastern and southern portions of the site. **Sizable cracks have developed**, and immediate sealing is needed to stop the increase of water infiltration, erosion, and further settlement; see *Images-009 through -014*.

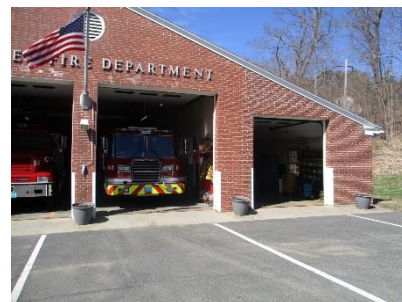
Image-030 - East

The eastern façade is comprised of a mix of two different construction projects. The Radio Room and two Bays adjacent to the Radio Room were part of the original 1963 build. The brick façade is mostly in fair condition except for **significant cracking and spalling of the brick sill units** most likely due to water entering the wall assembly. Spalling occurs when moisture gets inside the brick and freezes, causing the face to spall off, vastly increasing the deterioration process for bricks. **Mitigating these conditions is important to slow down the deterioration; see Images031 through -034.**

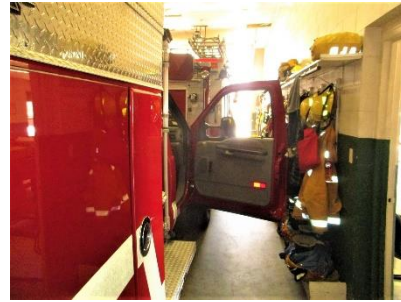
Image-064

2-bays with 12' x 12' apparatus openings, these bays represent what is quite common for 1960's era station design. With narrower trucks, the 12' opening widths were appropriate for the time of construction but with modern apparatus averaging a full 8' in width and large side mirrors often extending the widest points of the apparatus from 11' to 12' in overall width, modern bay openings are designed at 13'-4" to 14' in width to allow better clearances at the bay doors as well as down the bay aisles. **Fire Safety Code deficiencies and deployment egress issues** with the existing aisle widths are exhibited in *Images-059 through -064*.

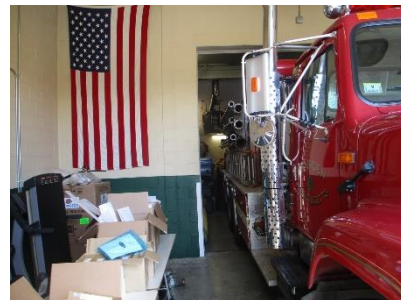
Image-080

The 2011 addition was a small, square addition on the southwest corner of the facility which lengthened the short bay facing south in the 1988 addition. The extended bay now houses the Fire Department's T-1 Tanker. While acceptable in length, the width of this bay does not meet the needs of a modern-day apparatus bay. The clear distance between the side of the truck to the wall between the 2 additions is less than 20". This is **far narrower than the required OSHA and Building Code clearances and recommendations from NFPA**; see *Images-073 through -080*.

As mentioned above, firematic equipment and materials are stored in the narrow bays and at the back of bays **further reducing egress and creating safety concerns for First Responders**. While the side clearance next to the apparatus in *Image-080* above is more like modern-day designs, the floor is covered with storage boxes due to the **lack of dedicated Storage Rooms**, thus reducing the egress path to a non-conforming width; see *Images-081 and -082* for further examples of floor space hazards.

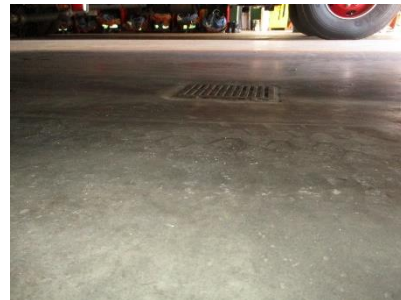
Image-086

The 1963 bays are 6" thick slabs, per the original building plans, and are each sloped separately to two (2) square cast iron drains centered in each bay. Despite their age, these slabs appear in moderately good condition. The bay concrete slabs are unfinished (i.e., not seal-coated nor broom finished) and have an average to below-average slip resistance for firefighter safety. Some minor surface cracking was observed throughout, although these cracks can be corrected by removing all loose materials, air blasting to remove any dust and particulates, and infilling the slabs with a structural crack sealer.; see *Images-083 through -086*.

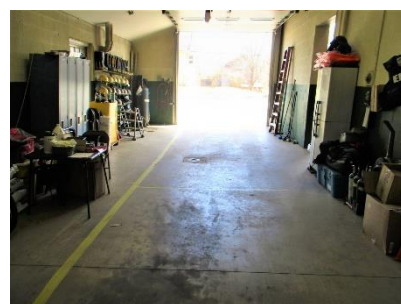
Image-090

The 1988 Addition main bay (facing North Road) is sloped to the center of the bay and drains to two (2) round cast iron grates atop a larger drain plate. The slab had no observed cracking or settlement issues. The slab did exhibit a good amount of floor grease from the on-going maintenance in this bay. The Bay concrete slab is unfinished (i.e., not seal-coated nor broom finished) but has an apparently acceptable slip resistance for firefighter safety; see *Images087 through -090*.

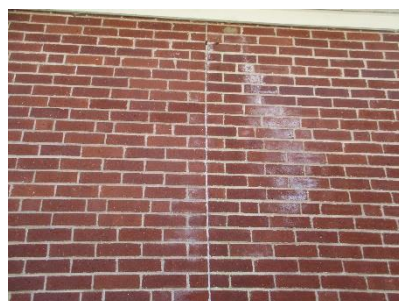
Image-134

The exterior walls of the original 1963 building have moisture issues on the East side of the facility ranging from **deteriorating brick window sills at the Radio Room** to **efflorescence at most areas** at and around the bay door openings. The 1988 addition exterior walls to the North and West are slightly better in condition although similar efflorescence markings were observed at the East and North exterior wall assemblies. The brick walls on most sides of the building have intermittent areas of **missing mortar, cracked bricks, missing and spalling bricks**; see *Images 129 through 134*.

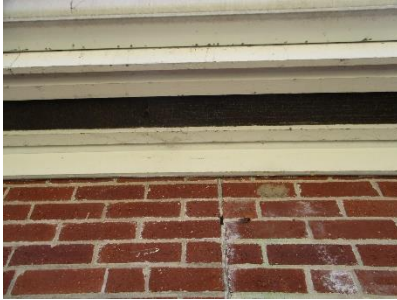
Image-135

Partially **open and completely failing expansion joints** were observed on all sides of the building. Water will enter these points unless corrected and create further exterior wall damage and decay. It seems that there are not enough expansion joints installed on the building exterior to prevent cracking. A further review of the various building additions should be performed to determine if **new expansion/control joints should be cut into the existing exterior wall(s)** to properly follow the guidelines of the *National Concrete Masonry Association TEK 10-2C* for CMU and the *Brick Institute of America tech Note 18A* for brick for locations and spacing of these joints. The east façade has no expansion joints. The 1988 addition was “toothed-in” instead of providing an expansion joint between the new and the existing walls; see *Images-135 and -136*.

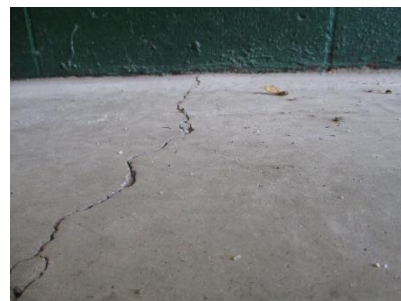
Image-146

The small to moderate cracks should be repaired as soon as possible. Structural crack sealant should be used on all of the existing slab crack locations. This will limit/eliminate water from finding its way into the cracks and possibly opening the cracks up more. Similar **preventative maintenance should be performed at the slab** perimeter in the entire bay. Concrete sealant should be installed at all open joints around the edge of the slabs; see *Images-143 through -146*.

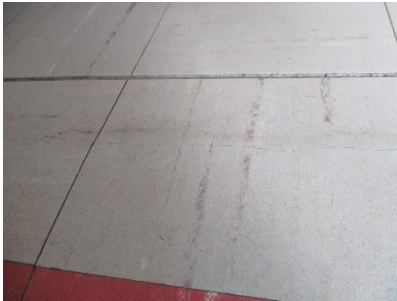
Image-165

Failing concrete floors at most building entrance doorways create **potential trip hazards** for visitors and especially First Responders during times of alarm response. Cracks, voids, and floor height differentials should be mitigated at the earliest ability; see *Images-165 and -166.*

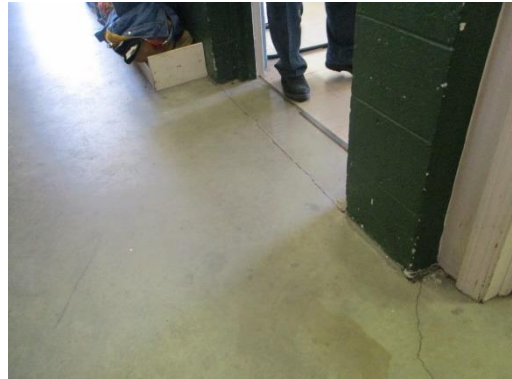
02 – Various Bay and floor slab cracks

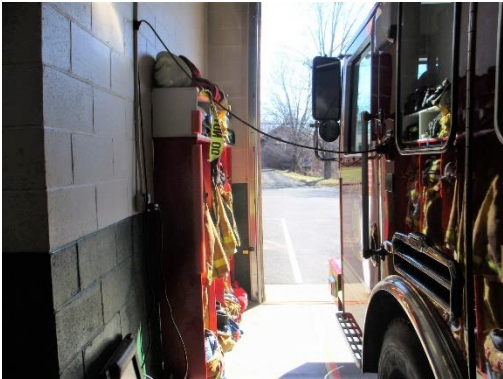
07 – Lack of electric drop reels creates hazard

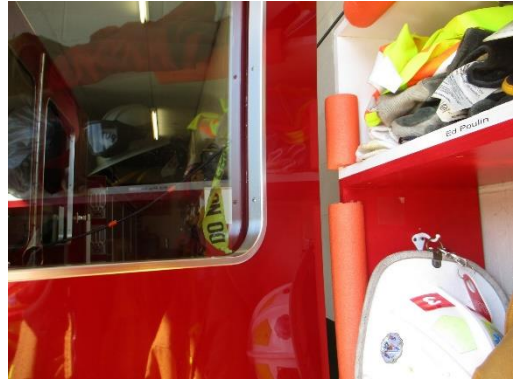
08 – Door protectors needed on gear lockers

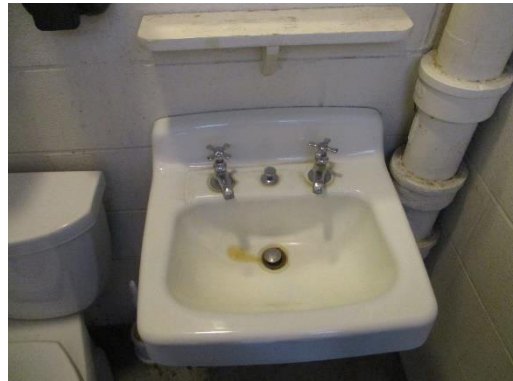
10 – Restrooms old and beyond repair

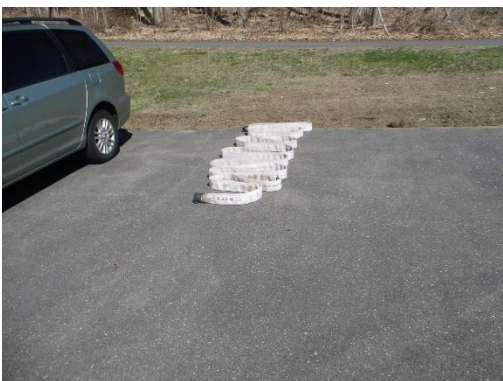
11 – No room inside building to dry hoses

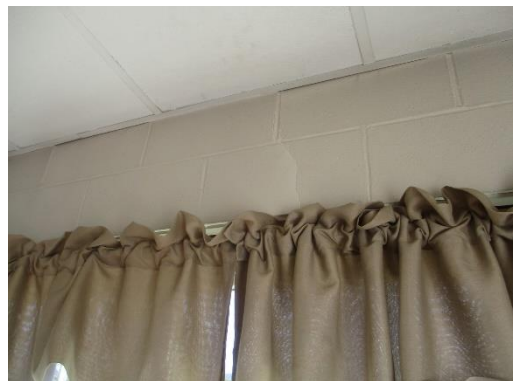
12 – Cracks in Radio Room from water damage

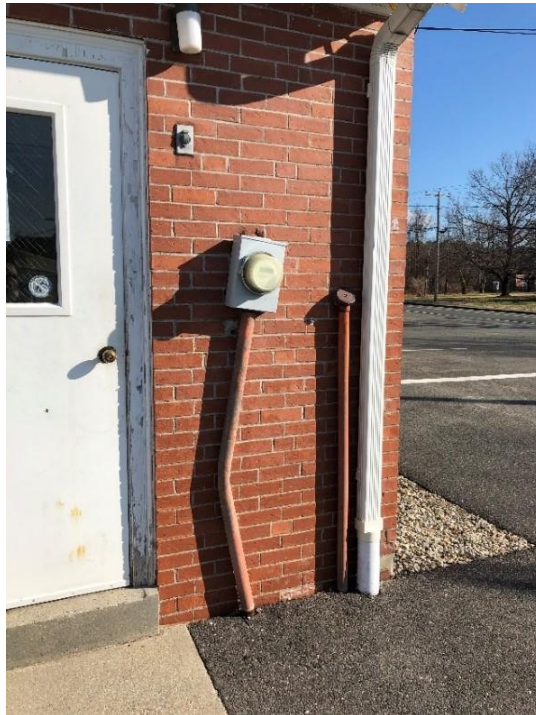
EL-2 Damaged Service Meter
