Hampden Town Hall Capital Improvement And Accessibility Study

May 22, 2017

MAROIS CONSTRUCTION CO. INC.

Introduction

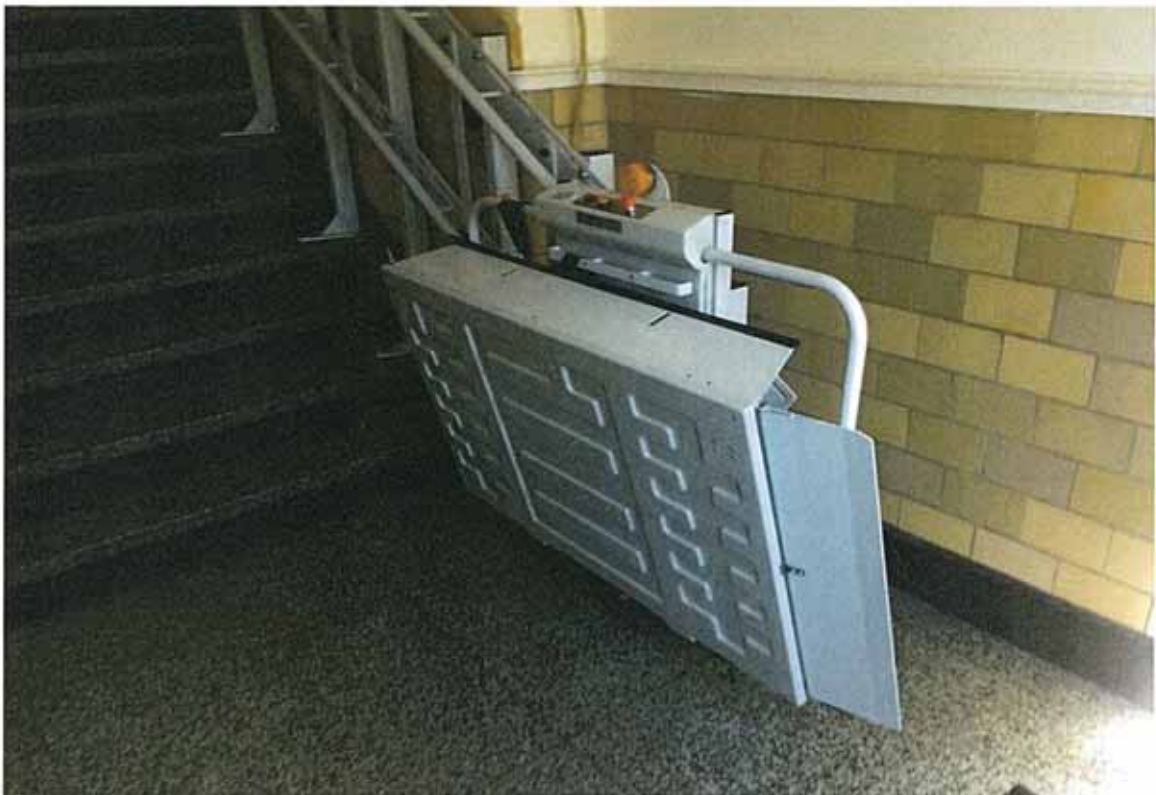
The existing handicap lifts are not an efficient means of conveyance and do not provide accessibility to significant portions of the building. The installation of an elevator is necessary to provide compliant access to the building. To comply with the AAB/ADA, elevators must be easily accessible to visitors in a public place. An elevator will not be in compliance with the ADA if it is in an inaccessible portion of a building even if it otherwise meets the required ADA dimensions therefore selection of location is critical. The design of an elevator would be performed by an Architect/engineer; typical installation conditions have been assumed for solely for budget consideration purposes.

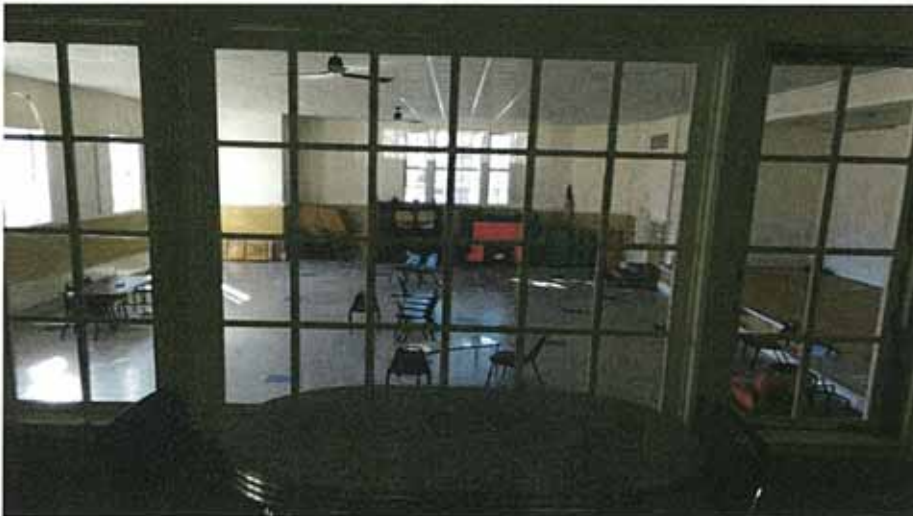
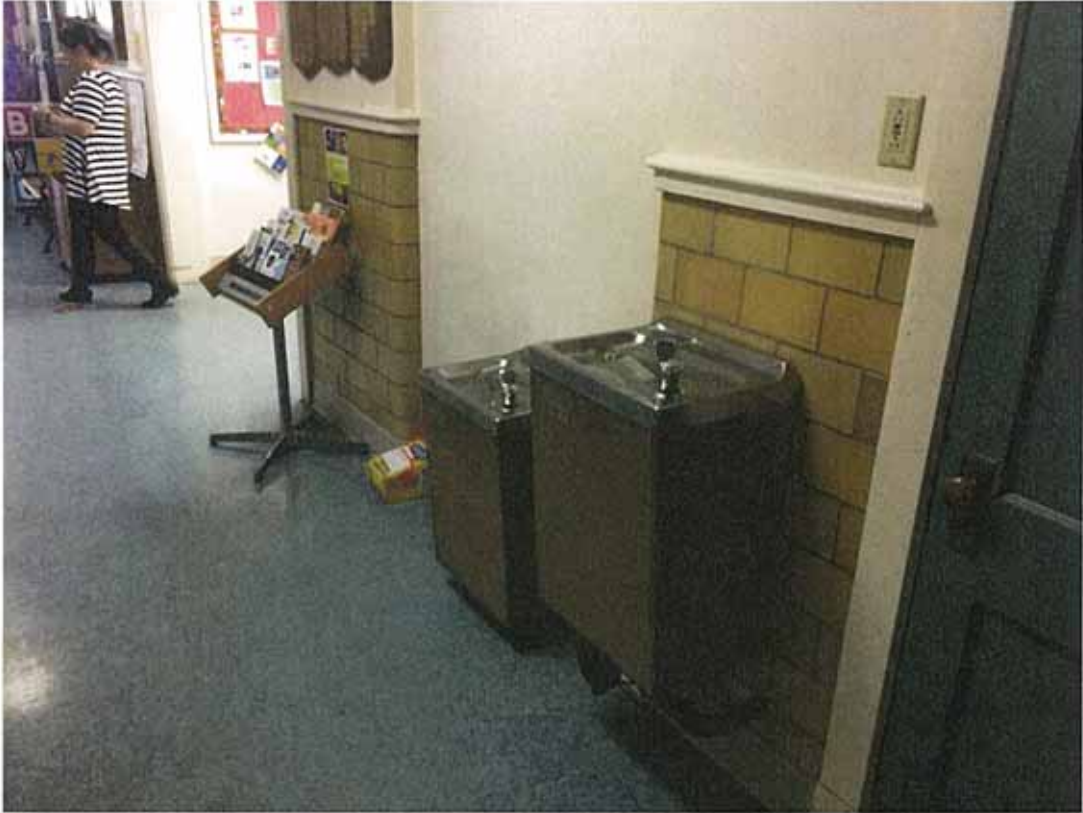
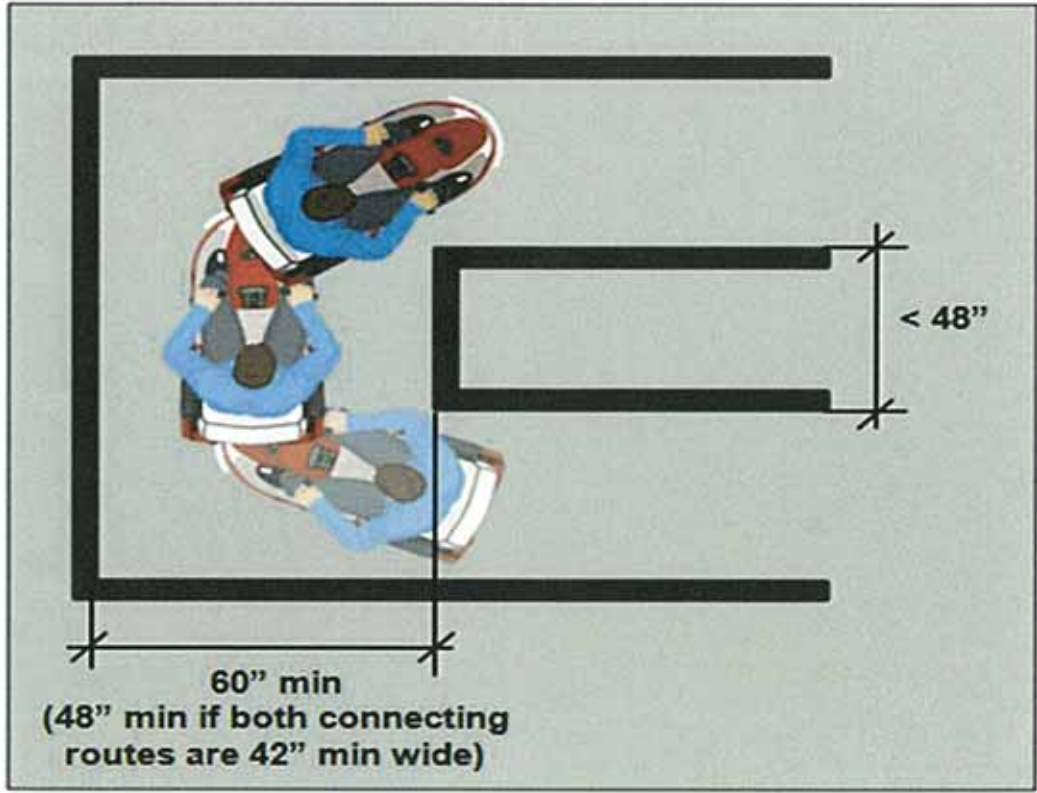
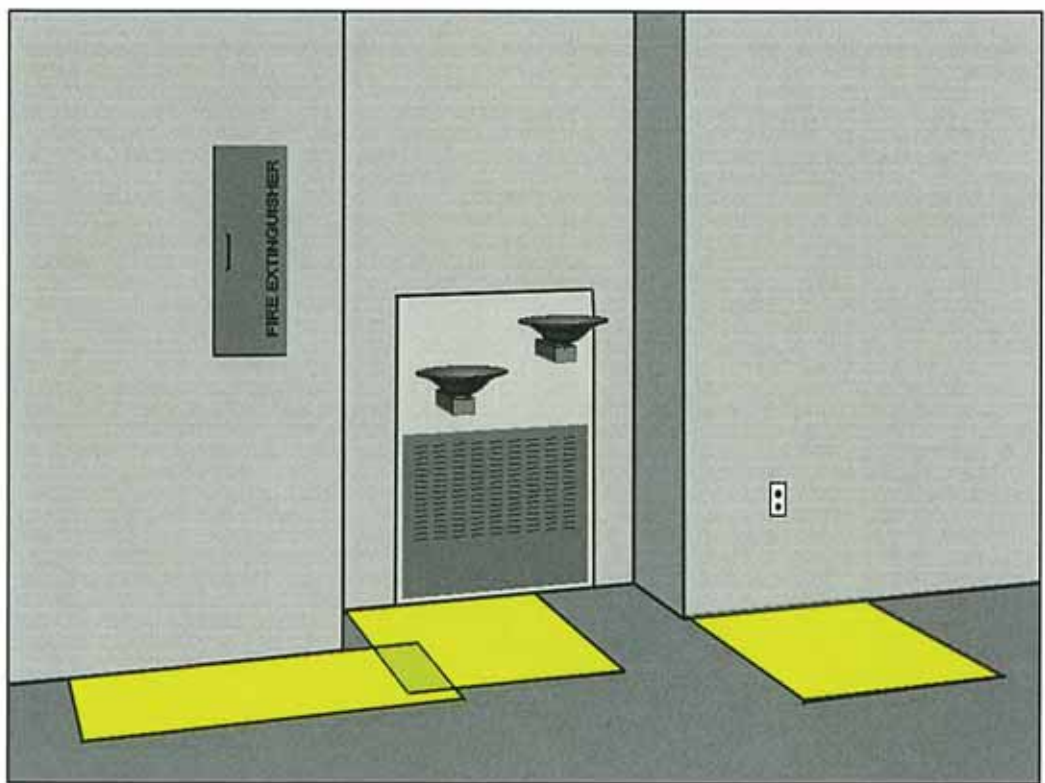
Many of the buildings current furnishings don't comply with current AAB/ADA and accessibility requirements and guidelines. The library lacks proper maneuverability clearances between book stacks; and proper height for checkout lane counters needs to comply with 521 CMR 12.2. If triggered by full compliance scope, 521CMR 14.5.1 would require assisted listening devices for the entry level of the auditorium. Under 14.5.4 signage for assisted listening would be required in the auditorium. The drinking fountains are not accessible, and there are existing countertops throughout the building that would need to be modified to comply with 521 CMR Guidelines.
