Hampden Town Hall Capital Improvement And Accessibility Study

May 22, 2017

MAROIS CONSTRUCTION CO. INC.

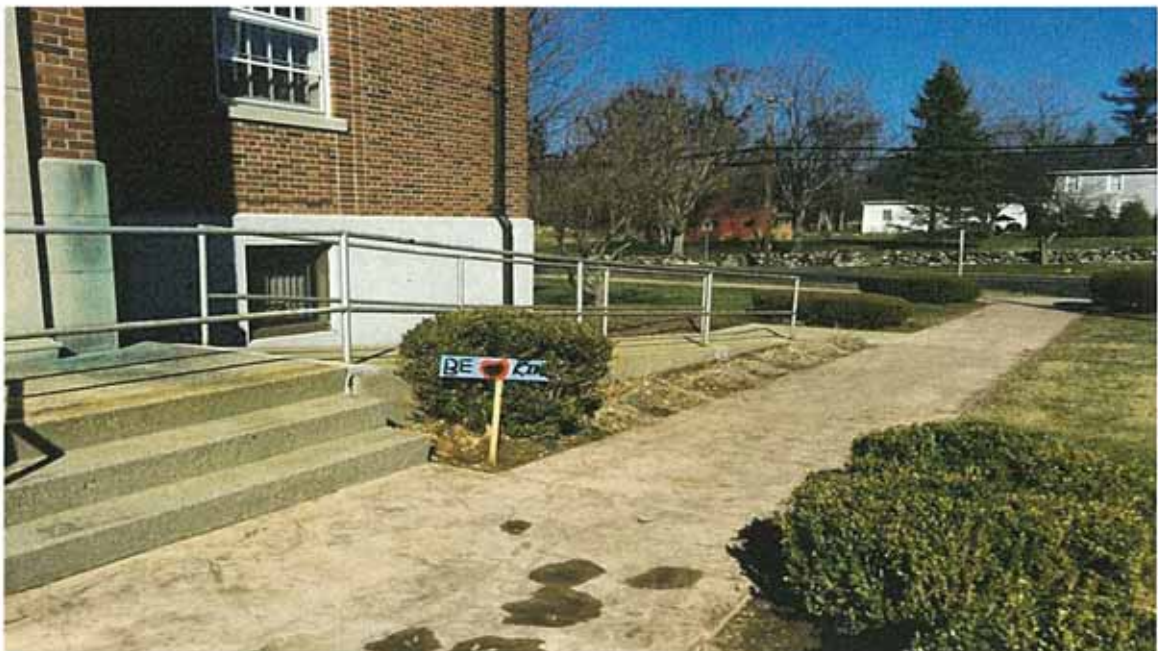
- Front Entrance

The handicap ramp located at the front of the building is not compliant with current code. The running slope of the ramp and the handrails do not meet code requirements as defined by CMR 521. The concrete structure is deteriorating as well.

| Deficiency | Proposed Resolution | Cost range | Estimated Cost |
|--|--|---|---|
| Front Handicap Ramp deterioration and non-compliant handrails | The ramp must be rebuilt to not exceed the maximum 8.3% slope and furnished with compliant handrails | \$58,000-68,000 | \$ 63,000.00 |

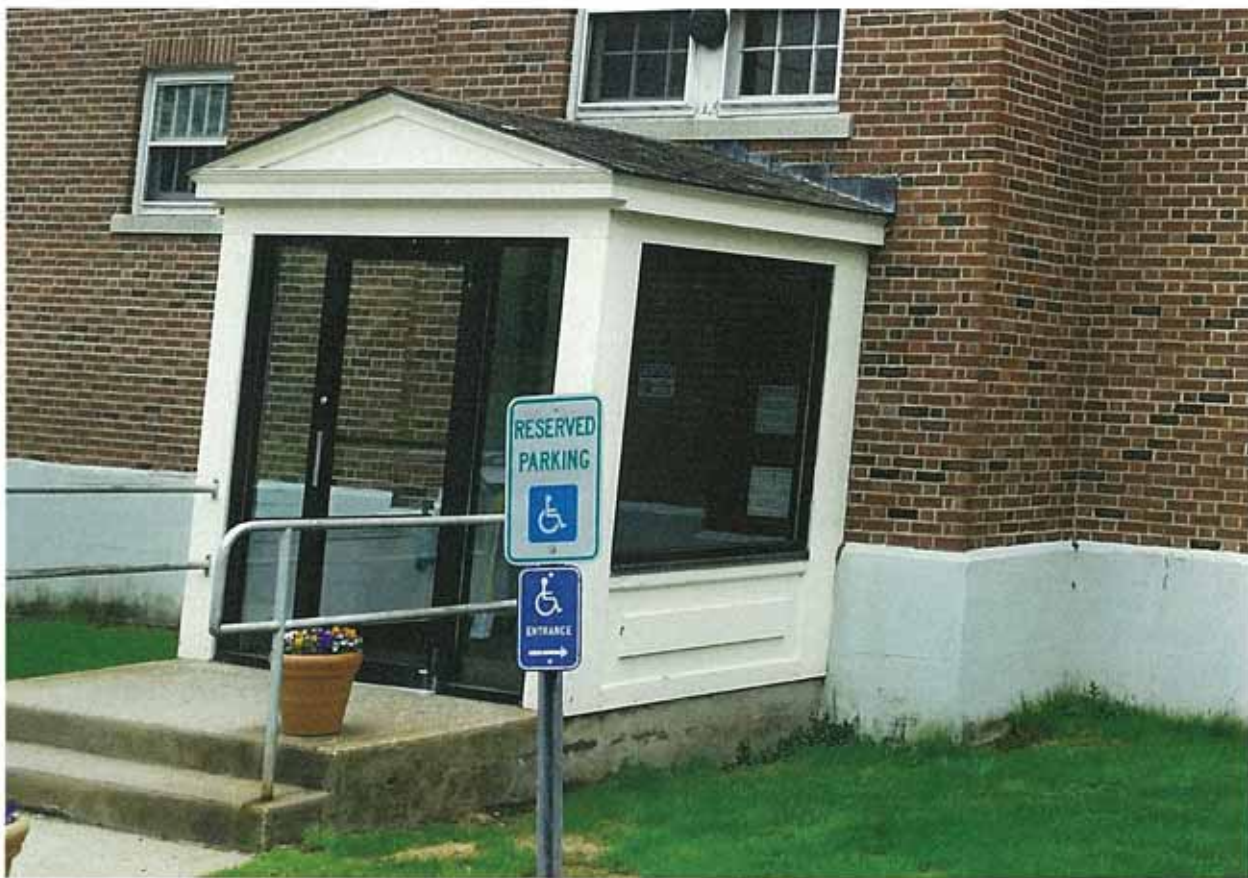
- Rear Entrance

The existing step and handrails at the rear entrance adjacent to parking lot are not compliant. The suggested correction is a regrade of this entry walk to eliminate the step.

| Deficiency | Proposed Resolution | Cost range | Estimated Cost |
|--|--|---|---|
| Rear Entrance not Accessible | Regrade at rear entrance to eliminate step. Replace handrail | \$6,000-10,000 | \$ 8,000.00 |

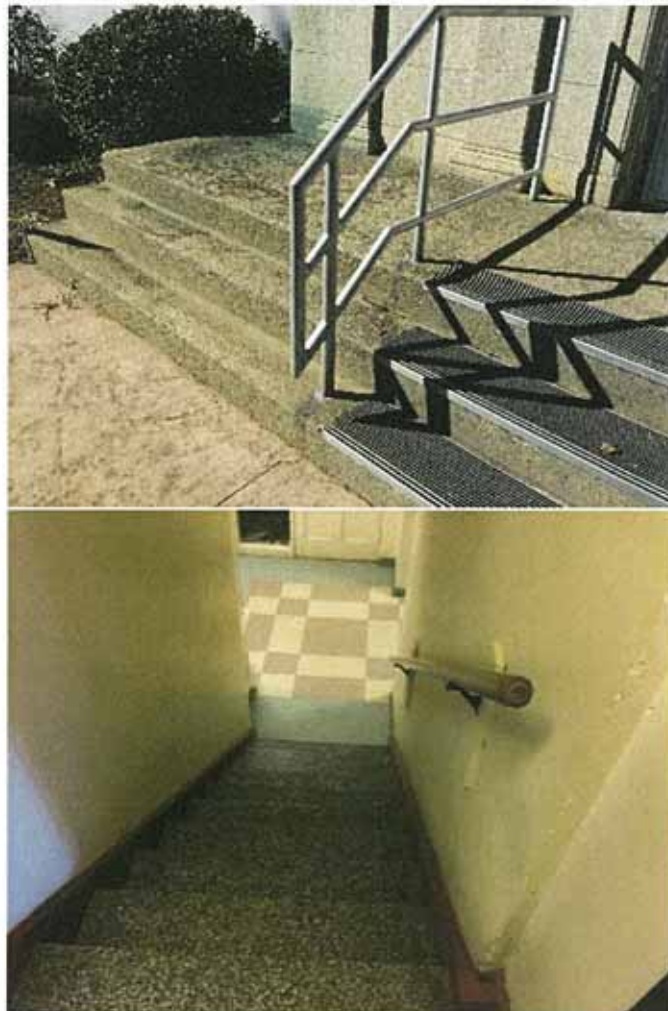
The handrails in stairways throughout the building are not code compliant and will need to be modified or replaced to comply with standards specified in 521 CMR 27.

| Deficiency | Proposed Resolution | Cost range | Estimated Cost |
|--|--|---|---|
| Stair treads/risers/handrails do not meet accessibility standards | Modify existing treads Replace/extend handrails to meet current standards | \$24,000-32,000 | \$ 28,000.00 |

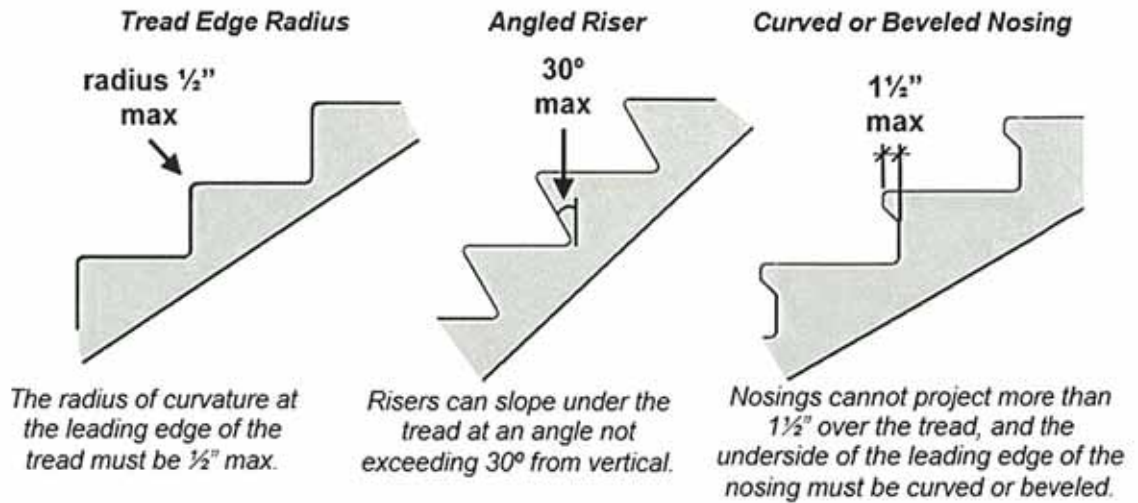
In addition, existing tread nosing on stairs does not conform to 521 CMR 27.3 for angle and radius requirements.

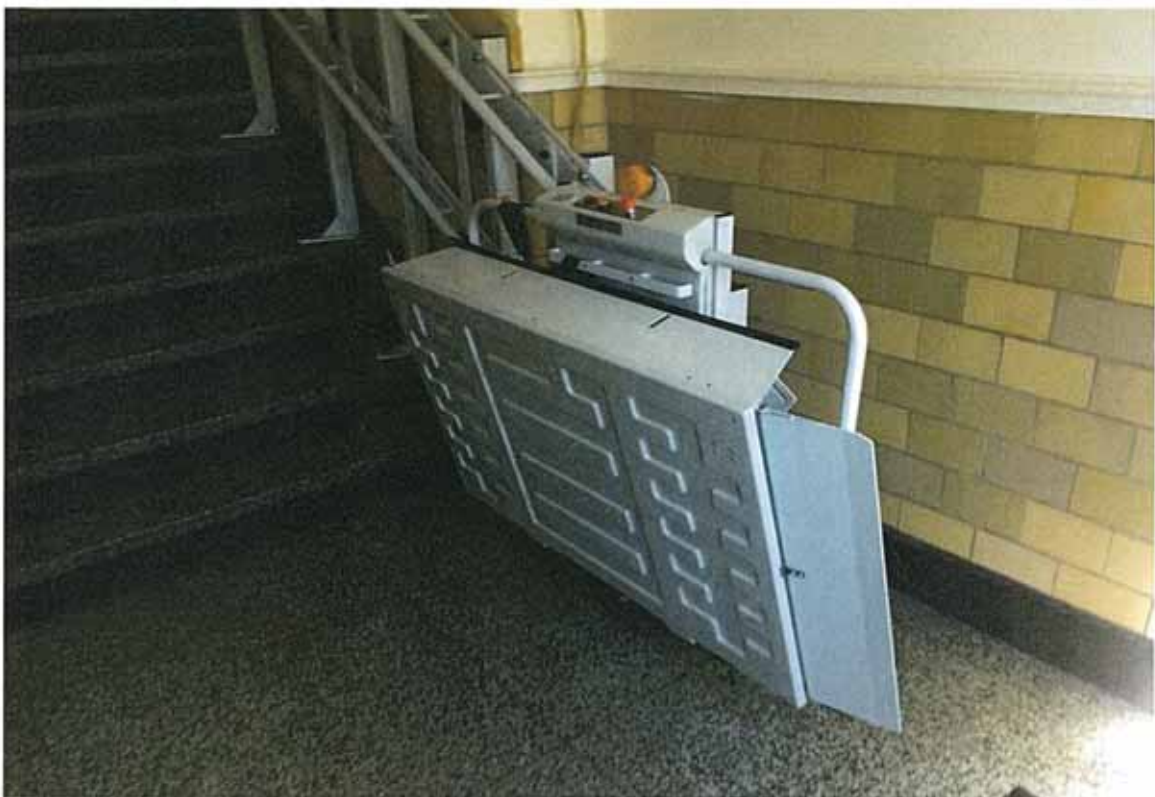
The existing handicap lifts are not an efficient means of conveyance and do not provide accessibility to significant portions of the building. The installation of an elevator is necessary to provide compliant access to the building. To comply with the AAB/ADA, elevators must be easily accessible to visitors in a public place. An elevator will not be in compliance with the ADA if it is in an inaccessible portion of a building even if it otherwise meets the required ADA dimensions therefore selection of location is critical. The design of an elevator would be performed by an Architect/engineer; typical installation conditions have been assumed for solely for budget consideration purposes.

| Deficiency | Proposed Resolution | Cost range | Estimated Cost |
|--|--|---|---|
| Elevator needed to provide adequate access to all floors | Install typical ADA Elevator Electrical upgrades to meet power requirement | \$255,000-275,000 | \$265,000.00 |

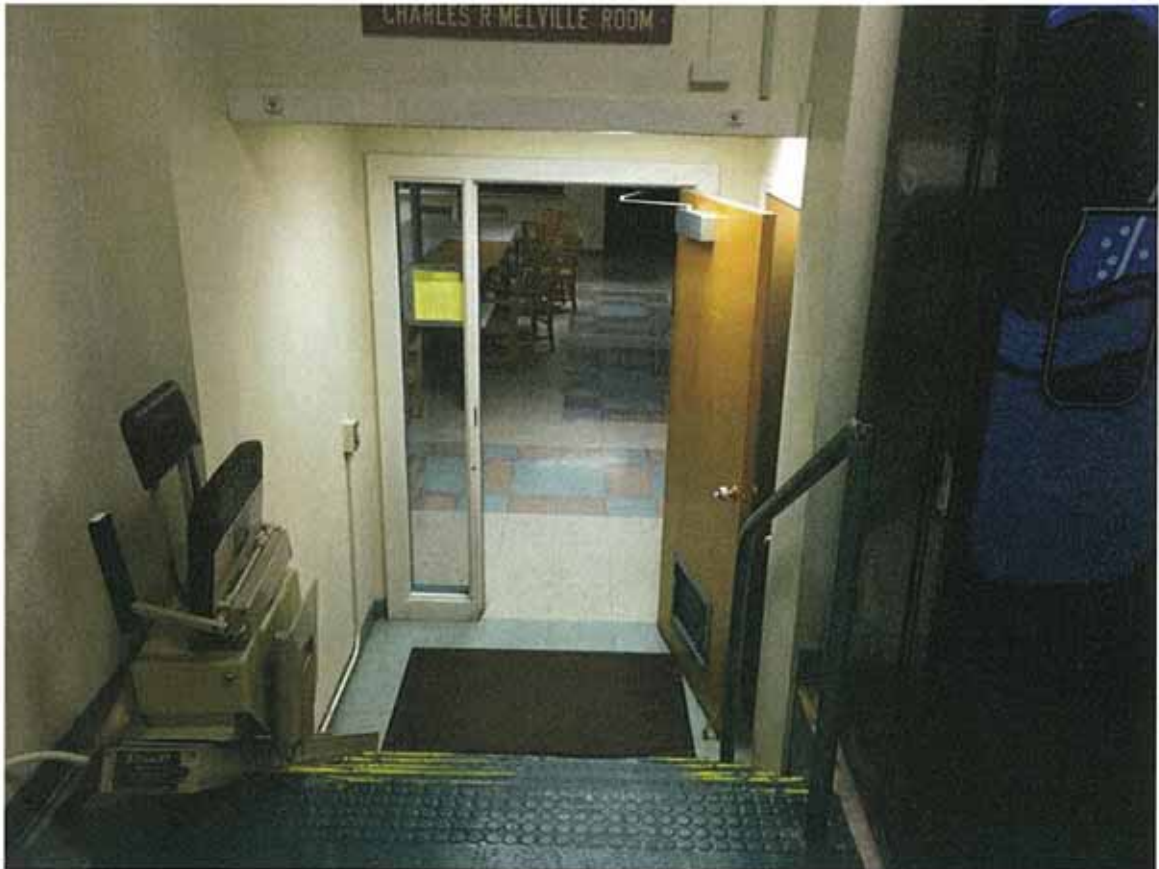
Most doors in the building do not meet both fire code/life safety requirements and the ADA requirements for accessibility. Specific concerns include AAB/ADA compliant handles, closers, and maneuvering clearances.

| Deficiency | Proposed Resolution | Cost range | Estimated Cost |
|--|--|---|---|
| Doors and hardware not accessible and/or fire rated | Install ADA compliant hardware, replace slabs and/or frames to as needed | \$50,000-70,000 | \$60,000.00 |

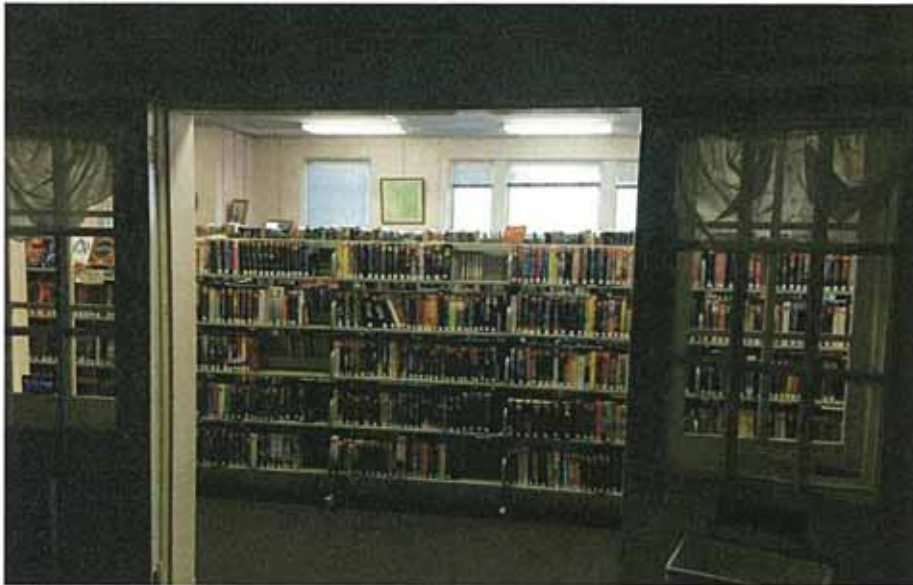
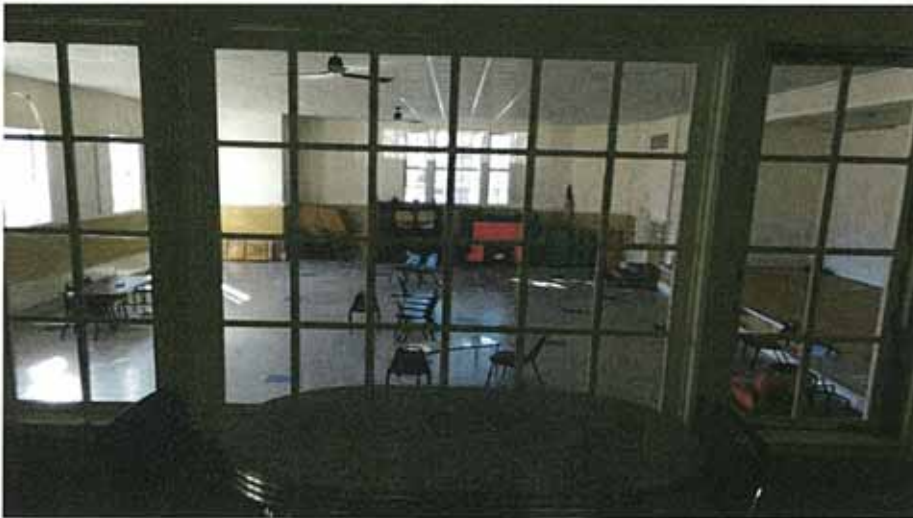
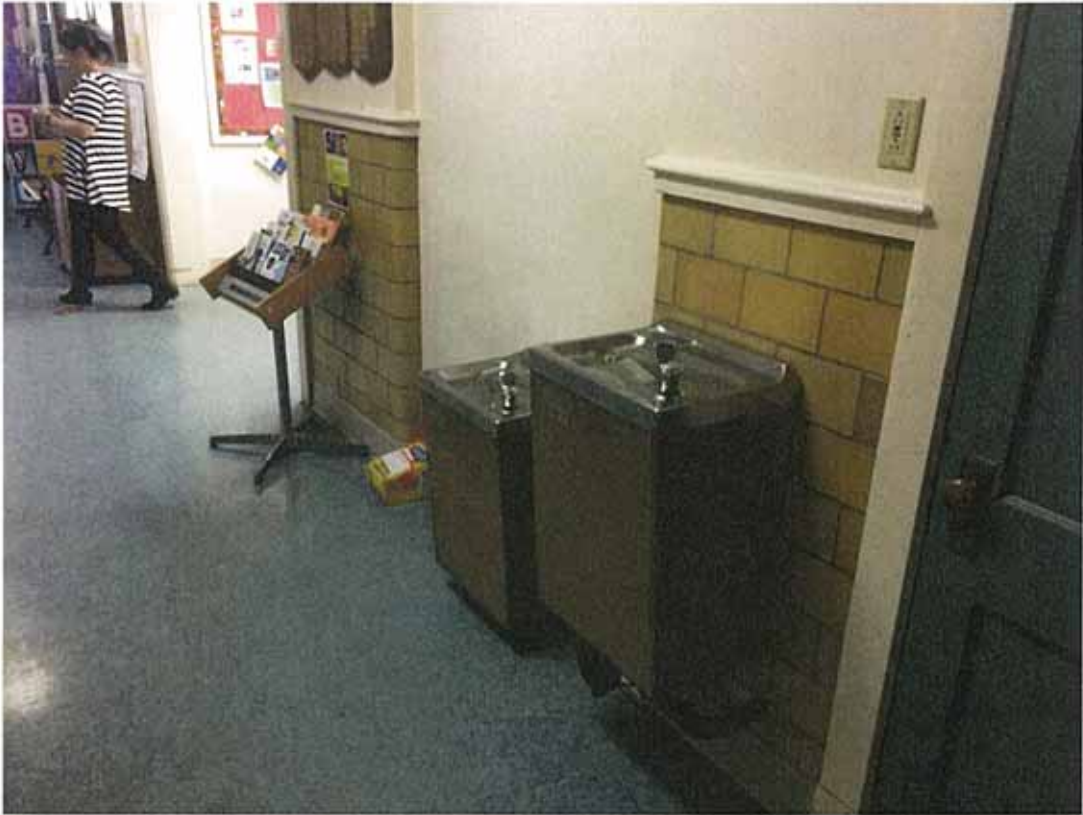
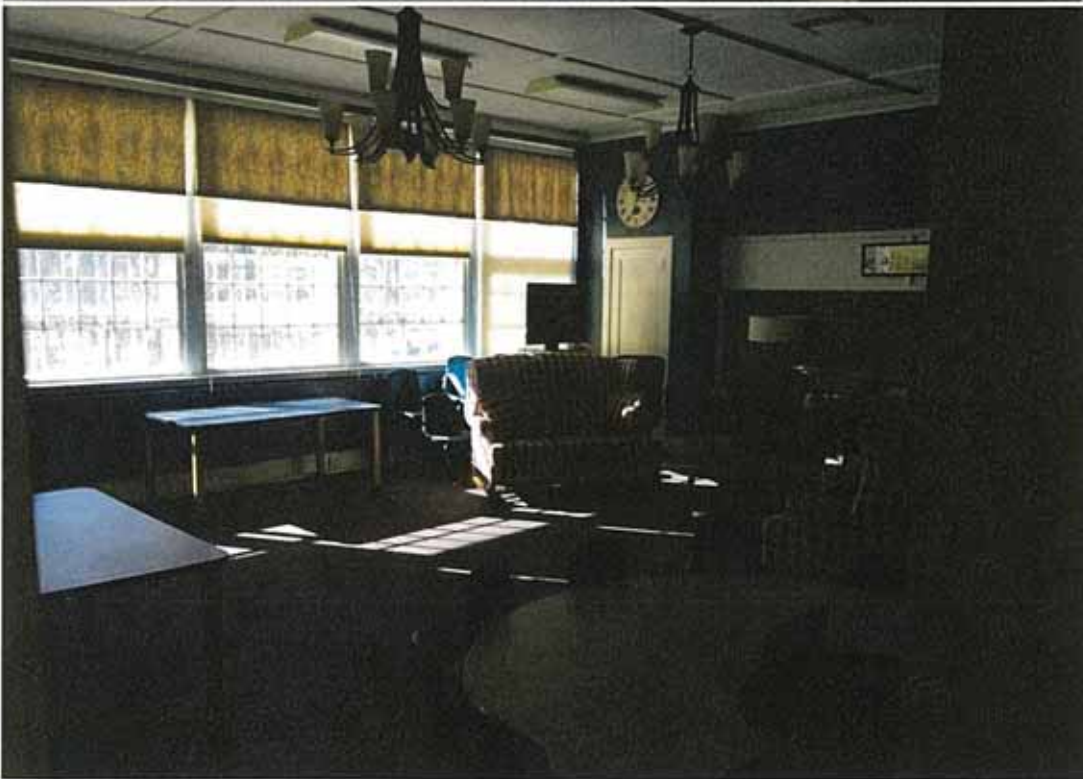
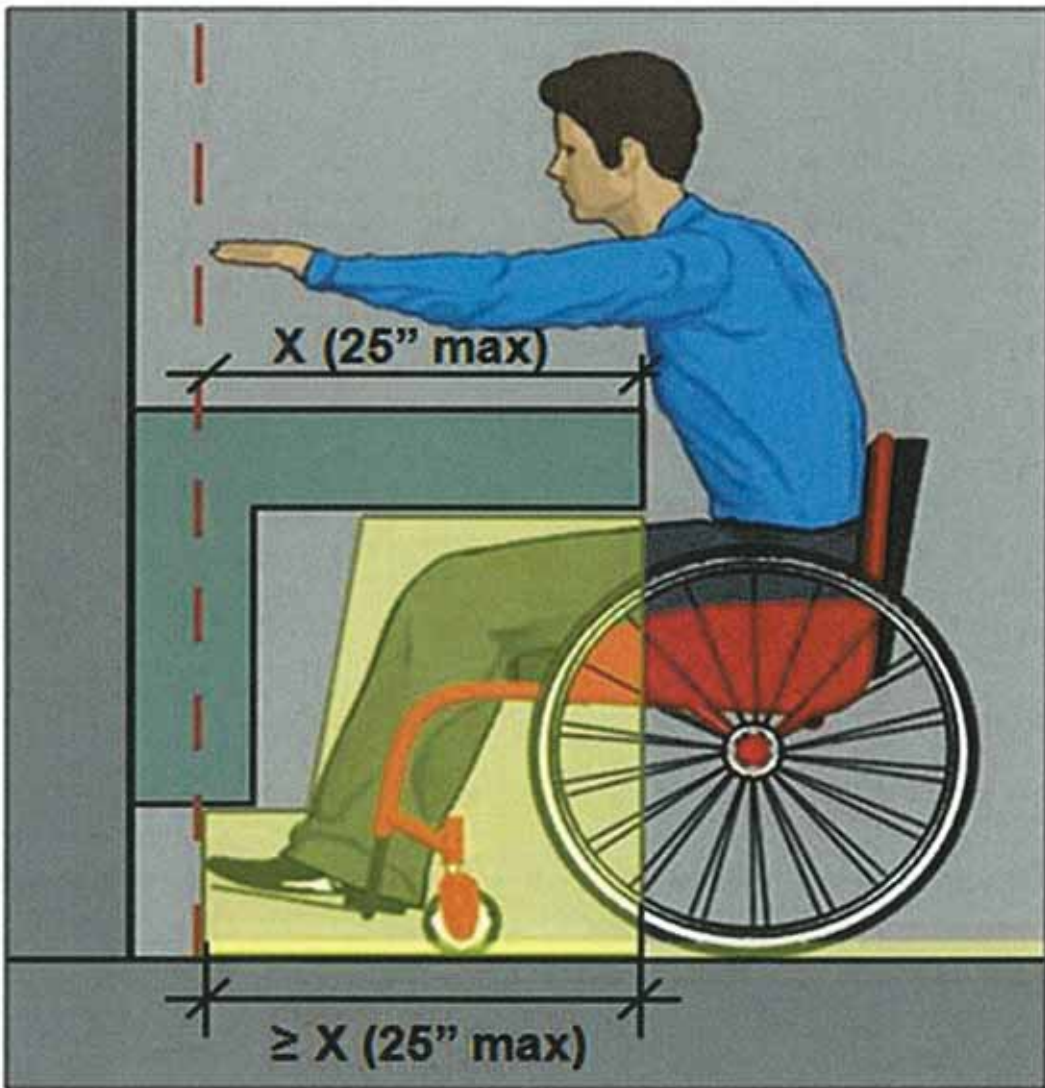
Many of the buildings current furnishings don't comply with current AAB/ADA and accessibility requirements and guidelines. The library lacks proper maneuverability clearances between book stacks; and proper height for checkout lane counters needs to comply with 521 CMR 12.2. If triggered by full compliance scope, 521CMR 14.5.1 would require assisted listening devices for the entry level of the auditorium. Under 14.5.4 signage for assisted listening would be required in the auditorium. The drinking fountains are not accessible, and there are existing countertops throughout the building that would need to be modified to comply with 521 CMR Guidelines.

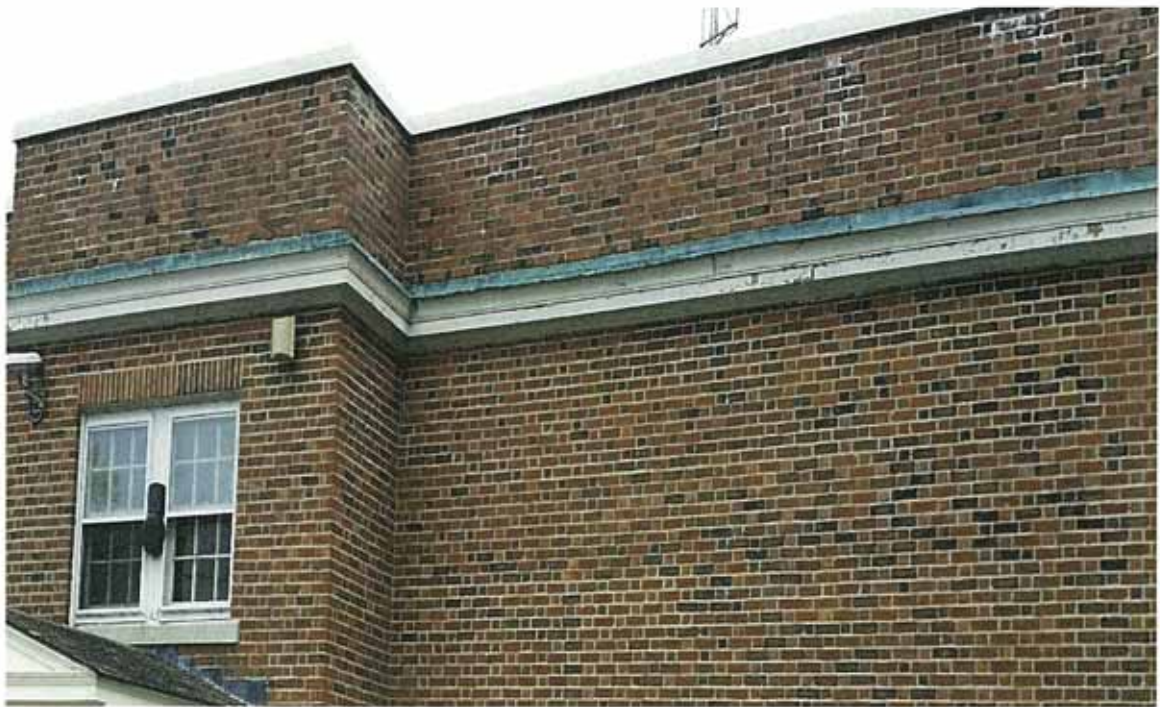
Exterior cornice trim is in need of prep work and paint to prevent further decay.

| Deficiency | Proposed Fix | Estimated Cost |
|---|---|---|
| Peeling Paint | Scrape and paint cornice | \$13,500.00 |

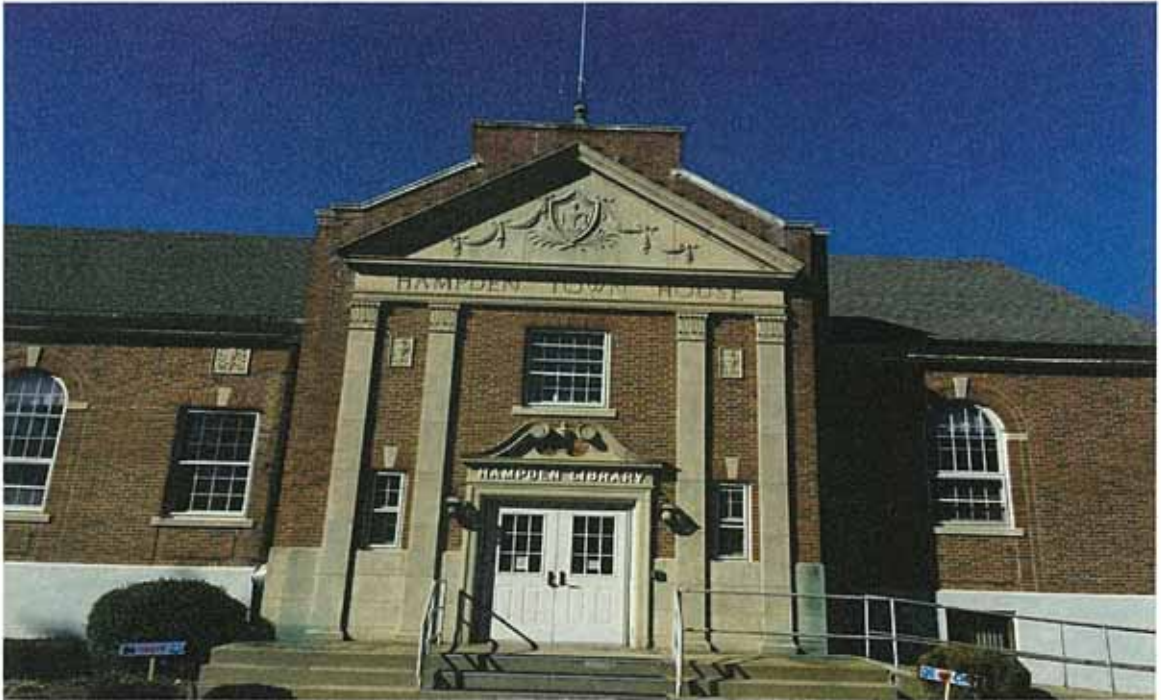
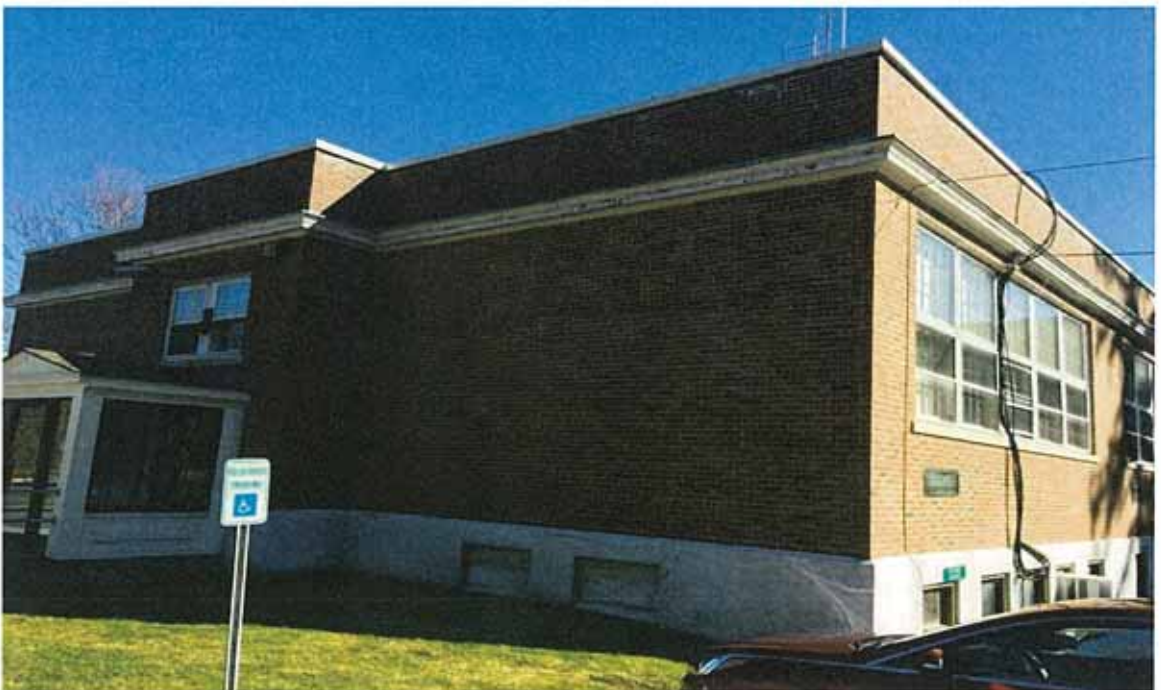
Exterior masonry and Façade are need of cleaning and repointing work to maintain integrity of building envelope and to prevent further deterioration.

| Deficiency | Proposed Fix | Estimated Cost |
|---|---|---|
| Deteriorating masonry, stained façade. | Pointing, patching, repair, cleaning, and patch concrete foundation | \$23,000.00 |

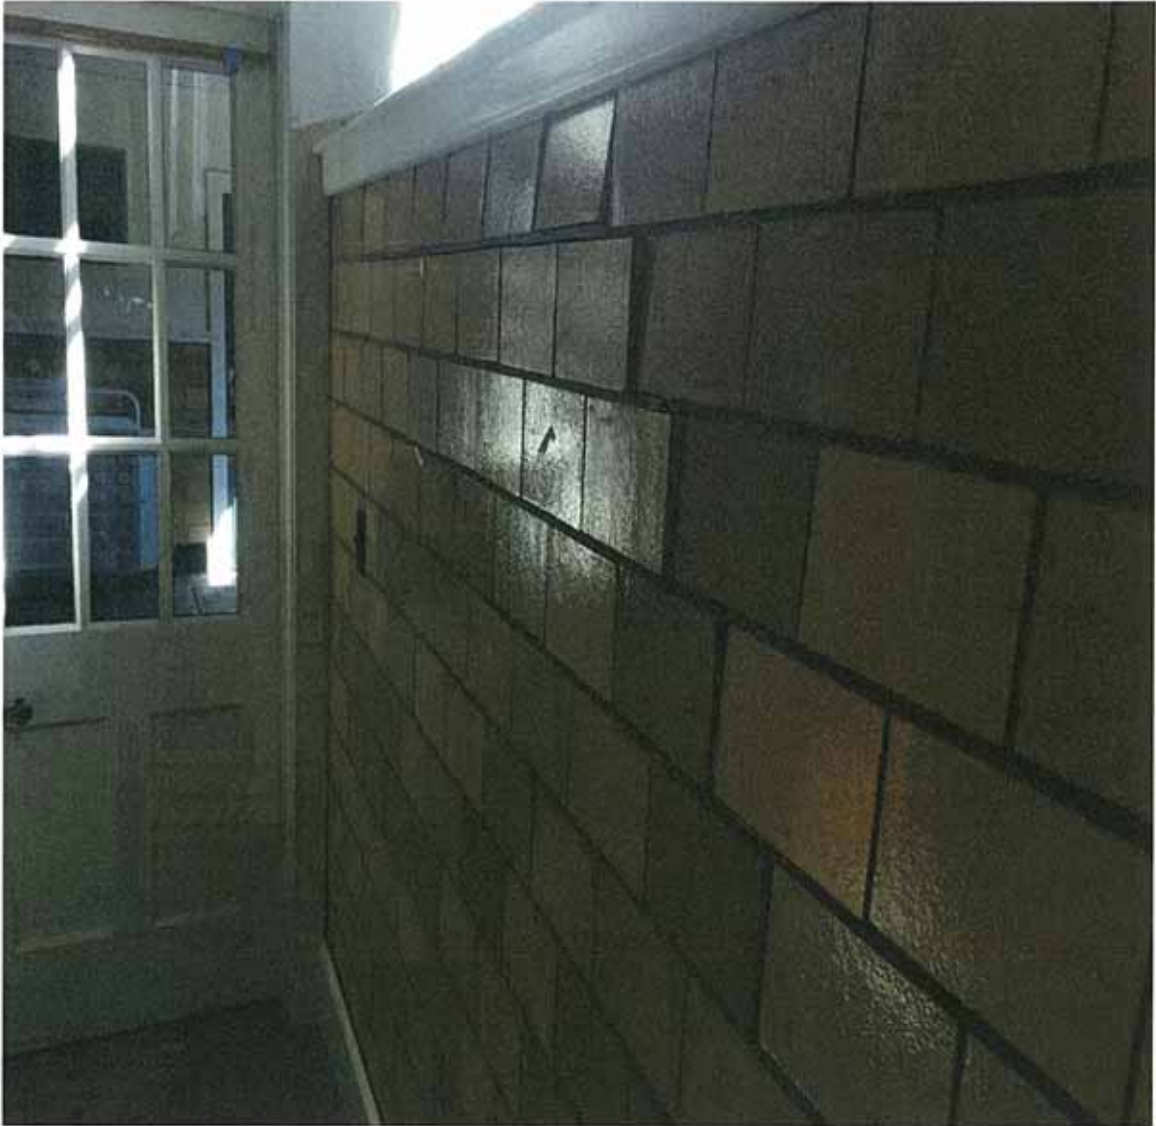
This shows the interior wall that needs partial demo and rebuilding to fix the underlying structure.

Apparent water infiltration of the building envelope has caused the accumulation of moisture in this wall cavity. The lack of sufficient insulation further subjects this cavity to freeze/thaw cycles that have combined to cause the glazed tile adhesive mortar to fail. Further repairs to the building envelope and additional insulation would be required to prevent reoccurrence. As we have noted moisture intrusion in the building, the age of the roofs should be verified to determine what the remainder of their life expectancy is.

| Deficiency | Proposed Fix | Estimated Cost |
|---|---|---|
| Interior Glazed Block wall | Remove, salvage block, repair wall framing, reinstall block | \$5,000.00 |

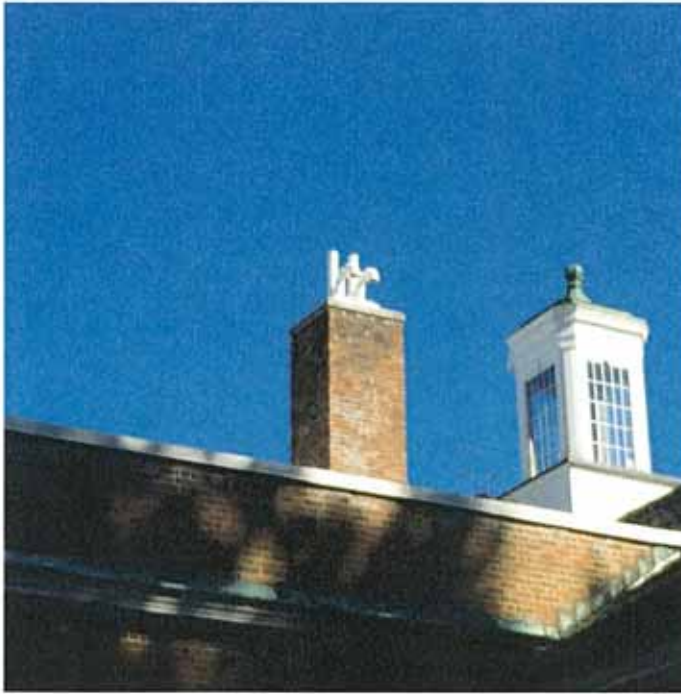
This Chimney is in need of repointing or rebuilding along with a new concrete cap to prevent further deterioration and water infiltration into the building.

| Deficiency | Proposed Fix | Estimated Cost |
|---|---|---|
| Deteriorating Chimney | Repoint/ Rebuild chimney, install cap | \$10,000.00 |

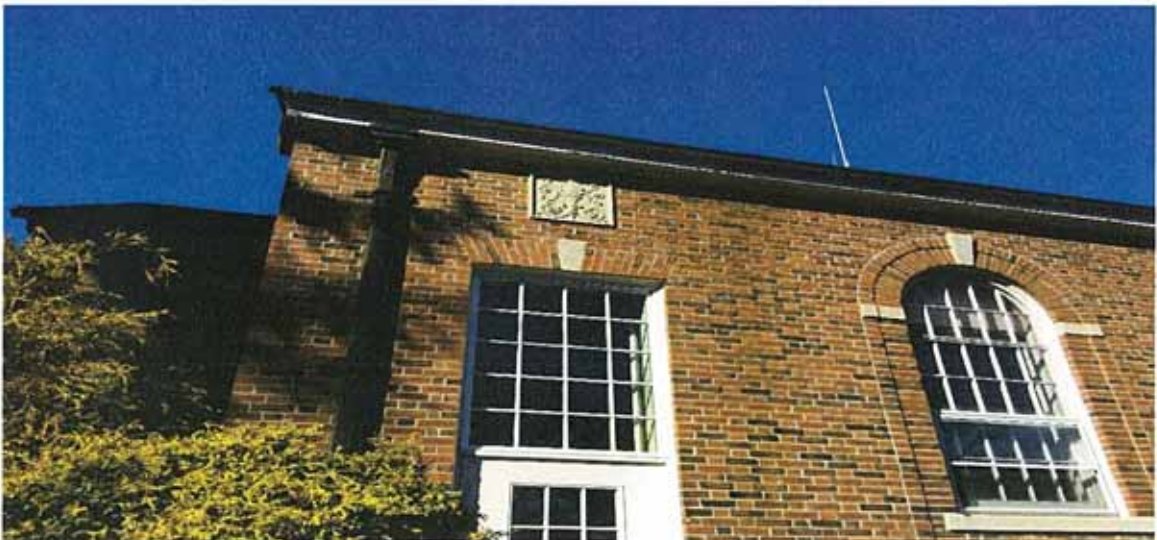
The windows are old, inefficient, and in some cases are deteriorating or not functioning properly.

New windows would offer increased comfort, lower maintenance costs, and should provide energy savings.

| Deficiency | Proposed Fix | Estimated Cost |
|---|---|---|
| Old windows | Replace with new more efficient windows | \$102,000.00 |
