# Hampden Senior Center Feasibility Study

Town of Hampden

104 Allen Street  
Hampden, Massachusetts

*January 2021*

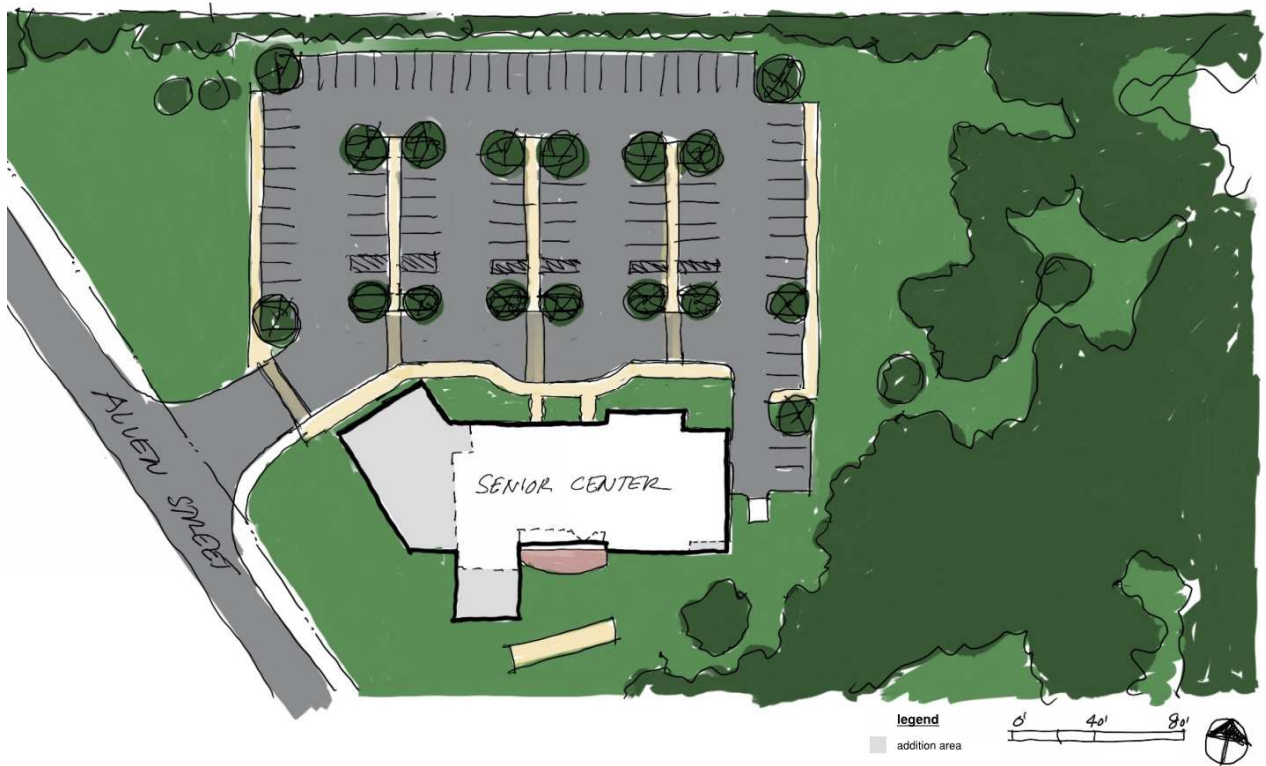
proposed site plan

The existing parking lot was determined to be in poor overall condition and the recommendation was to remove and re-pave the entire parking lot. In addition, the original parking lot and front entry walkway designs were deemed inappropriate for the use of the building and a new site plan with the parking layout reoriented has been provided as part of this study. Additional parking spaces were recommended as well, but due to on-site septic, proximity to wetlands and other site restrictions, there was no feasible way to increase the parking count in any significant manner. However, in discussions with the Senior Center Director, we came to understand that the Bethlehem Church across the street allows the Senior Center to use their parking lot in the few occasions overflow might be needed and it was determined that this condition is acceptable. The proposed site layout was estimated to have a project cost in the range of **\$1.5M and \$1.7M (construction cost + soft cost), based on an escalated construction cost to 2022.**

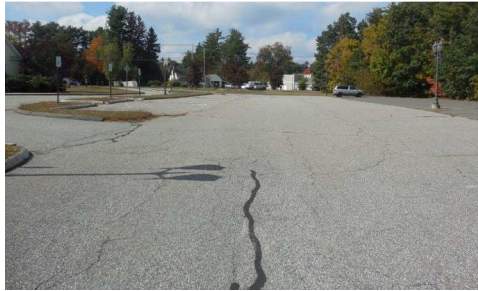
**parking** The existing parking lot has approximately 96 parking spaces and was originally paved around the year 2000, with additional spaces added thereafter. The pavement is cracked extensively with failure of the asphalt in the rear, adjacent to the sewer structures and dumpster pad. The asphalt curb is broken and has many sections missing or displaced. Parking spaces along the wood line are being overtaken by the trees and some clearing is recommended. The drainage grates are recessed and the grading to them doesn't meet recommended slopes at less than 2%. Consideration should be given for adding more structures allowing the existing grates to be raised. The grates are also not pedestrian friendly grates where canes, walkers and other assists could go clear through the grates.

cracking pavement

**design recommendations:** The asphalt and curbs are recommended to be replaced. The orientation of the parking could be improved by rotating the parking 90 degrees from the current orientation providing aisles for pedestrians and removing barriers. Some consideration could be given for adding sidewalks and improved access with less stepping up onto or over curbs. See attached site concept plan. The deeply recessed or pocketed grates should be raised to reduce steep grades into the grates by adding additional structures.

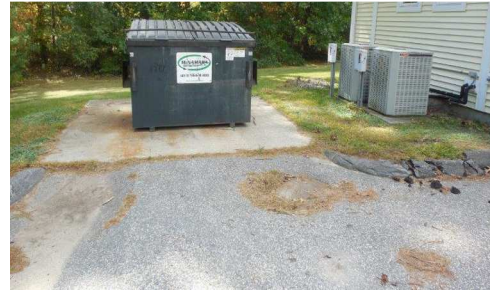
dumpster pad

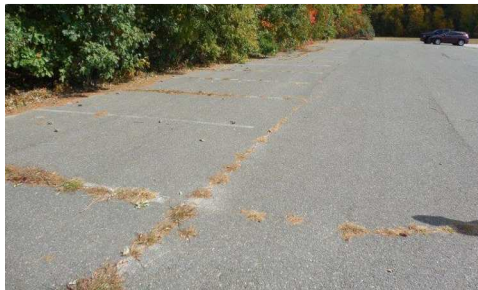
overgrowth at parking lot

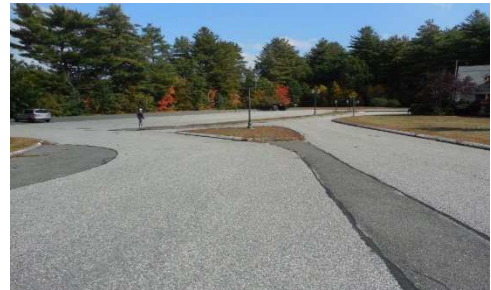
parking lot

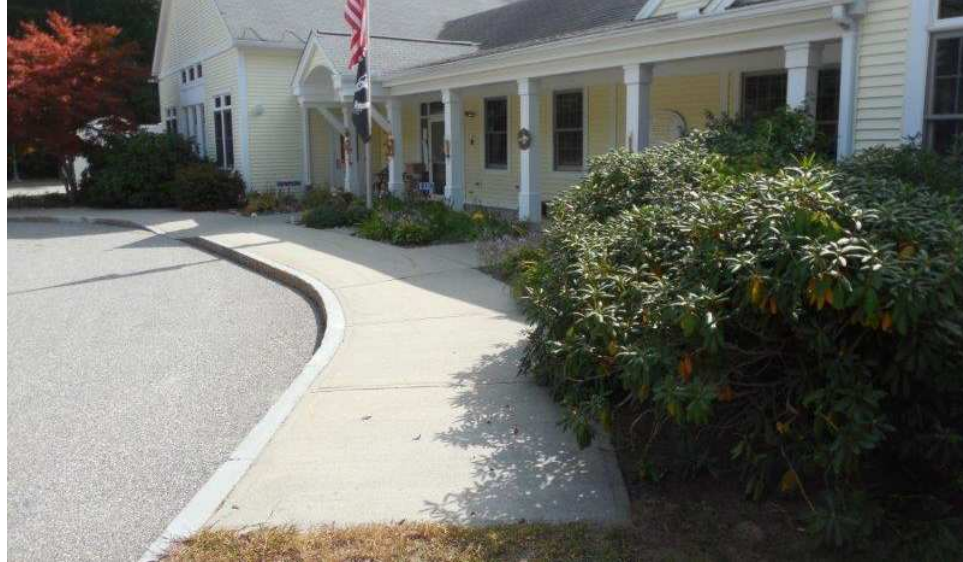
**walkways** The existing concrete walks appear to be in good condition in most locations and replacement isn't required. The sidewalks lack detectable warning panels at approaches to the parking lot which is a code compliance issue. Crosswalk painted markings are absent.

front entry walkway

**design recommendations:** As described above, it is recommended the parking lot be repaved and reoriented. Along with that, the front walkway should be made flush with the parking lot to reduce barriers for seniors. If the parking lot remains as-is, another drop-ramp is recommended which was proposed on the original plans. The crosswalk areas could be improved physically, have painted crossings, and cross walk signage.

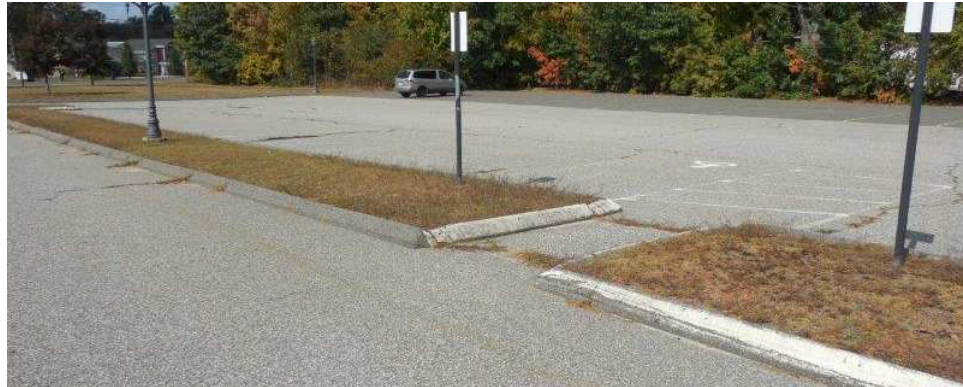
island between parking lot and drop off

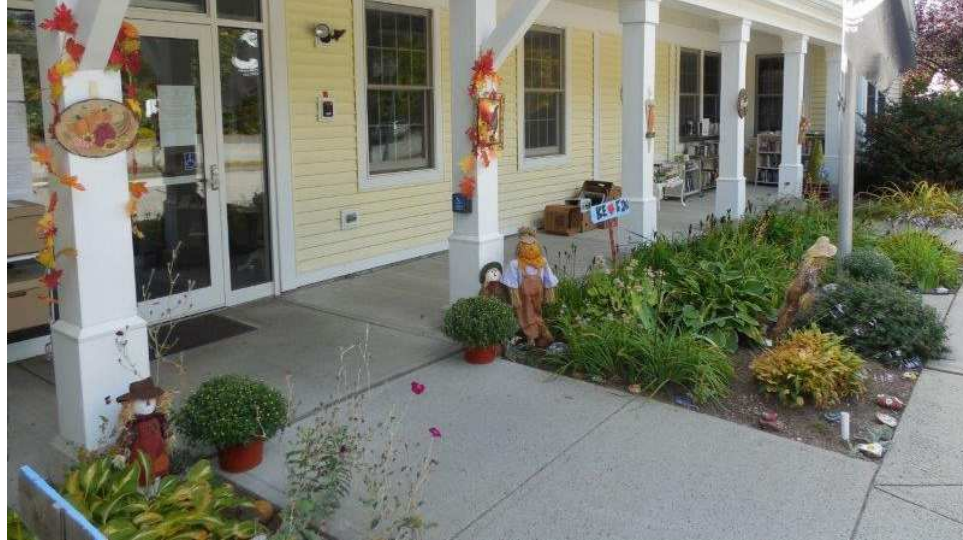
The front entry landscaping is well maintained and appropriate. The remainder of the landscaping has become overgrown and it is difficult to differentiate what is intended to be and what shouldn't be in the beds. The plants are touching the building which is an issue. The plants designed to screen the condensers have exceeded the design intent and are impacting circulation around the units. The lawn is intact with no signs of erosion.

front entry porch landscaping

**design recommendations:** Some of the existing plant material could be salvaged with strategic pruning and relocations. However, a substantial amount of material should be removed and replaced.

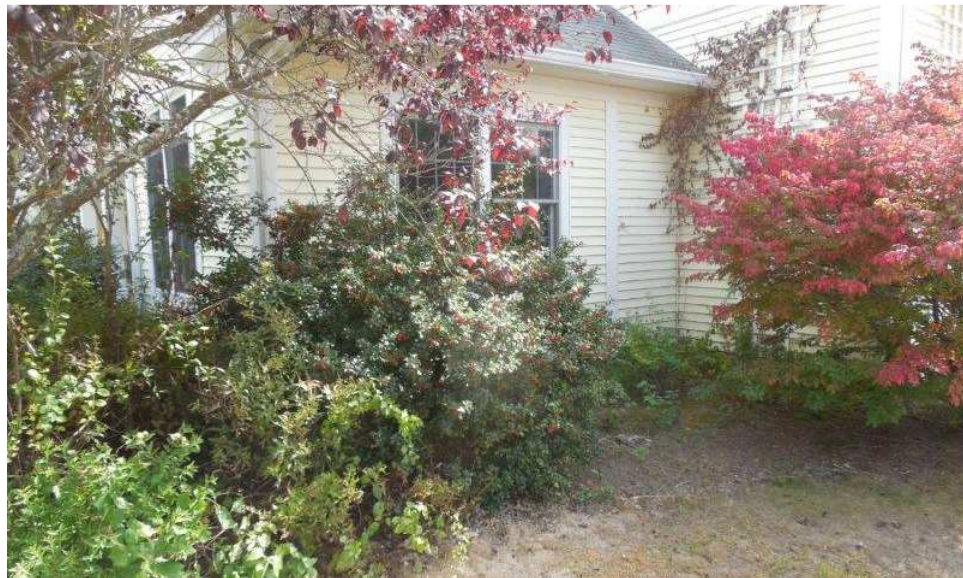
condenser screening

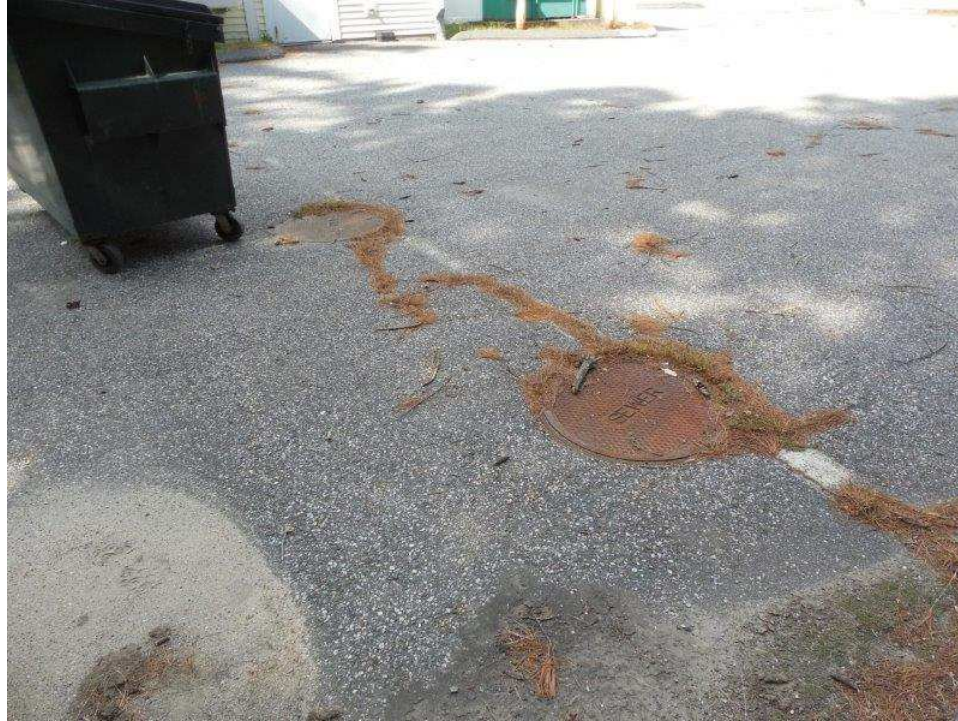
Based on record drawings, the building waste line connects to a 2,500-gallon septic tank located under the pavement within the loading area on the east side of the facility. A 1,000-gallon grease trap connected to the waste line from the kitchen also connects to the inlet pipe of the septic tank. A 2,500-gallon pump chamber pumps effluent through a 2" PVC pressure line to the existing septic field located at the northeast corner of the site adjacent to the parking area. Given the granular soils in the area, it appears the fields had to be elevated to attain the 5' minimum separation to seasonal high ground water.

manhole covers near dumpster pad

**design recommendations:** The existing system appears well designed and seems to have significant reserve capacity for future expansion. However, occupancy loads should be evaluated based on future occupancy of the building pursuant to the requirements of Massachusetts Title V. The existing pumps in the pump chamber are manufactured by Gould, which have proven reliable and will most likely have many more years of service life considering their intermittent use. The reserve area along the east side of the septic field can be used for future expansion of the field as necessary, which is greater than the 50-foot minimum setback, per Mass Title V, to the adjacent wetland resource area.

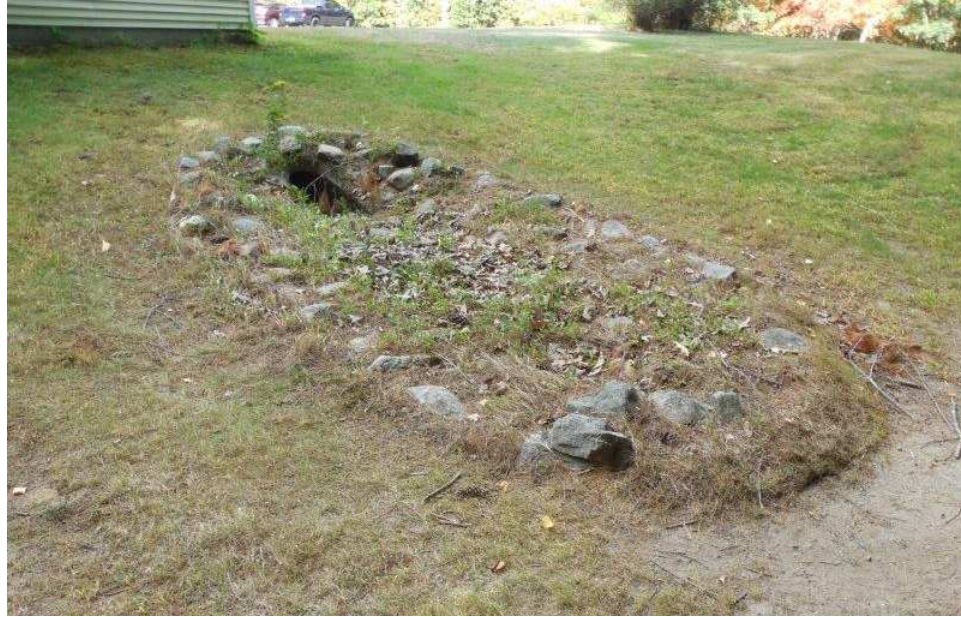
A stormwater collection system, consisting of catch basins connected in series with storm drain piping, drains the existing paved parking area and discharges to a stone riprap swale on the east side of the building. Rooftop runoff from the building drains to gutters and downspouts connected to drains around the perimeter of the building which we suspect connect to the same stormwater collection system that drains the parking area. Several of the downspouts were observed broken or disconnected from the perimeter drain risers. It appears no additional drainage structures were added when the parking area was expanded to the north.

stone riprap swale

**design recommendations:** The existing stormwater collections system should be evaluated for capacity with respect to the additional parking expansion to the north and any future additional impervious area that might drain to the system. The damaged downspouts and connections should also be repaired. Subsurface infiltration should be considered for runoff from the future building rooftop to attenuate overall peak flows from the site while addressing groundwater recharge and water quality requirements in accordance with the Massachusetts DEP stormwater manual.

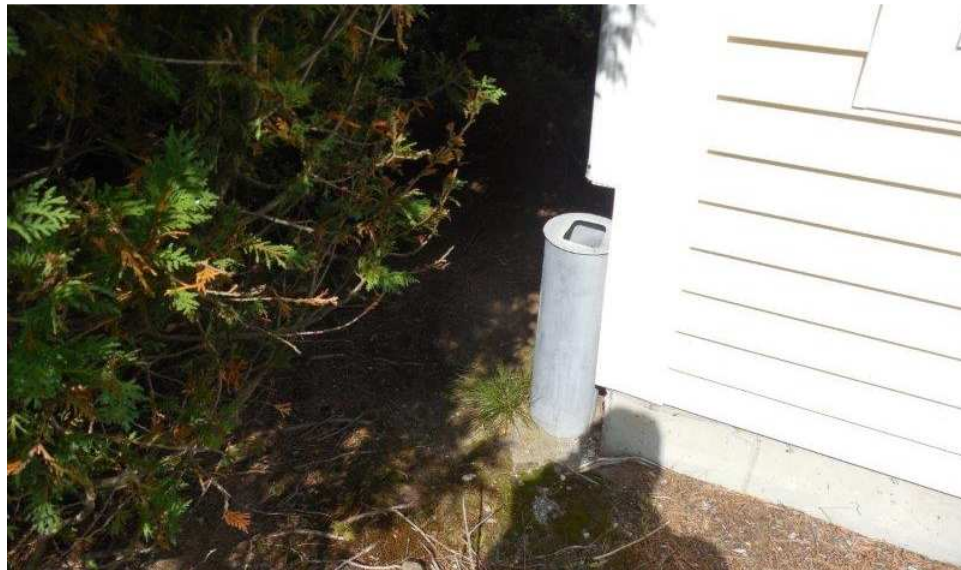
disconnected drain riser

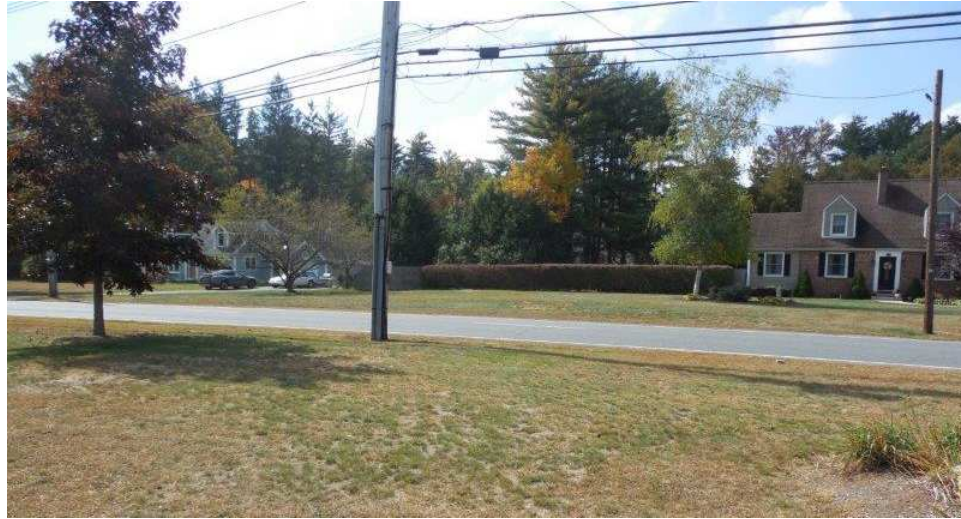
**electric service** The existing electric service runs underground from a utility pole on Allen Street and appears to run underground along the south side of the facility, entering the building at the emergency generator enclosure at the northeast corner of the building, into the utility room. The electric meter is located inside of the utility room.

utility pole on Allen Street

**design recommendations:** The existing electric service should be evaluated based on the additional electrical load associated with the building expansion. A cursory review of the electrical service is noted below in the building evaluation section.

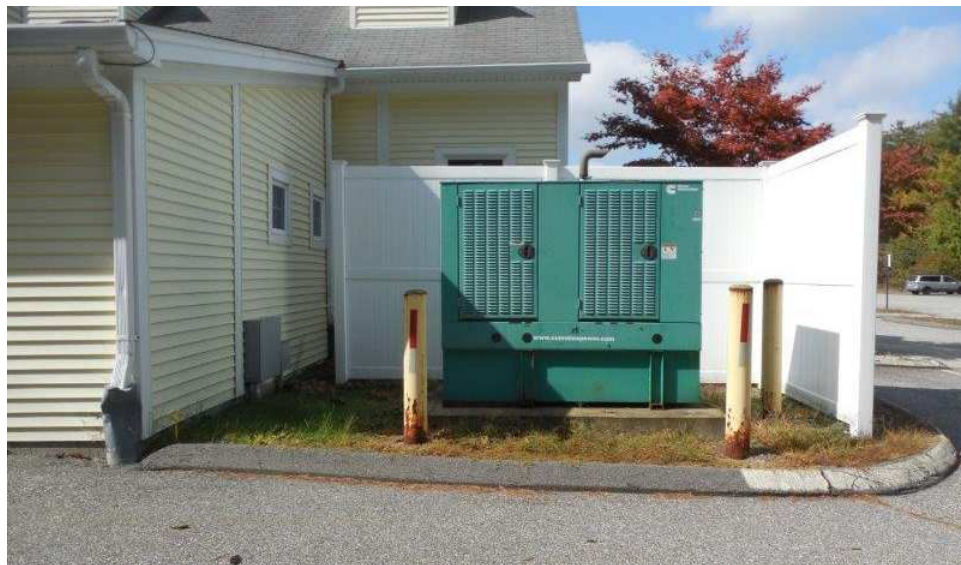
back-up generator

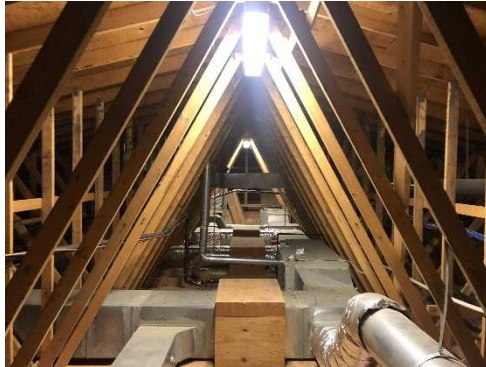
**exterior shell** The exterior shell of the building appears to consist of 2X6 wood wall framing (R-19 batt insulation) with a drywall finish to the interior and plywood sheathing, clad with vinyl siding towards the exterior on a concrete strip foundation. The roof construction consists primarily of wood trusses with plywood sheathing and asphalt shingles. The attic space created by the trusses is insulated at the floor. The slab on grade appears to only have insulation at the perimeter.

attic trusses

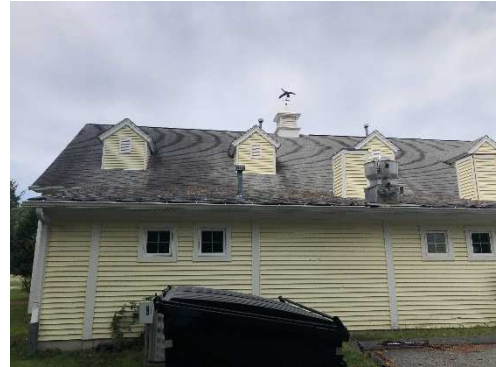
stained roof shingles

**design recommendations:** The existing exterior shell appears to be in overall acceptable condition. However, the asphalt shingles appear to be reaching the end of their life and it would be recommended to replace the shingles as part of the expansion design.

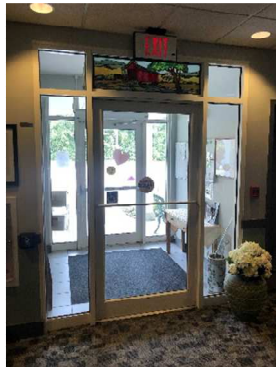
The front door is an aluminum storefront frame and has an automatic door operator. All of the interior doors appear to be painted hollow metal frames and doors. All of the windows appear to be operable (double-hung) vinyl window frames with insulated glass.

power door operator at front entry

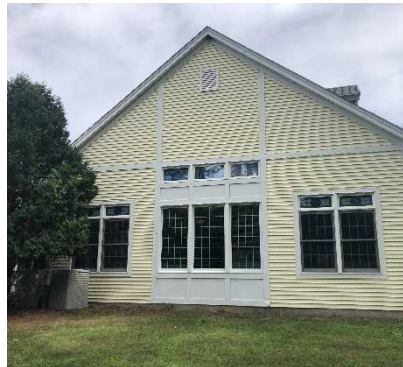
exterior view of windows

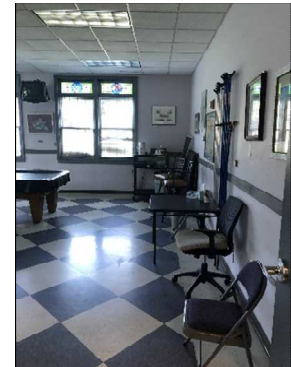
interior view of windows

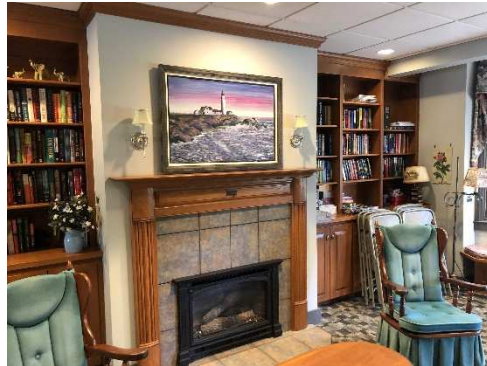
The library/lounge space is open to the main entry lobby, with fabric curtains used to separate the library/lounge for the main entry lobby when privacy is needed. Within the library/lounge space, there is a gas fireplace with surrounding stained wood trim and bookshelves.

library/lounge fireplace

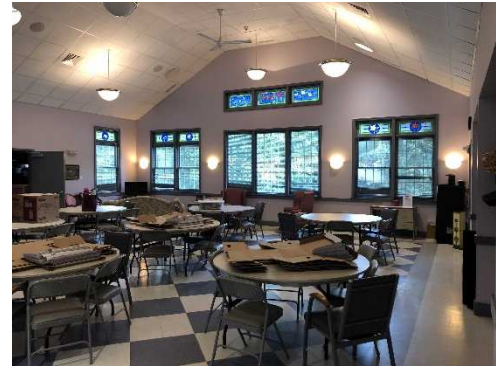
The large multipurpose room has a vaulted ceiling that consists of acoustic ceiling tiles and pendant light fixtures. The room can be separated by a large, manual operable partition that divides the room into 2 spaces, one larger than the other.

multipurpose room vaulted ceiling

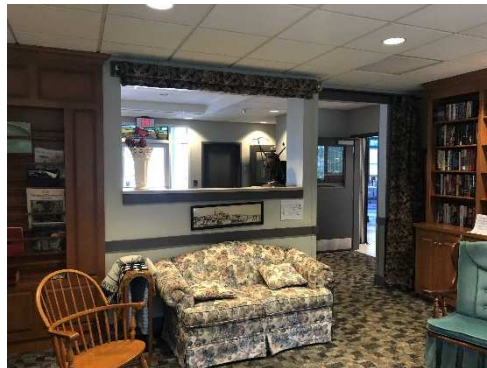
openings from library/lounge into main entry lobby

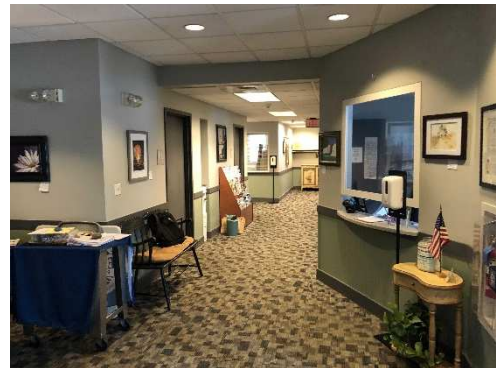
main corridor

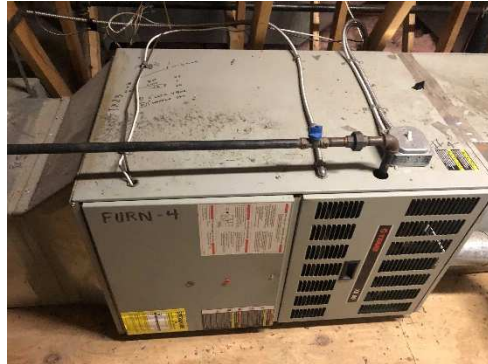
**HVAC** The existing HVAC system consist of (4) four gas-fired furnaces with DX cooling coils located in the attic. The kitchen has a separate mini-split unit that appears to have been added on after the original construction.

gas-fired furnace

**design recommendations:** Extend existing ductwork from existing gas-fired furnaces to serve new Storage Room and enclosed porch infilled additions. Install three new attic mounted gas-fired furnaces with split DX based air conditioning to serve spaces in new addition.

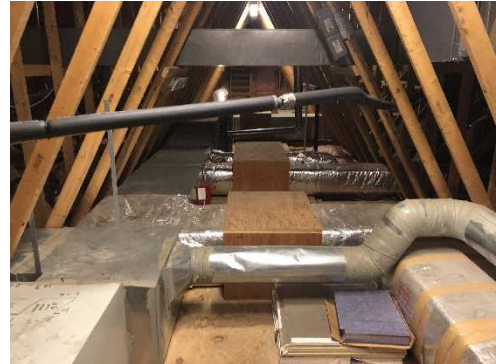
ductwork in attic

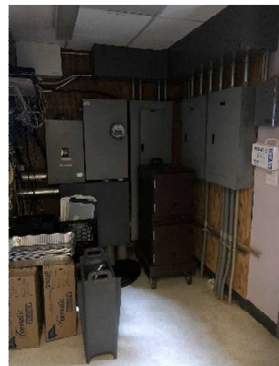
**electrical** The electrical service at the current facility is rated at 208/120V, 400A, 3-phase, 4-wire with a peak demand of 43.05kW (as supplied by the client). Based on calculations utilizing a watts / sq. ft. method, and assuming general lighting, convenience power and a single packaged air handling unit providing heating and cooling, the existing service is assumed to be adequate to handle the additional loads for the new proposed expansion of the existing facility.

electrical panels

**design recommendations:** Modifications to the distribution system may be required due to lack of available spare circuits in the existing panelboard(s). This would require replacement of existing panels or additional panels configured in a sub-feed setup.

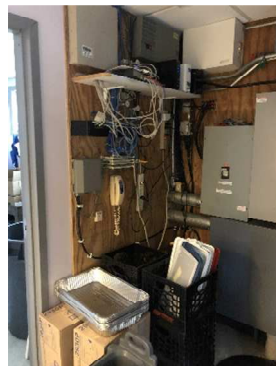
technology/security equipment
