TOWN OF HAMPDEN Fire Department Conditions Assessment & Expansion Options Report

Phase 1

July 14, 2020

Mitchell Associates Architects, PLLC
29 Thacher Park Road, Voorheesville, NY 12186
518 765-4571 www.mitchell-architects.com

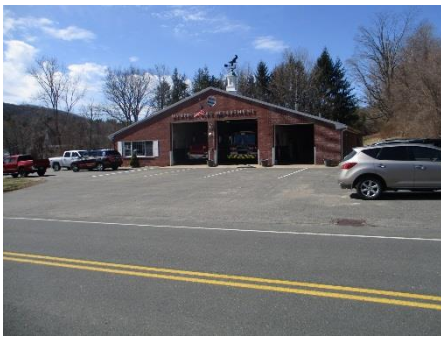
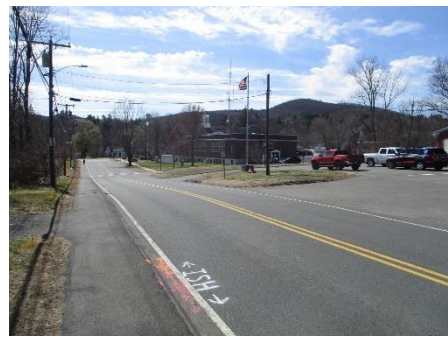
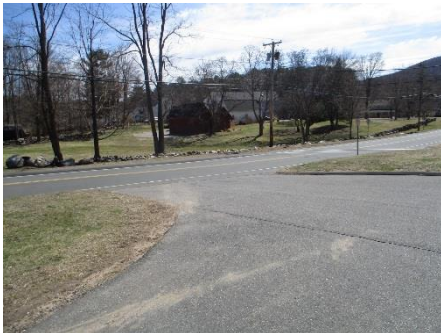
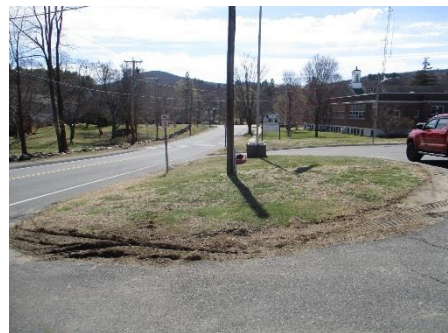
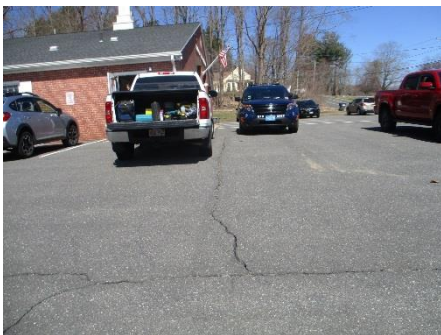
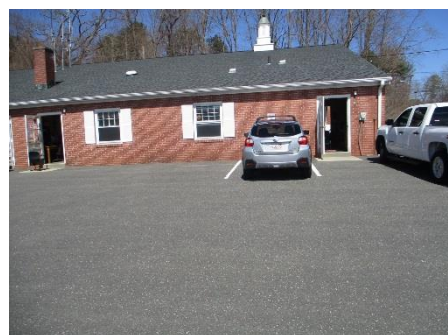
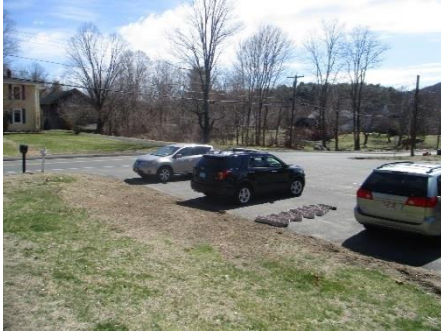
The existing site is accessed from North Road with two sets of egress drives to the road. One drive provides dedicated egress for the fire apparatus bays at the north side of the site and the other drive provides egress for Apparatus Room #3 as well as firefighter and visitor parking on the south side of the site; see *Images-001 through -006*. Additional firefighter parking exists on the northernmost portion of the asphalt driveway beyond the bay door openings; see *Images-007 and -008*. Only one striped parking space exists on the site and there is no dedicated accessible parking space, although room exists and simply needs to be signed and striped.

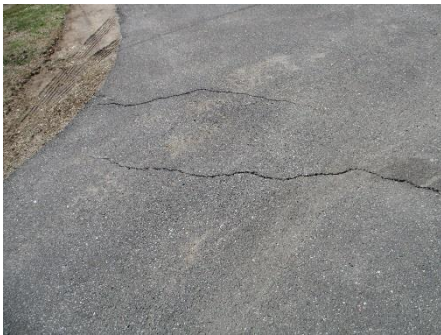
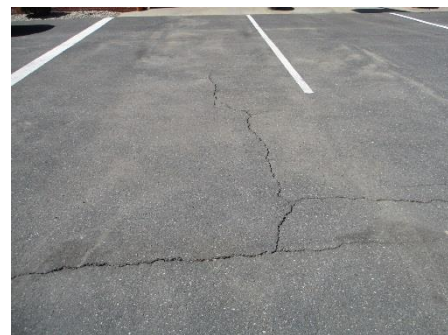
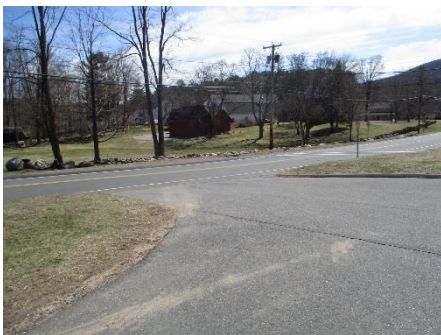
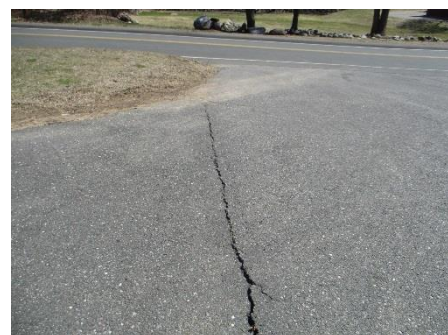
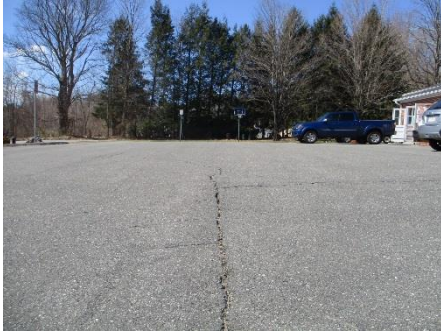
The site has asphalt surfacing wrapping around the building on three sides - to the east, south and west - and was replaced approximately 6 years ago by Department of Public Works (DPW) personnel. Overall, the asphalt is in good condition although areas of settling are developing primarily on the southeastern and southern portions of the site. **Sizable cracks have developed**, and immediate sealing is needed to stop the increase of water infiltration, erosion, and further settlement; see *Images-009 through -014*.

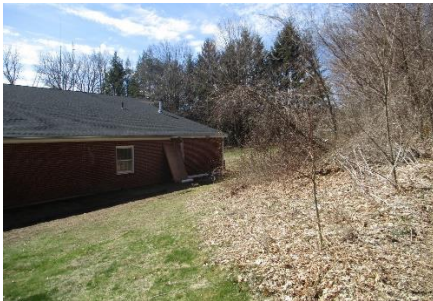
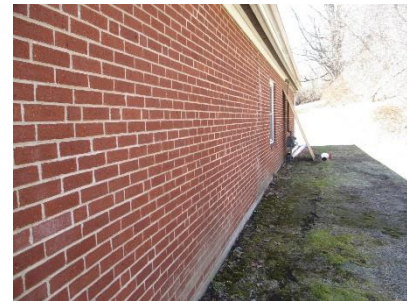
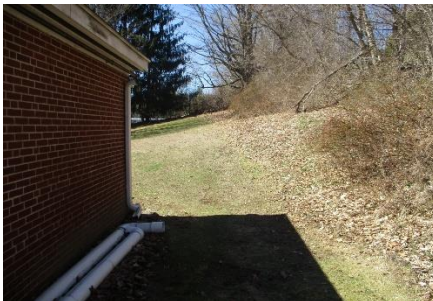
The site has a steep slope down toward the building at the north and northwest of the building. An erosion swale has developed as a result of this condition and the moisture and lack of sun on the north side of the building has created **large areas of moss development and moisture retention at the building base**; see *Images015 through -017*. The west side of the property offers a more level grading and appears relatively flat and free of water retention; see *Image-018*.

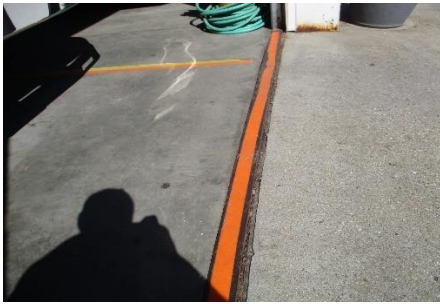
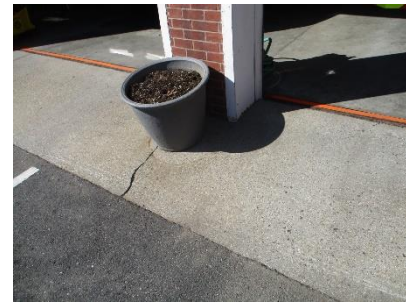
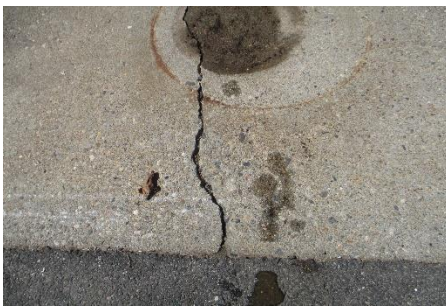
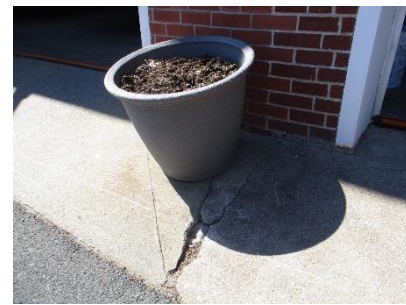
Separate building concrete aprons do not exist at the 3 bay door openings facing North Street; rather, the site asphalt aprons run back to the leading edge of the Apparatus Bay concrete slabs. This is atypical for current station design as asphalt aprons are not as robust as concrete aprons that sit on the foundation walls. Asphalt aprons have tendencies to settle and need replacement every 10-20 years, while properly formed and designed concrete aprons should have a life expectancy of 50+ years thus greatly reducing the possibility for water intrusion at and under the structural bay slabs. The current **asphalt aprons are cracked** and have begun the water infiltration process creating further settling and widening of the cracks. These should be repaired/sealed to eliminate further deterioration; see *Images-019 through -022*. The bay opening for Apparatus Room 3 was designed and built with a building

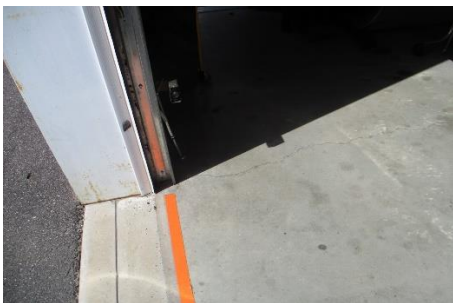
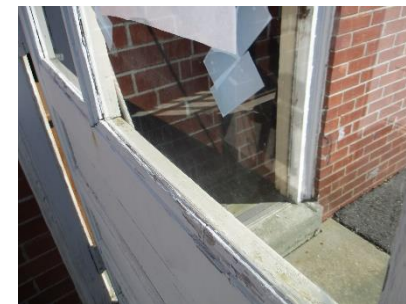
concrete apron and its condition was observed to be in good condition; see *Images 023 and 024*. It should be noted that this building apron is integral to the Bay concrete slab and future cracking at the interior top edge of the foundation wall may occur.

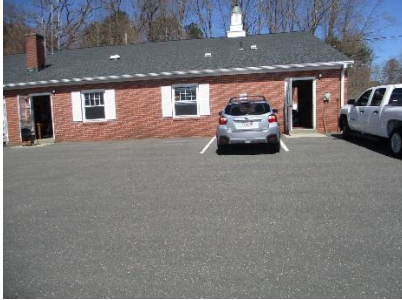
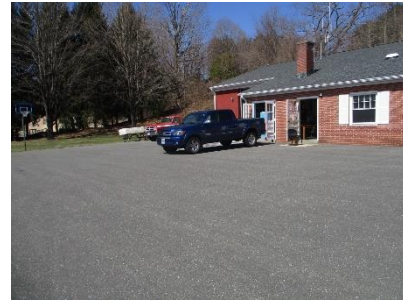
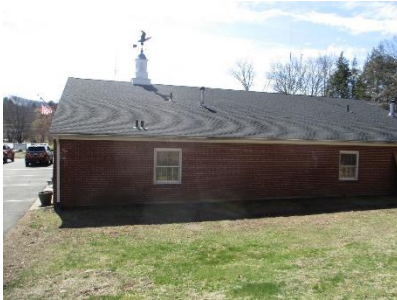
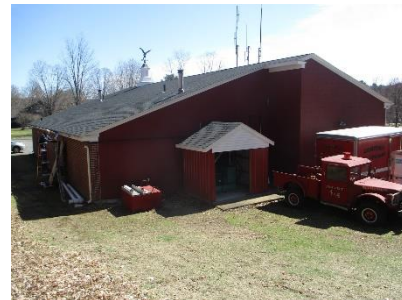
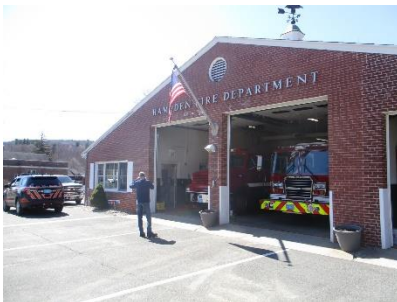
The facades of the fire station are in **fair to poor condition** depending on which façade is viewed. The south and west facades are in fair condition, while the north and east facing façades are in fair to poor condition; see *Images-025 through -030*. The east facing façade spans from the Radio Room at the south to the 1988 addition at the northern end of the building. Most of the issues on the eastern façade are due to **water damage and infiltration into the exterior wall system**.

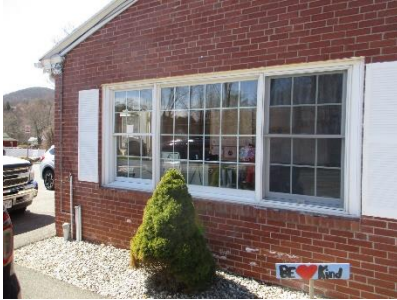
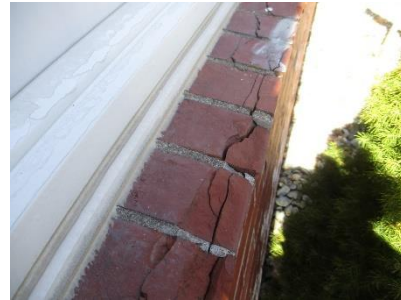
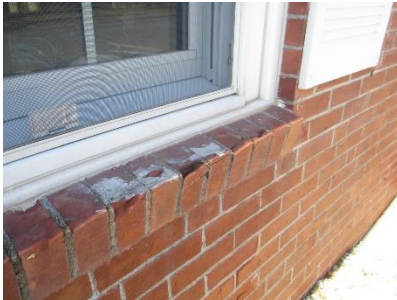
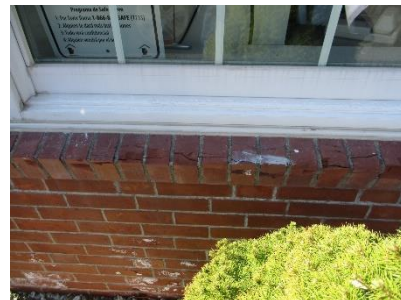
The eastern façade is comprised of a mix of two different construction projects. The Radio Room and two Bays adjacent to the Radio Room were part of the original 1963 build. The brick façade is mostly in fair condition except for **significant cracking and spalling of the brick sill units** most likely due to water entering the wall assembly. Spalling occurs when moisture gets inside the brick and freezes, causing the face to spall off, vastly increasing the deterioration process for bricks. **Mitigating these conditions is important to slow down the deterioration; see Images031 through -034.**

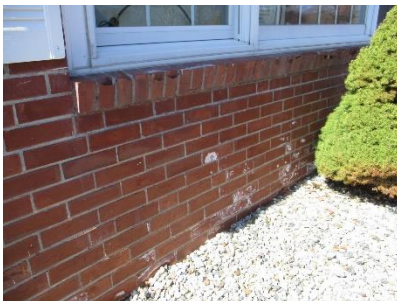
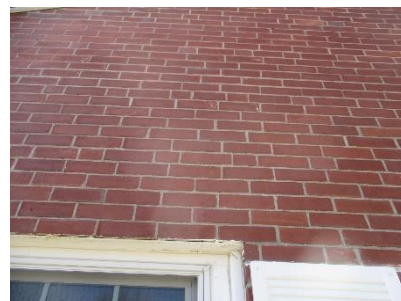
A replacement window was installed at the Radio Room due to severe rotting of the original 3-unit window assembly. Sealant at the bottom of the new window assembly appears intact and properly installed. This is the likely point of previous water entry into the exterior wall causing the **cracking/spalling bricks** at the sill and **efflorescence** (white "staining" caused by salt and lime pulled out from inside the brick by water). Sealant is missing from beneath the steel lintel above the Radio Room window and should be installed immediately to prevent more water from entering the wall assembly; see *Images-035 and -036.*

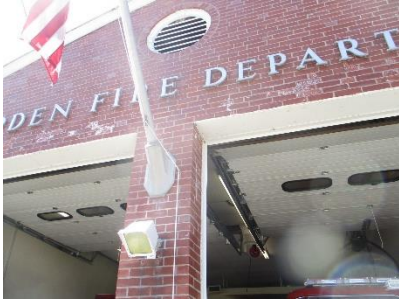
Image-037

Further signs of efflorescence exist on the east façade above the original two bay door openings. It was inconclusive from our field visit the source of **water entry into the exterior wall assembly** at these locations; see *Image-037*.

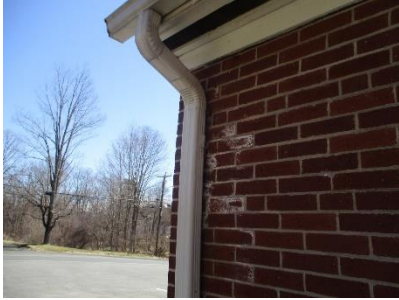
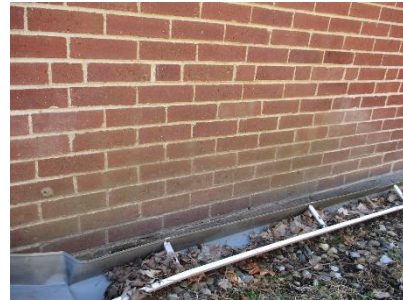
Further conditions needing remediation are a failing rain gutter system on the north side of the facility and additional areas of **efflorescence** also exist on the northern side of the 1988 addition; see *Images-039 through -042*.

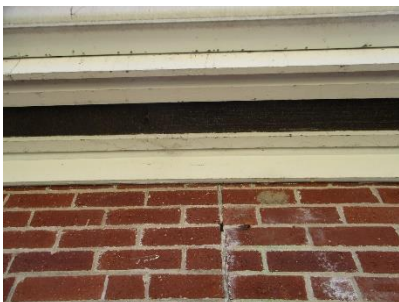
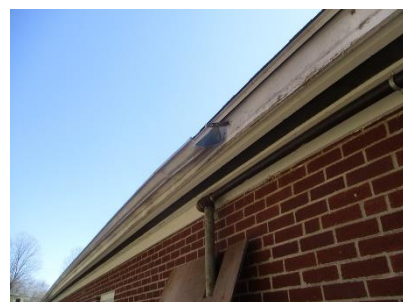
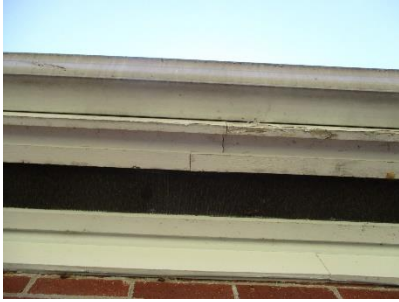
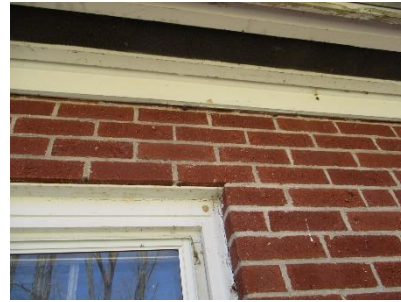
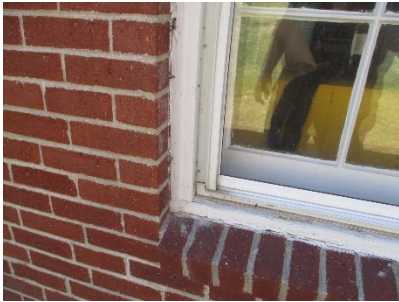
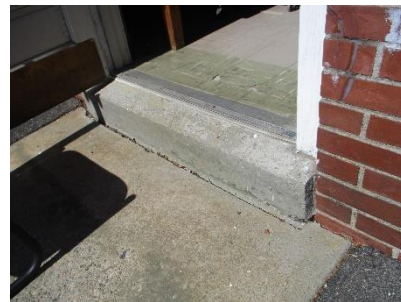
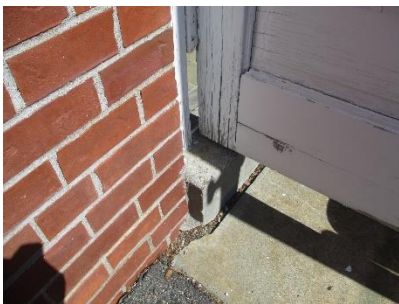
Other conditions on all facades requiring attention are **failing masonry expansion joints, deteriorating wood trim throughout, rusting steel lintels, failing window sealant and sunken concrete exit pads**; see *Images-043 through -050*. All wood trim on the exterior façade at roofline and windows should be replaced in its entirety.

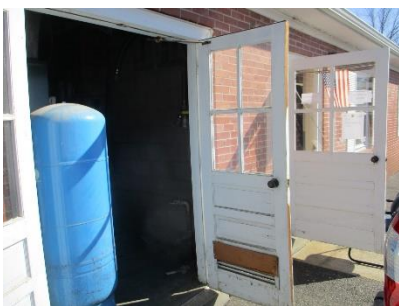
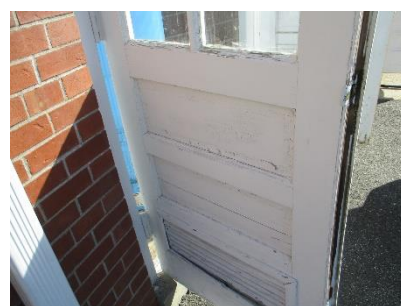
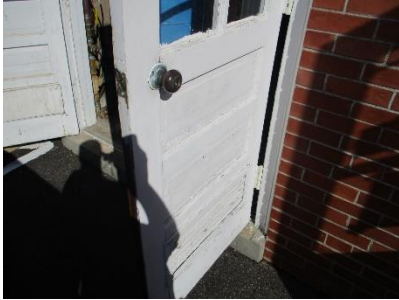
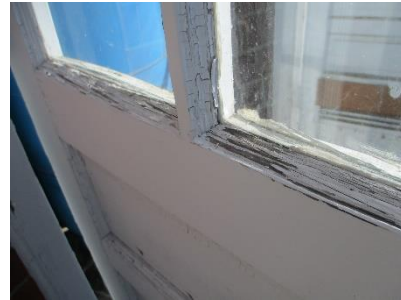
Exterior doors, likely from the original 1963 construction, have single pane vision glass and are past their useful life and should all be **replaced with exterior grade doors with tempered/insulated glass**; see *Images-051 through -054*.

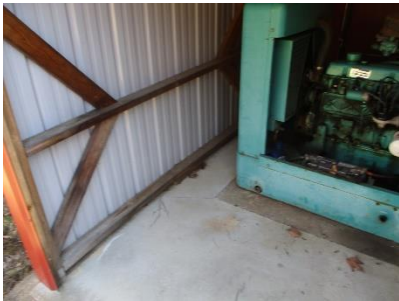
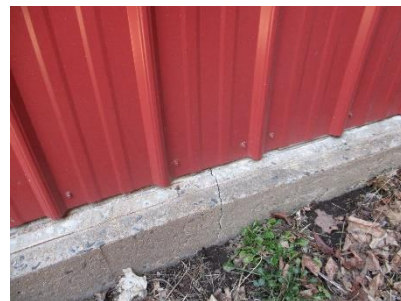
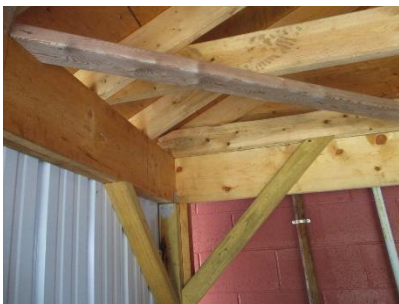
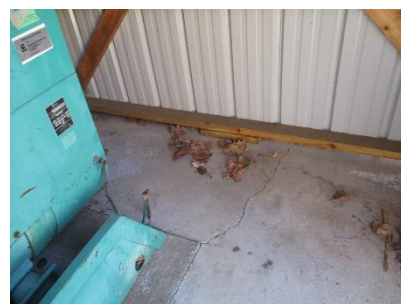
An exterior, open-faced shed on the west side of the building houses the building generator. The generator sits atop a small concrete slab which is surrounded by a larger concrete slab which supports the shed walls. **Cracks have developed** at the corners of larger concrete slab, at the corners of the smaller generator pad. These cracks should be sealed immediately to prevent further deterioration. The shed appears to have been built in-place and is inadequately framed with only the corner posts tied down to the slab. The sill plates are raised above the slab with wood blocking. Drilled in epoxy embedded anchor bolts should be added at each blocking location.

The roof rafters should have hold-down brackets installed per current Code for to prevent roof uplift; see *Images-055 through -058*.

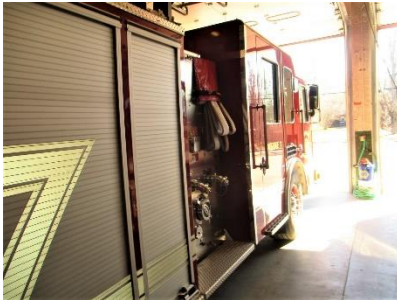
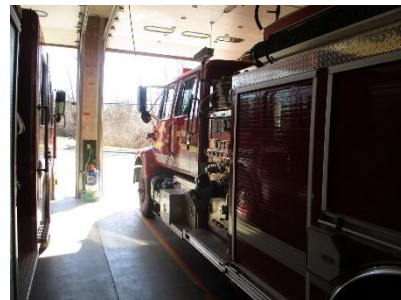
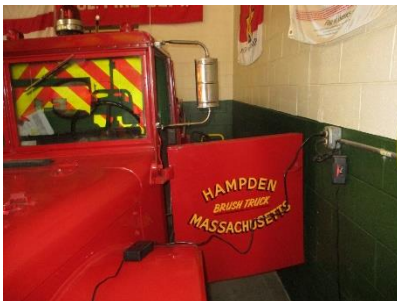
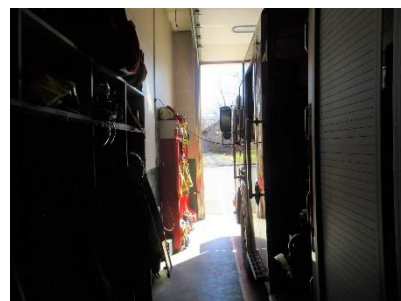
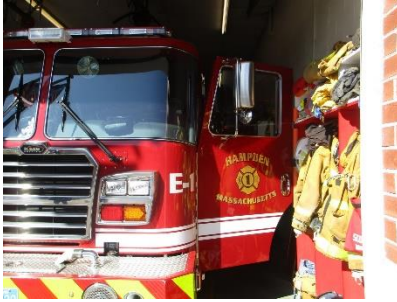
2-bays with 12' x 12' apparatus openings, these bays represent what is quite common for 1960's era station design. With narrower trucks, the 12' opening widths were appropriate for the time of construction but with modern apparatus averaging a full 8' in width and large side mirrors often extending the widest points of the apparatus from 11' to 12' in overall width, modern bay openings are designed at 13'-4" to 14' in width to allow better clearances at the bay doors as well as down the bay aisles. **Fire Safety Code deficiencies and deployment egress issues** with the existing aisle widths are exhibited in *Images-059 through -064*.

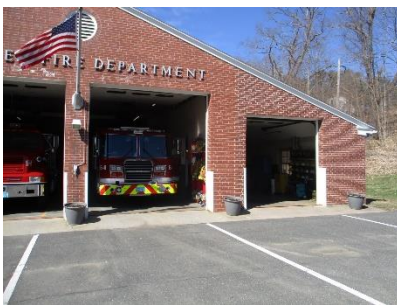
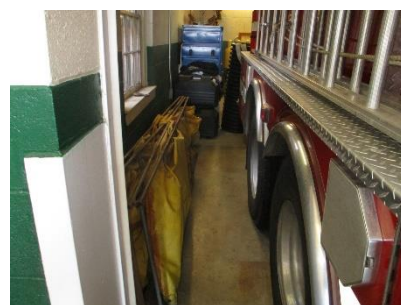
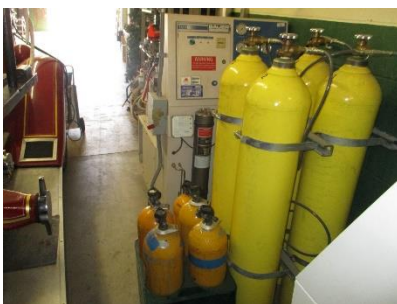
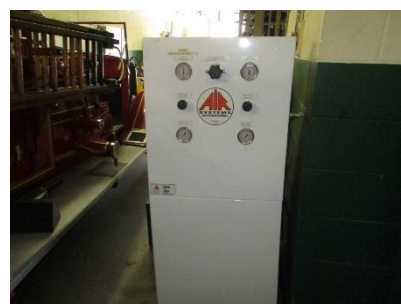
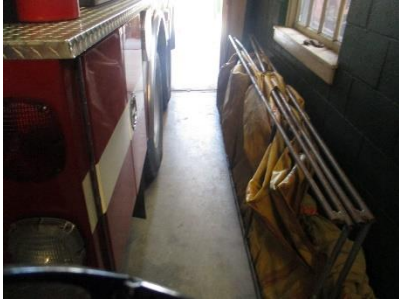
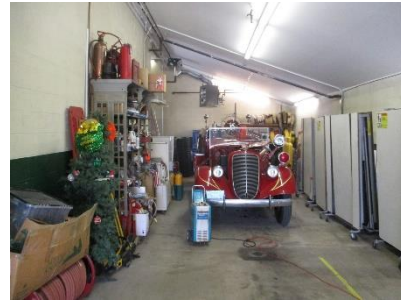
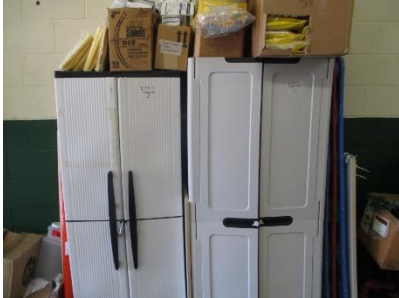
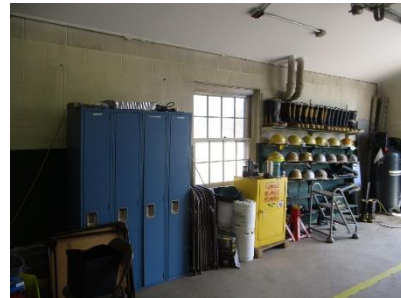
While only 32 years old at the time of this report, **this bay’s use is quite limited due to the size of modern-day firefighting apparatus** and should be repurposed for other facility needs.

The design intent of the north-south section of bay representing the short leg of the “L” is unclear. This bay currently houses a hose rack and firematic storage at the back end of the station’s tanker. See *Images-065 through -072*.

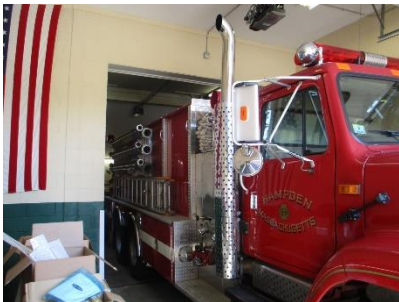
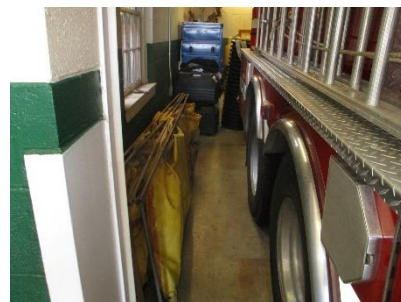
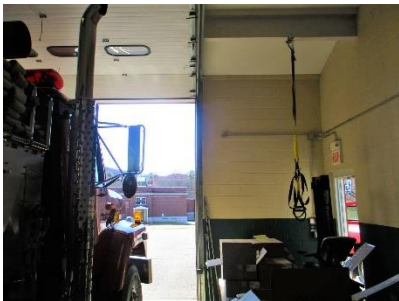
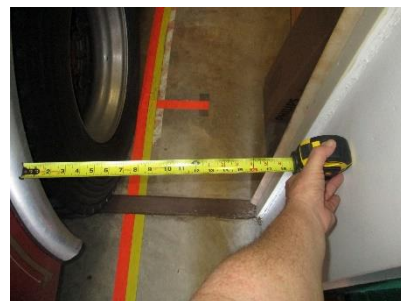
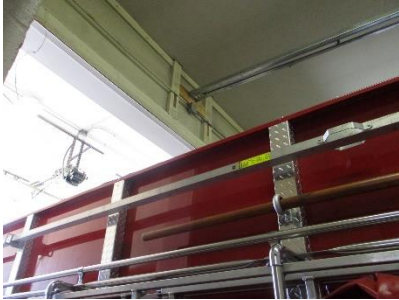
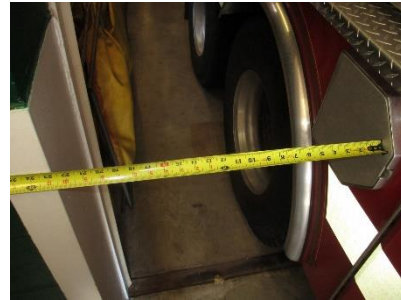
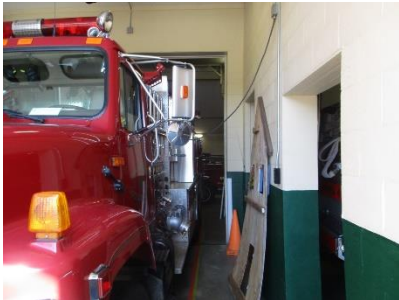
The 2011 addition was a small, square addition on the southwest corner of the facility which lengthened the short bay facing south in the 1988 addition. The extended bay now houses the Fire Department's T-1 Tanker. While acceptable in length, the width of this bay does not meet the needs of a modern-day apparatus bay. The clear distance between the side of the truck to the wall between the 2 additions is less than 20". This is **far narrower than the required OSHA and Building Code clearances and recommendations from NFPA**; see *Images-073 through -080*.

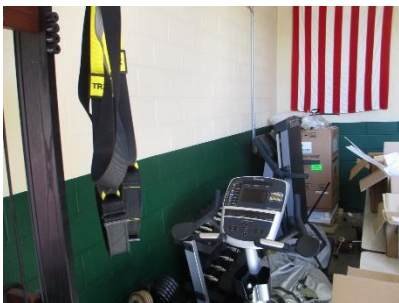
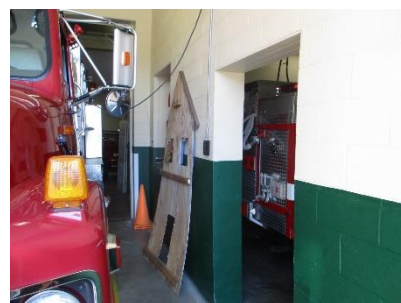
As mentioned above, firematic equipment and materials are stored in the narrow bays and at the back of bays **further reducing egress and creating safety concerns for First Responders**. While the side clearance next to the apparatus in *Image-080* above is more like modern-day designs, the floor is covered with storage boxes due to the **lack of dedicated Storage Rooms**, thus reducing the egress path to a non-conforming width; see *Images-081 and -082* for further examples of floor space hazards.

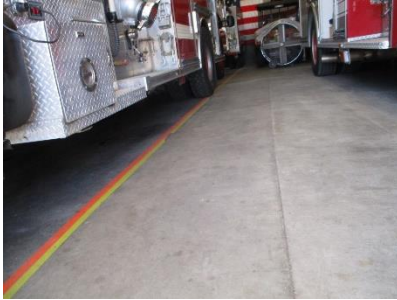
Image-083

The 1963 bays are 6" thick slabs, per the original building plans, and are each sloped separately to two (2) square cast iron drains centered in each bay. Despite their age, these slabs appear in moderately good condition. The bay concrete slabs are unfinished (i.e., not seal-coated nor broom finished) and have an average to below-average slip resistance for firefighter safety. Some minor surface cracking was observed throughout, although these cracks can be corrected by removing all loose materials, air blasting to remove any dust and particulates, and infilling the slabs with a structural crack sealer.; see *Images-083 through -086*.

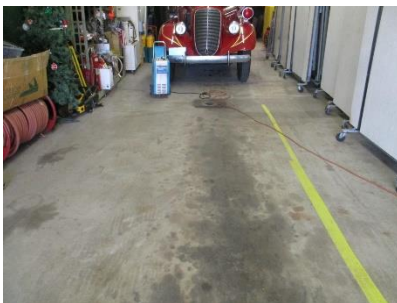
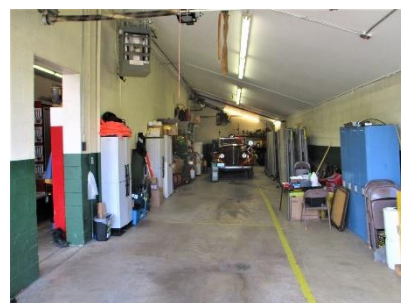
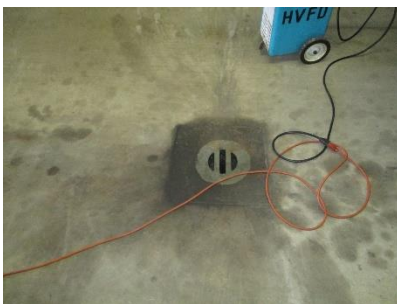
The 1988 Addition main bay (facing North Road) is sloped to the center of the bay and drains to two (2) round cast iron grates atop a larger drain plate. The slab had no observed cracking or settlement issues. The slab did exhibit a good amount of floor grease from the on-going maintenance in this bay. The Bay concrete slab is unfinished (i.e., not seal-coated nor broom finished) but has an apparently acceptable slip resistance for firefighter safety; see *Images087 through -090*.

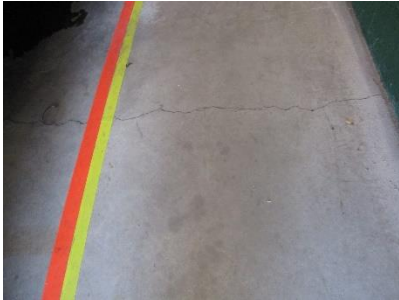
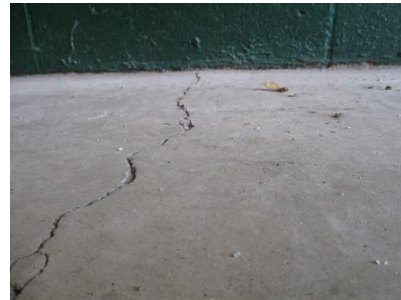
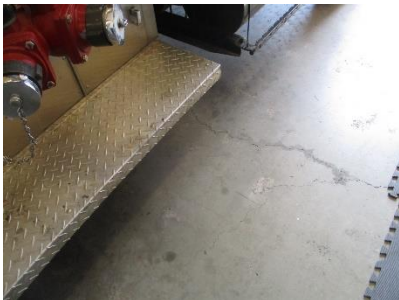
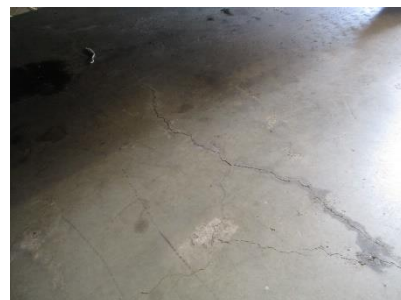
The 2011 small Addition on the southwest has a single cast iron drain centered in the 22' x 23' bay. The slab has developed numerous cracks which appear to be shrinkage cracks and not settlement cracks, although that has not been confirmed under the limited scope of this visual field investigation. The Bay concrete slab is unfinished (i.e., not seal-coated nor broom finished) but has an apparently acceptable slip resistance for firefighter safety; see *Images-091* through *-094*.

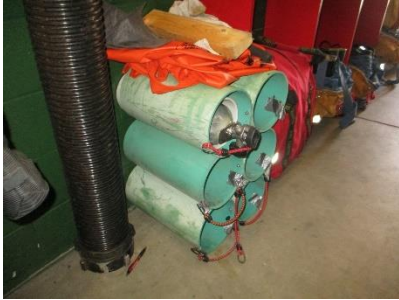
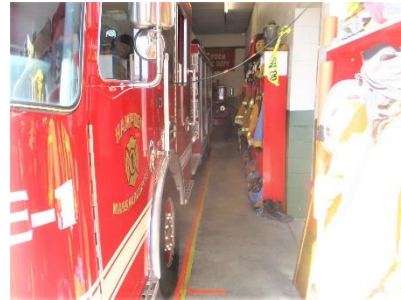
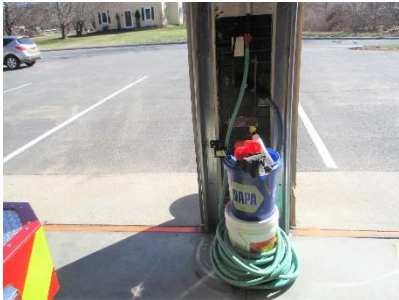
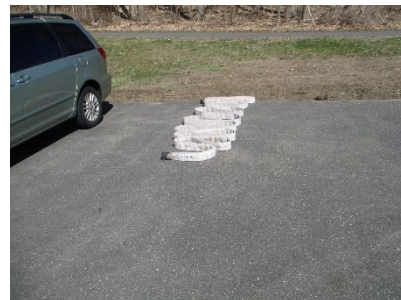
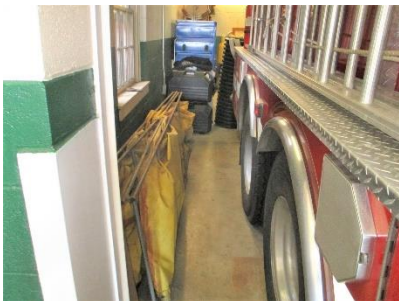
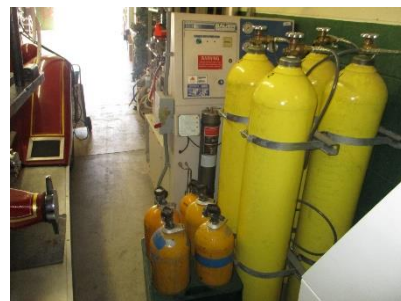
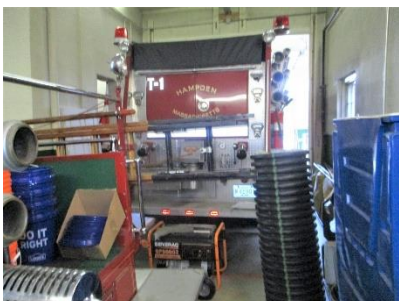
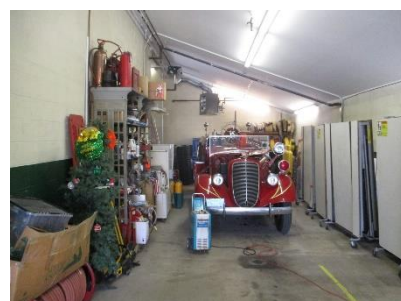
There are no residential style washer/dryers for cleaning rags and responder personal clothing after a fire event. No Washer/Extractor nor Gear Dryer for cleaning turn-out gear exists in the station. (It should be noted that the current Chief was implementing a plan to install a newly acquired washer/extractor into a wall niche into the current Woman's Restroom.) There are no sinks, drinking fountains, or hand-washing stations located anywhere in the three bays. All maintenance tools and firefighting gear are located within the bay egress paths on both sides of the apparatus; see *Images-095 through -102*.

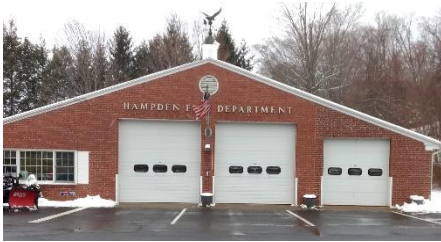
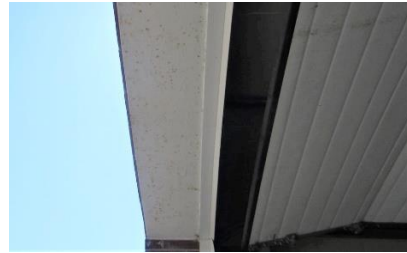
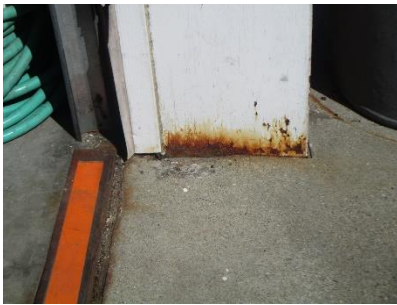
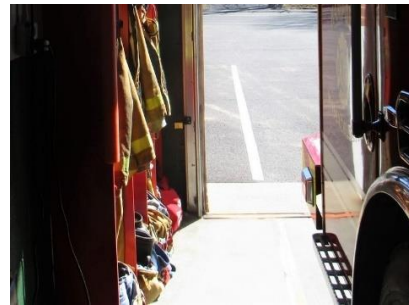
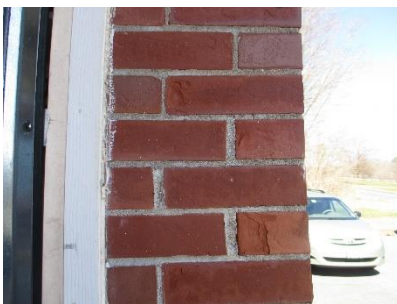
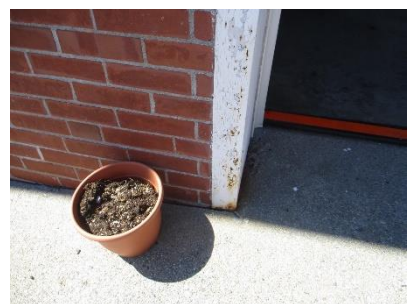
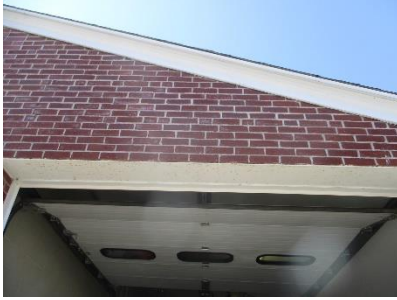
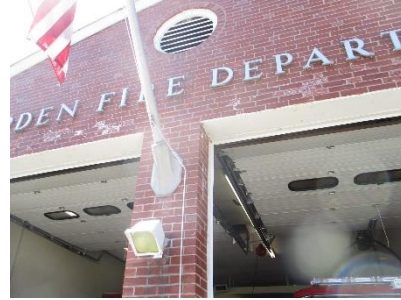
The overhead (OH) bay doors appear to be in good working order and have safety devices such as obstruction sensors, but do not have red/green lights installed. The doors are operated by a trolley hoist system. The bottom EPDM “U-type” bottom seal is showing signs of wear and should be replaced during the next maintenance visit by the vendor. The steel support lintels are showing **signs of initial rusting and efflorescence is visible directly above all three bay openings** facing North Road. The surrounding masonry at the bay door openings are slowly **failing** due to internal moisture and brick facings are seen “popping off” the brick units which will speed up the weathering deterioration of these masonry walls. Rust mitigation and sealant are needed to prolong the life of the steel and brick facade; see *Images-103 through -110*.

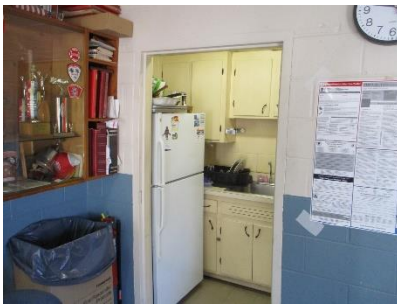
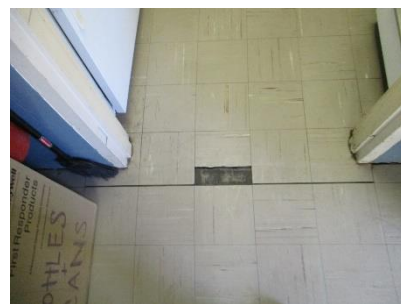
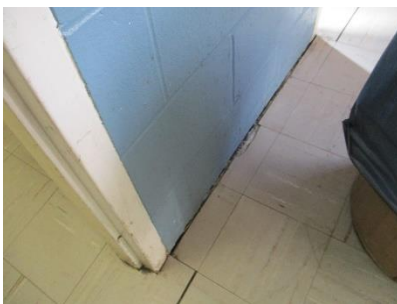
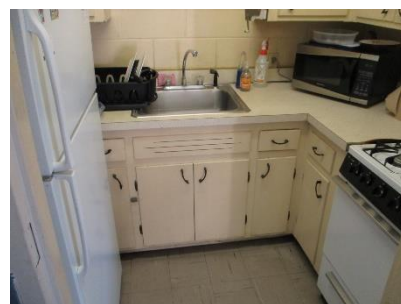
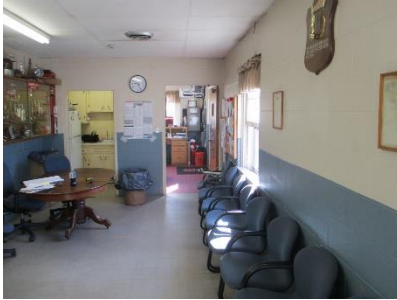
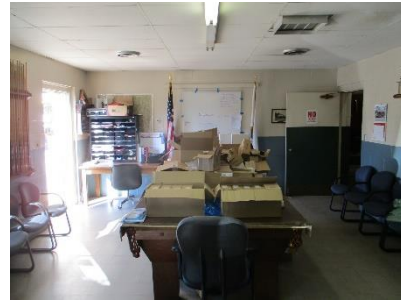
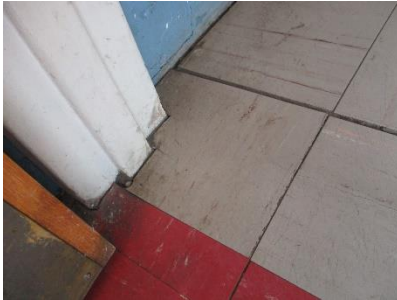
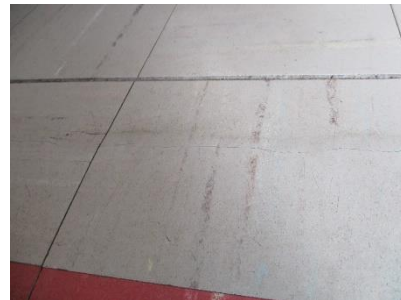
Little space exists in this station for non-firematic activity. The people/administrative space occurs in the Meeting Room and adjacent Kitchen which totals less than 600 square feet. The **Kitchen is smaller in size than the Apparatus Bay Closet** and provides poor amenities for the Town’s Firefighters. While the Meeting Room space is large enough for its function, it also doubles as a delivery staging and check-in area, as observed during our field visit. The floor is VCT tiles of a **size and appearance which strongly suggest ACM’s are present in the tile, the glue or possibly both.** (It was noted at this projects Bid Walk that formal testing of any of these materials has not been performed by the Town to anyone’s knowledge.) While encapsulation is generally an accepted practice, the room **concrete slab is exhibiting multiple signs of cracking and settlement,** especially noticeable at the building entrances. The floor tiles should be tested and removed to determine remediation measures for the concrete slab; see *Images-111 through -118.*

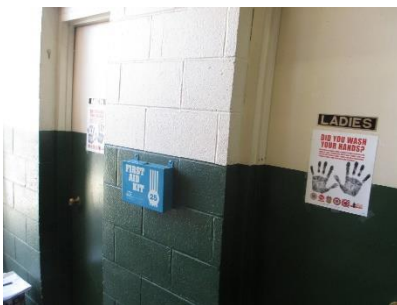
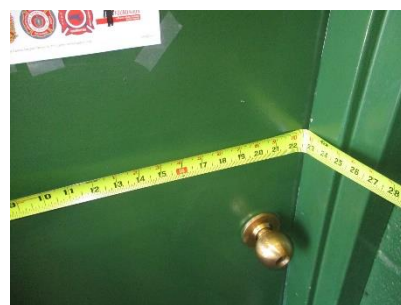
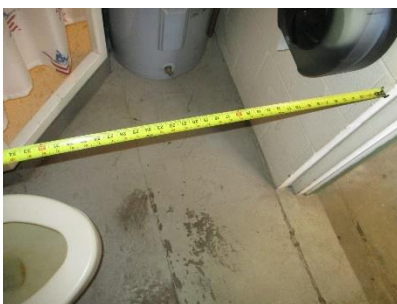
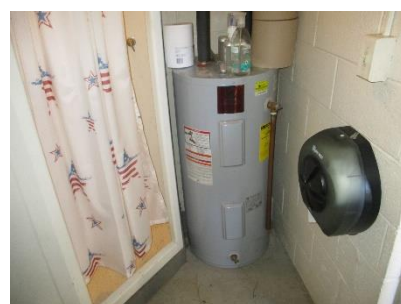
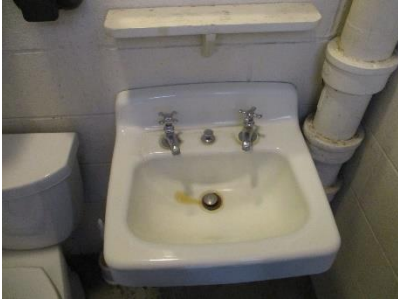
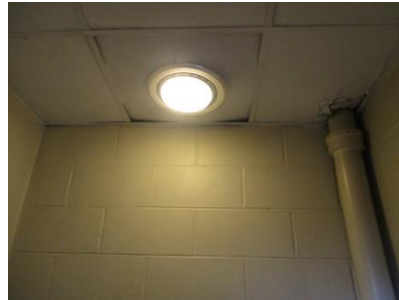
The restrooms are extremely small and cannot be modified without **extensive demolition** and full rework of all plumbing and sanitary lines. The **restrooms do not meet ADA compliancy for accessibility** in any of the required categories and are equipped with 24" wide doors offering a 22 ½" clear opening. The Woman's Room contains the facility shower stall, water heater and soon to be installed Washer/Extractor mentioned earlier in this **Section 2.1.c.3**; see *Images-119 through -124*.

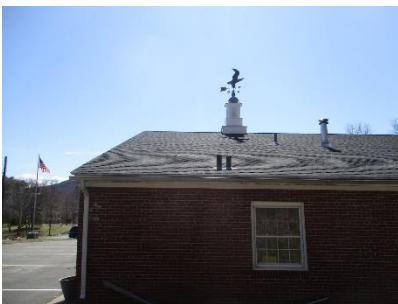
Image-125

The roof for this facility was recently replaced in its' entirety sometime during or after the last addition in 2011. Architectural asphalt shingles have been installed on plywood roof decking. It was confirmed that the previous layers of shingles were removed as part of that installation. Flashings at pipe penetrations and the cupola appear in good condition as observed from ground. The flashing conditions at the brick chimney were not observed. There is efflorescence near the top of the chimney, and signs of moisture at the interior Mechanical Room CMU. **This should be investigated** at the FD's earliest ability; see *Images-125 through -128*.

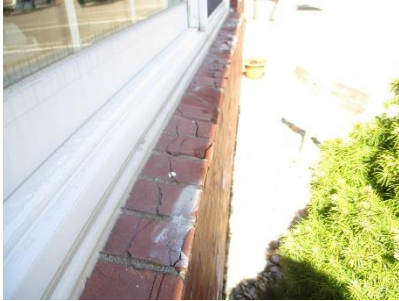
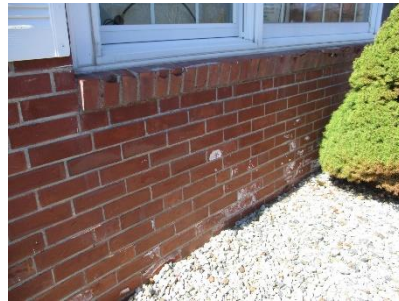
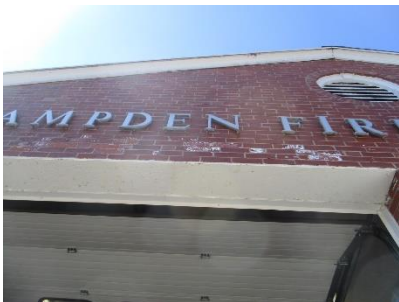
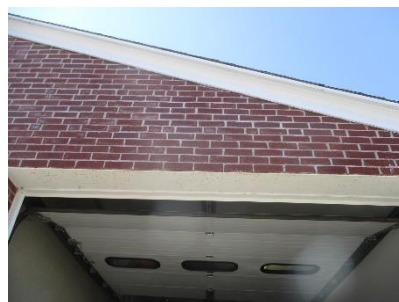
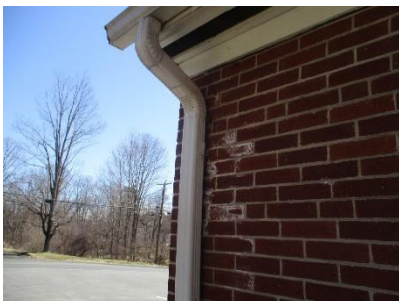
The exterior walls of the original 1963 building have moisture issues on the East side of the facility ranging from **deteriorating brick window sills at the Radio Room** to **efflorescence at most areas** at and around the bay door openings. The 1988 addition exterior walls to the North and West are slightly better in condition although similar efflorescence markings were observed at the East and North exterior wall assemblies. The brick walls on most sides of the building have intermittent areas of **missing mortar, cracked bricks, missing and spalling bricks**; see *Images 129 through 134*.

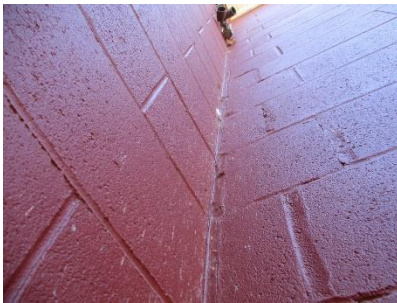
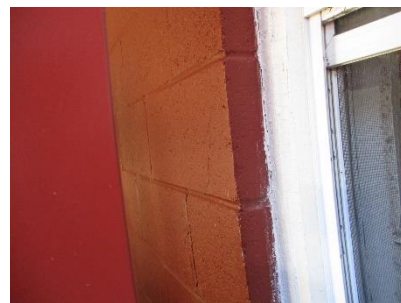
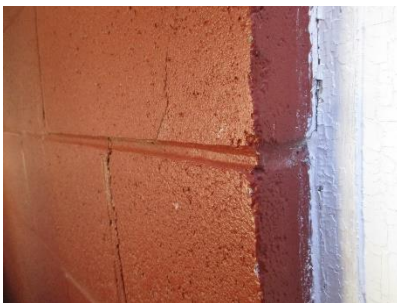
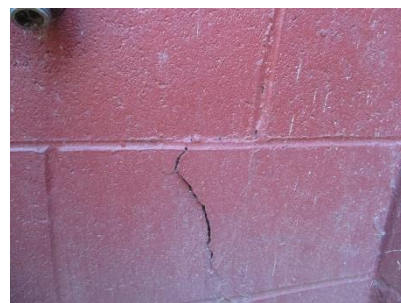
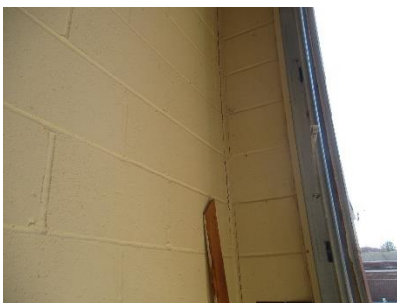
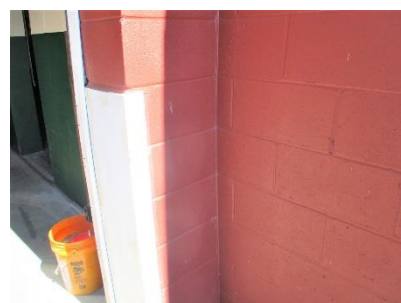
Cracking at the exterior walls were found primarily on the west side of the facility, at newest building addition. Areas of inside corner construction are showing settlement or expansion cracks, although seemingly at their early stages. These cracks should be remediated immediately to avoid increased damage due to water infiltration. Grinding out of these cracks and infilling with silicone sealant is the best course of preventative action; see *Images-137 through -142*.

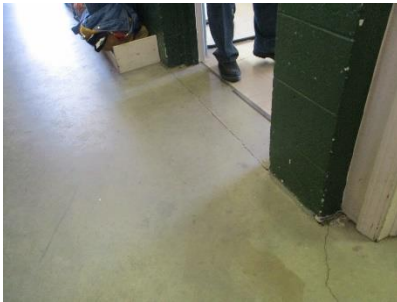
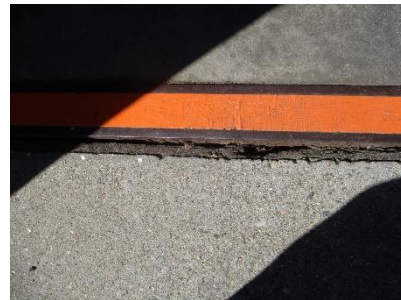
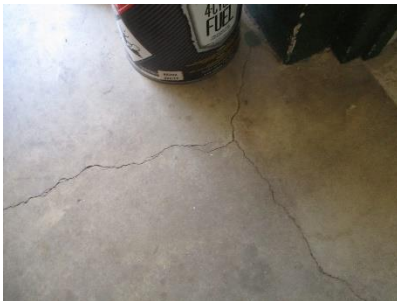
The apparatus bay slabs all have signs of **minor to moderate cracking** as detailed in **Section 2.1.c.3**. The slabs are in essentially fair to good condition. Salt deterioration was not found to be present.

The small to moderate cracks should be repaired as soon as possible. Structural crack sealant should be used on all of the existing slab crack locations. This will limit/eliminate water from finding its way into the cracks and possibly opening the cracks up more. Similar **preventative maintenance should be performed at the slab** perimeter in the entire bay. Concrete sealant should be installed at all open joints around the edge of the slabs; see *Images-143 through -146*.

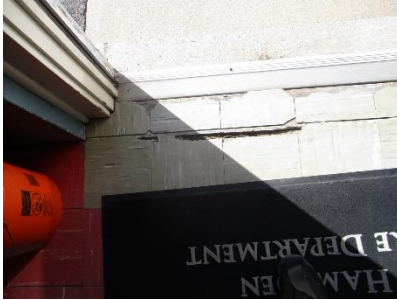
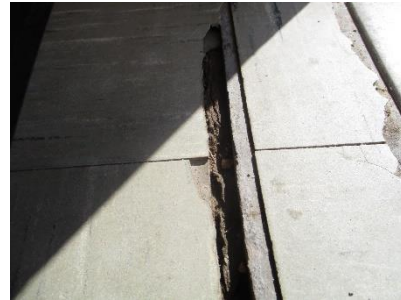
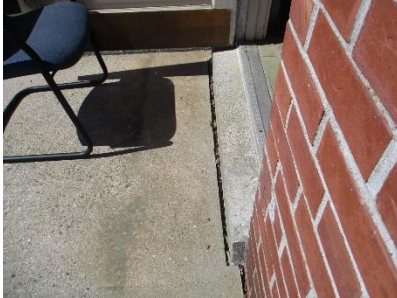
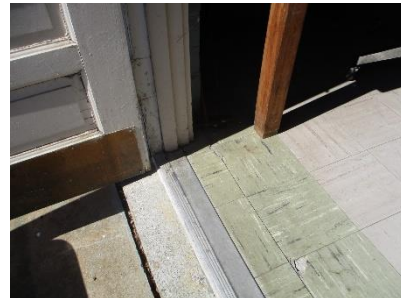
The perimeter of building concrete slabs, and exterior concrete entrance pads, are all showing signs of **cracking and significant settlement**. These are usually indications of inferior sub-base preparation. Any new interior finishes installed at the settlement crack locations will quickly telegraph the existing cracks; see *Images-147 through -150*.

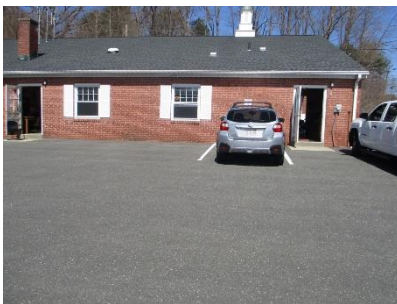
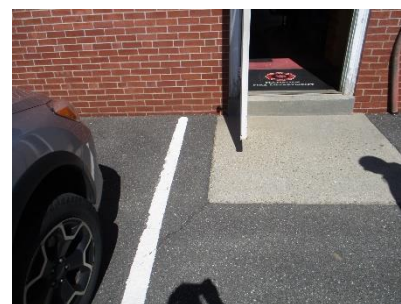
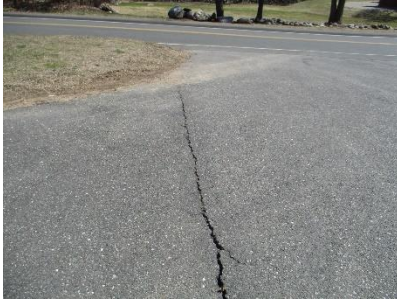
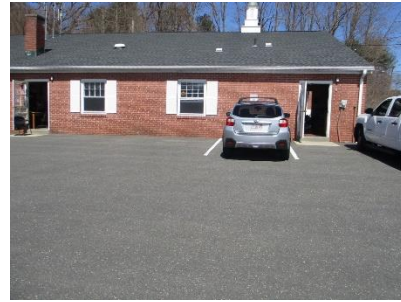
There are no accessible entrances to the building because of the 8+” step at all building doorways; see *Images 151 through 154*.

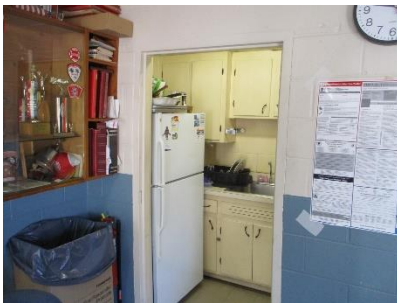
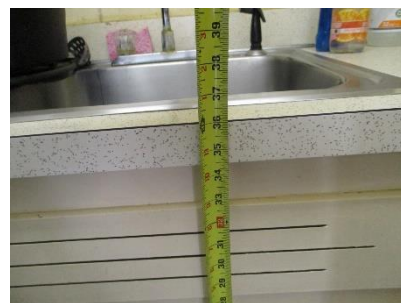
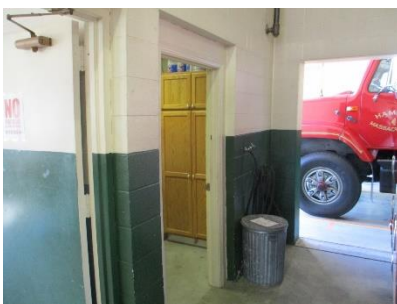
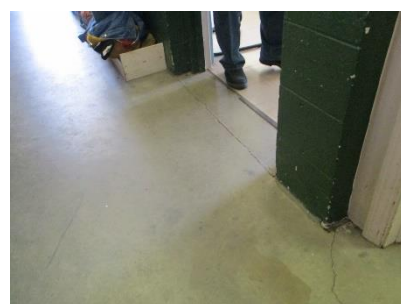
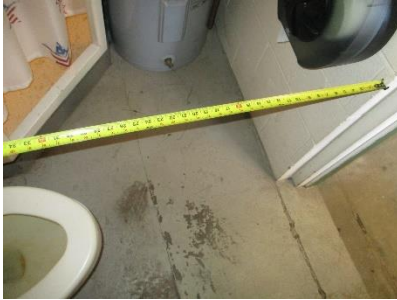
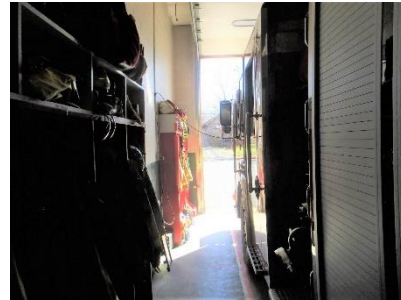
Other than level floors, **no interior aspects of this building meet the basic requirements for ADA accessibility standards.** Firefighters working in this facility will find the paths of egress inside the facility to be barely accessible. This is a **Building Code and Life Safety Code violation.** Few spaces have adequate egress widths; see *Images-155 through -160.*

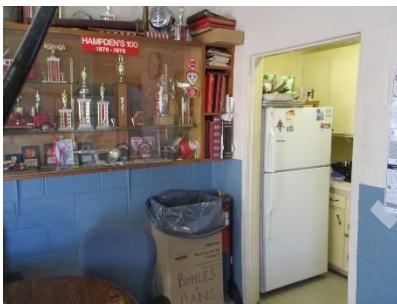
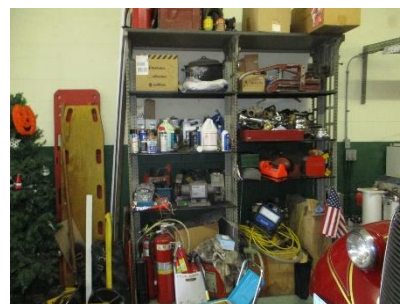
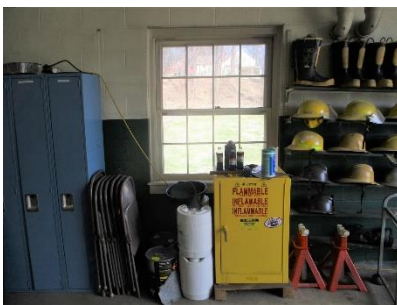
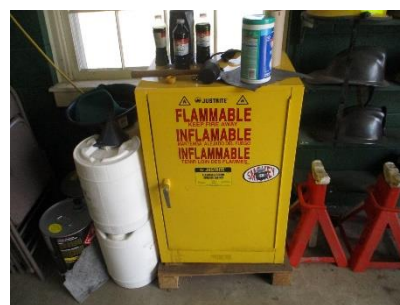
Only one (1) portable fire extinguisher (FE) was found mounted to a wall in the entire facility. The one mounted FE was however hidden behind a recycling box at the Kitchen doorway and not readily visible. While a good location, the box should be moved and a vertical NFPA approved sign should be mounted above on the wall. Several FE's were found on a steel shelving unit in the 1988 Addition alongside the bay wall. These should be verified to have current inspection stickers and wall mounted in each Bay (min of 1 per bay) as well as one mounted in the Mechanical Room. Install signage for all that are mounted.

With working motors throughout the facility and a flammables cabinet in the northernmost bay being heated with sunlight coming through the window, a minimum of one FE per single lane bay and two (at opposing corners) in the original double-lane bay should be installed; see *Images-161 through -164*. **All existing FE's on site need to be confirmed to be fully charged and up to date on inspections.**
