TOWN OF HAMPDEN Fire Department Conditions Assessment & Expansion Options Report

Phase 1

July 14, 2020

Mitchell Associates Architects, PLLC
29 Thacher Park Road, Voorheesville, NY 12186
518 765-4571 www.mitchell-architects.com

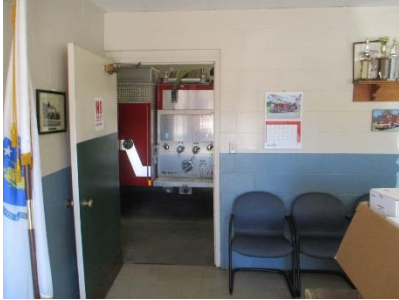
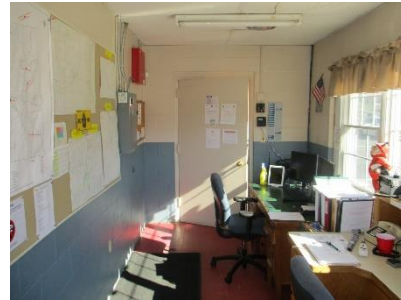
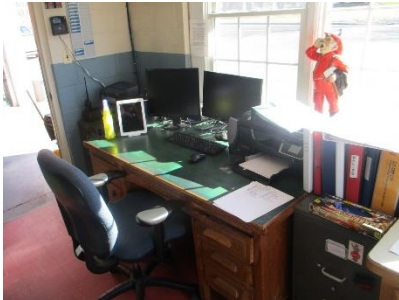
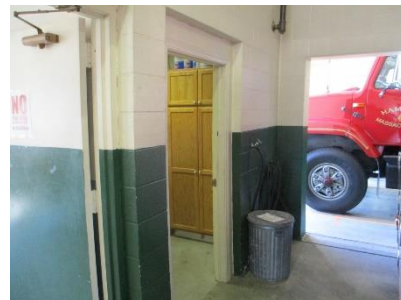
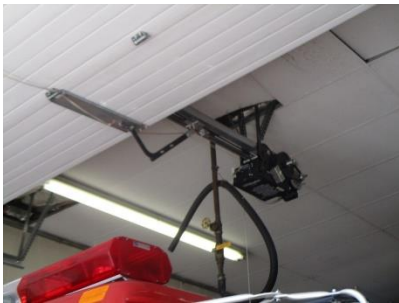
The Radio Room is located directly next to the original 1963 Apparatus Bays and has a poor hollow core wooden door with a faulty closure device. This results in the Radio Room to fill up with exhaust fumes when the apparatus is started. With poor ventilation other than the windows and main door, this is an **unhealthy situation that requires a solution as soon as possible**; see *Images-167 through -174.*

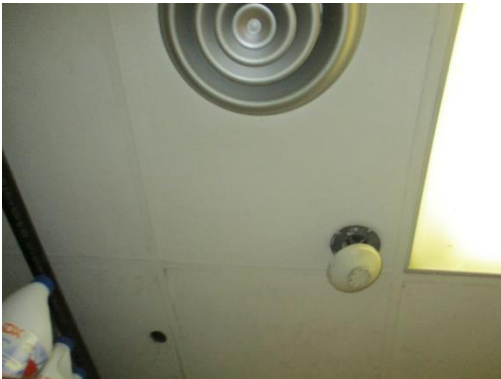
01 – Old ceiling assembly and hanging detector

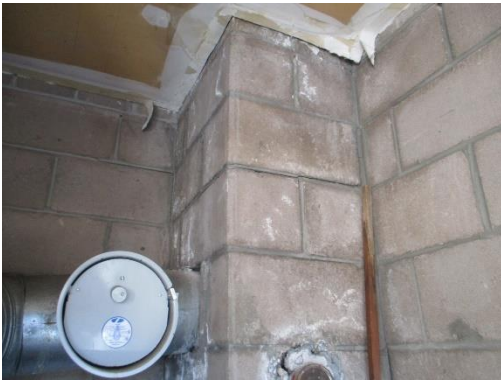
03 – Ceiling and Chimney in Mech. Room

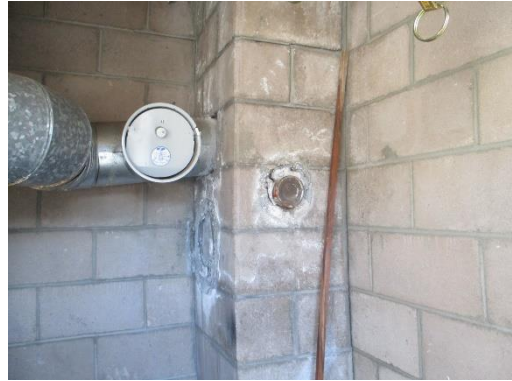
04 – Efflorescence all over chimney flue

- **Replace brick sills**
- **Replace masonry expansion joint sealant**
- **Investigate East and North masonry wall moisture infiltration**
- **Investigate and repair masonry chimney moisture source**
- **Repair or replace gutter and down leader**
- Replace and caulk exterior wood in its entirety.
- Replace exterior wood doors
- Repair generator shed slab cracks
- Upgrade generator shed framing connections
- **Provide sealant at building base at areas of impervious concrete/asphalt (East, West and South facades)**
- Façade restoration – repair mortar joints, repair/replace broken and loose bricks, install new flashing and weeps to allow water to shed from the exterior wall at all Bay door openings
- **Repair & caulk overhead door openings**
- **Window sealant upgrades**

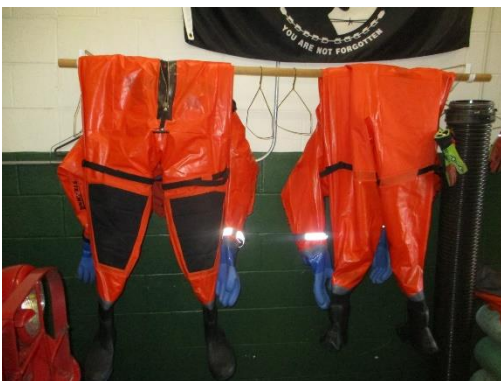
05 – "Drying racks" in the Apparatus Bay

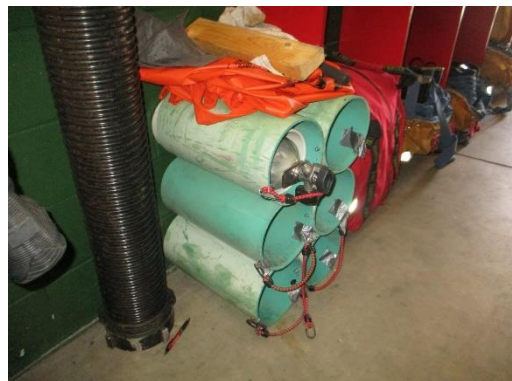
06 – Storage located throughout bays

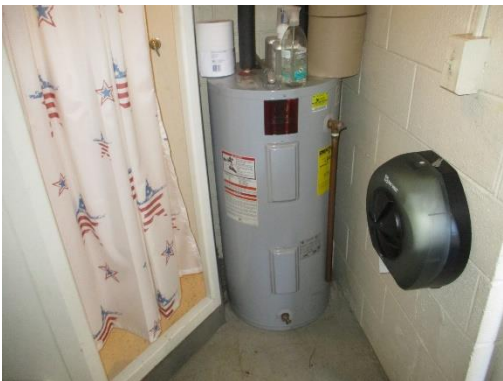
09 – Water heater located in Bay Bathroom

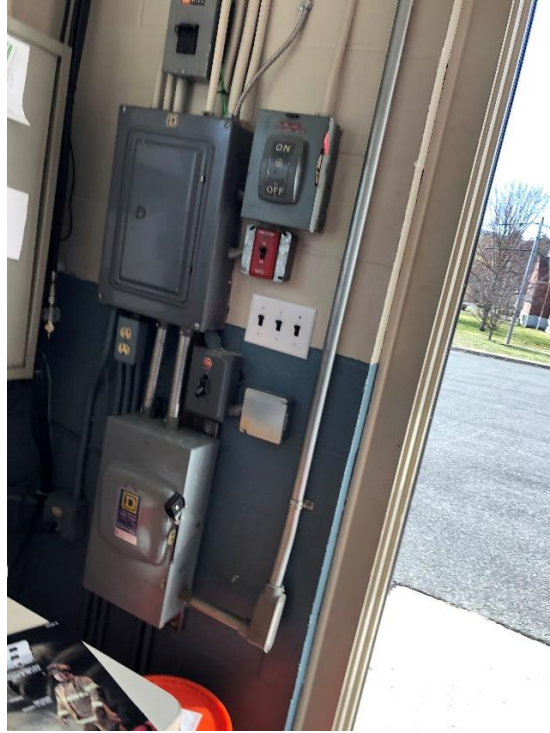
EL-2 Damaged Service Meter

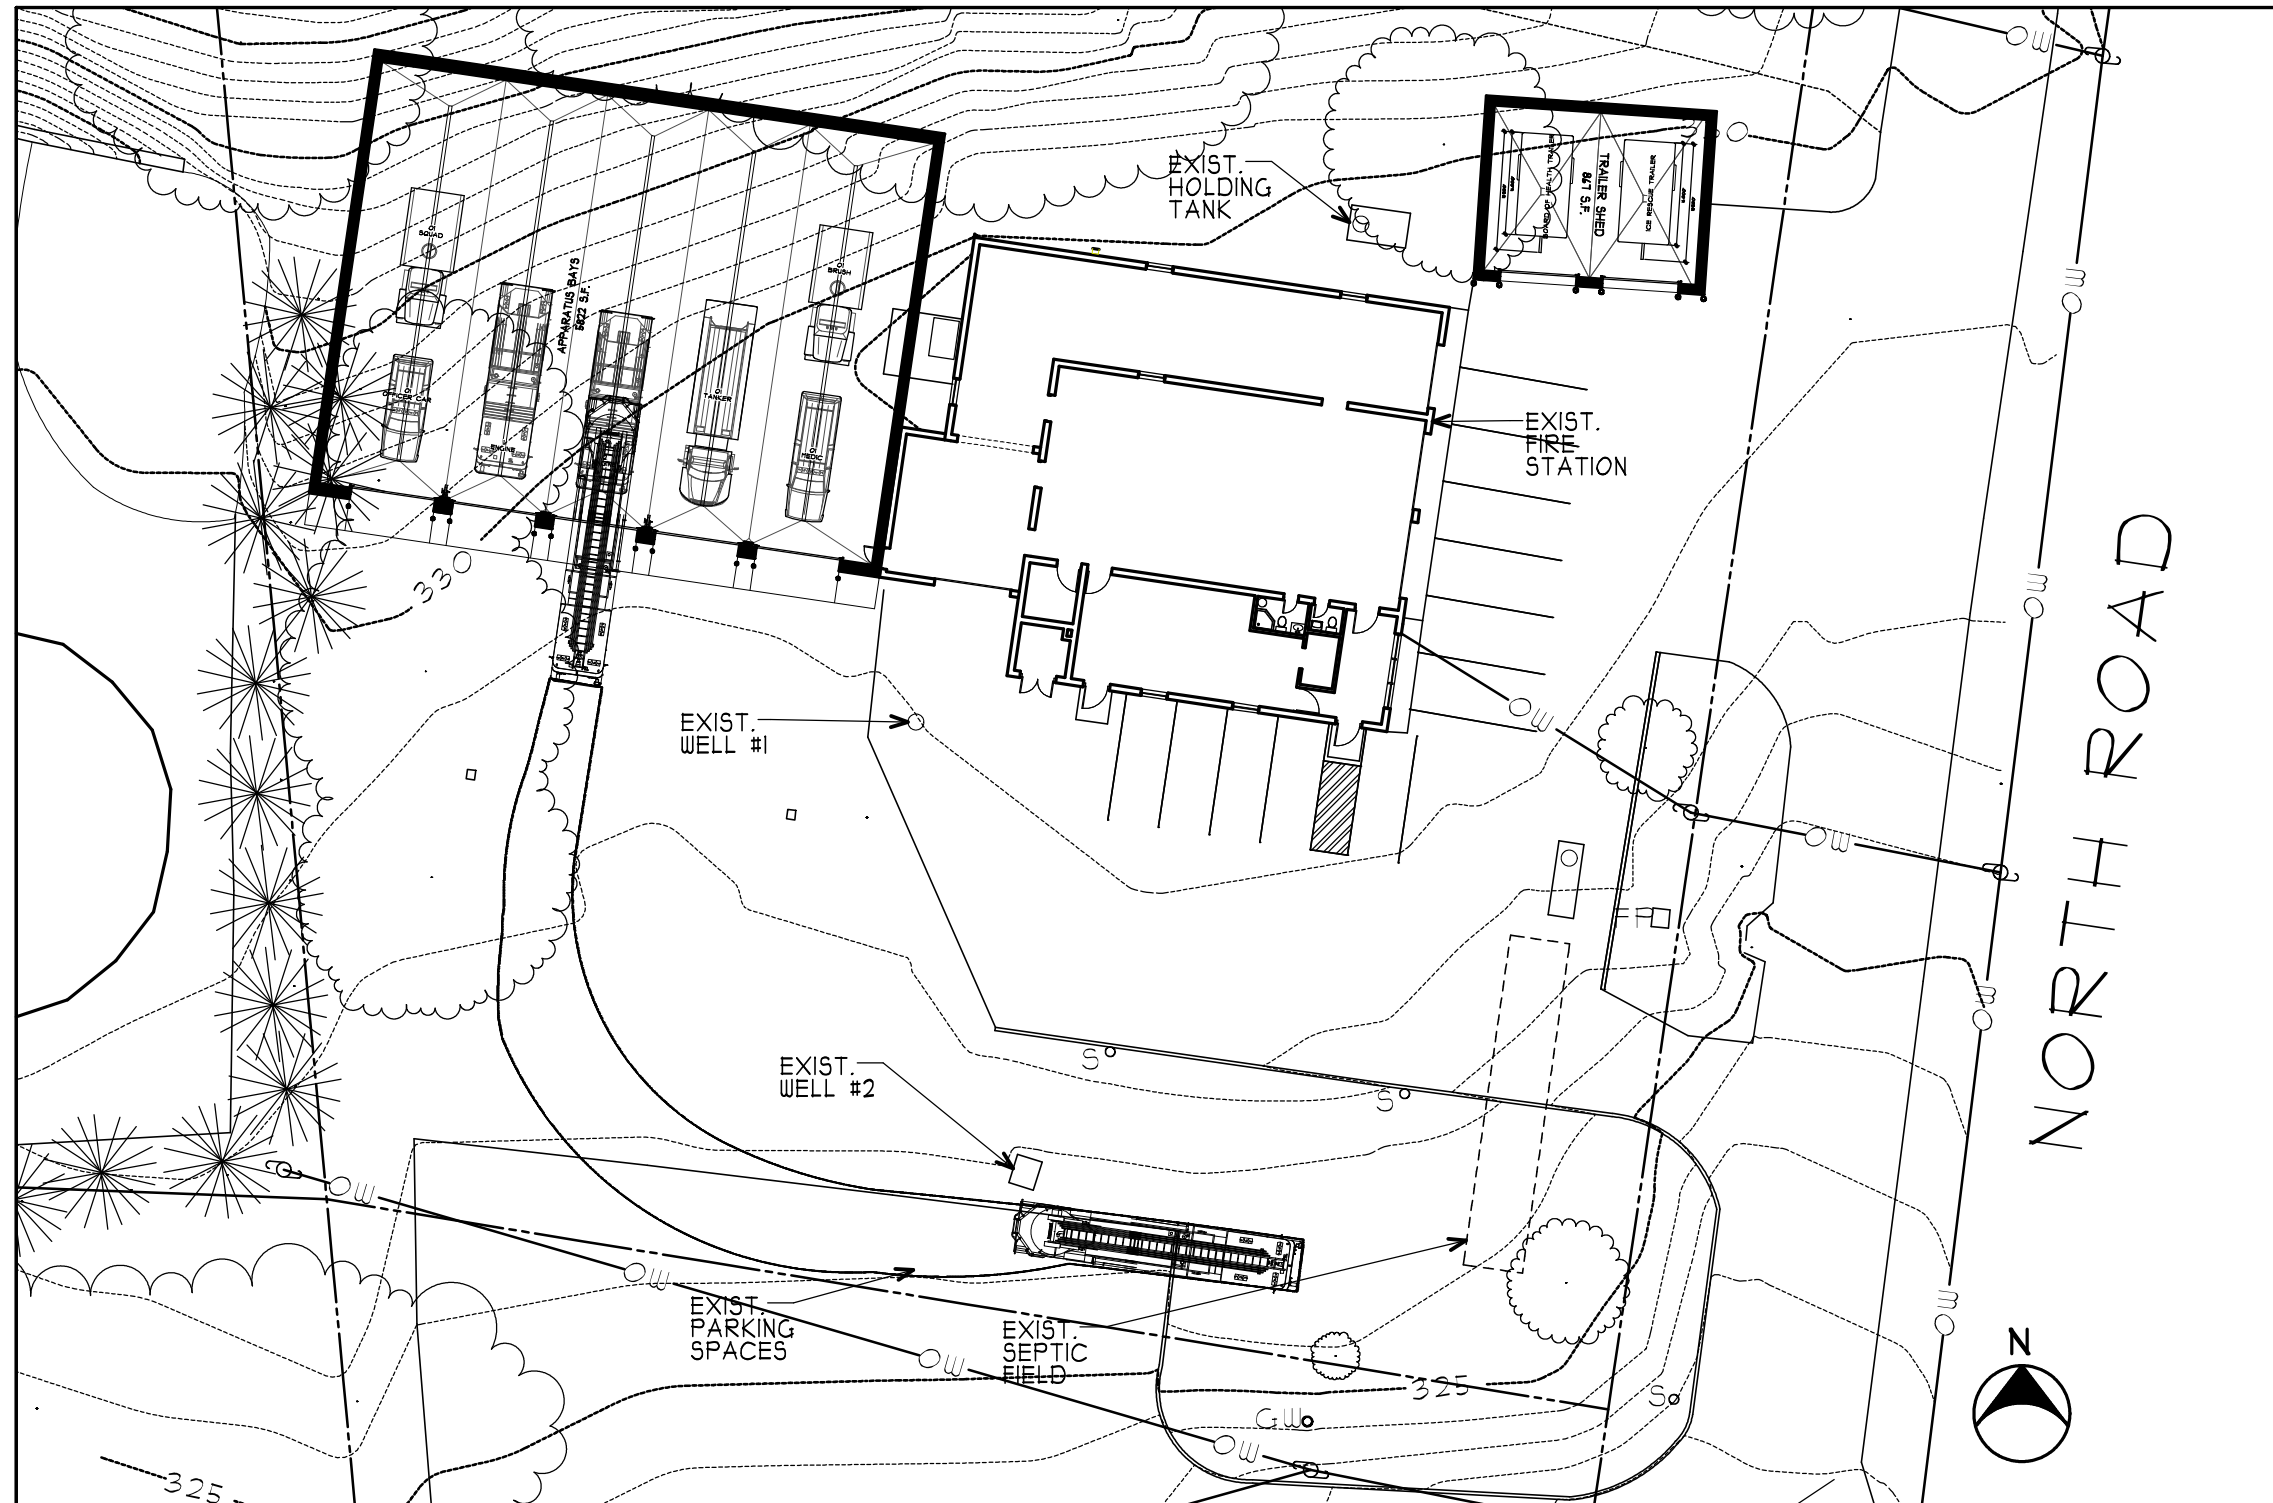
OPTION 2.1 SITE PLAN

THE TRAILER SHED CAN BE
ADDED TO THE NORTH EDGE
OF THE PARKING LOT

THERE IS NO SPACE ON THE
SITE FOR THE REQUIRED
PUBLIC PARKING

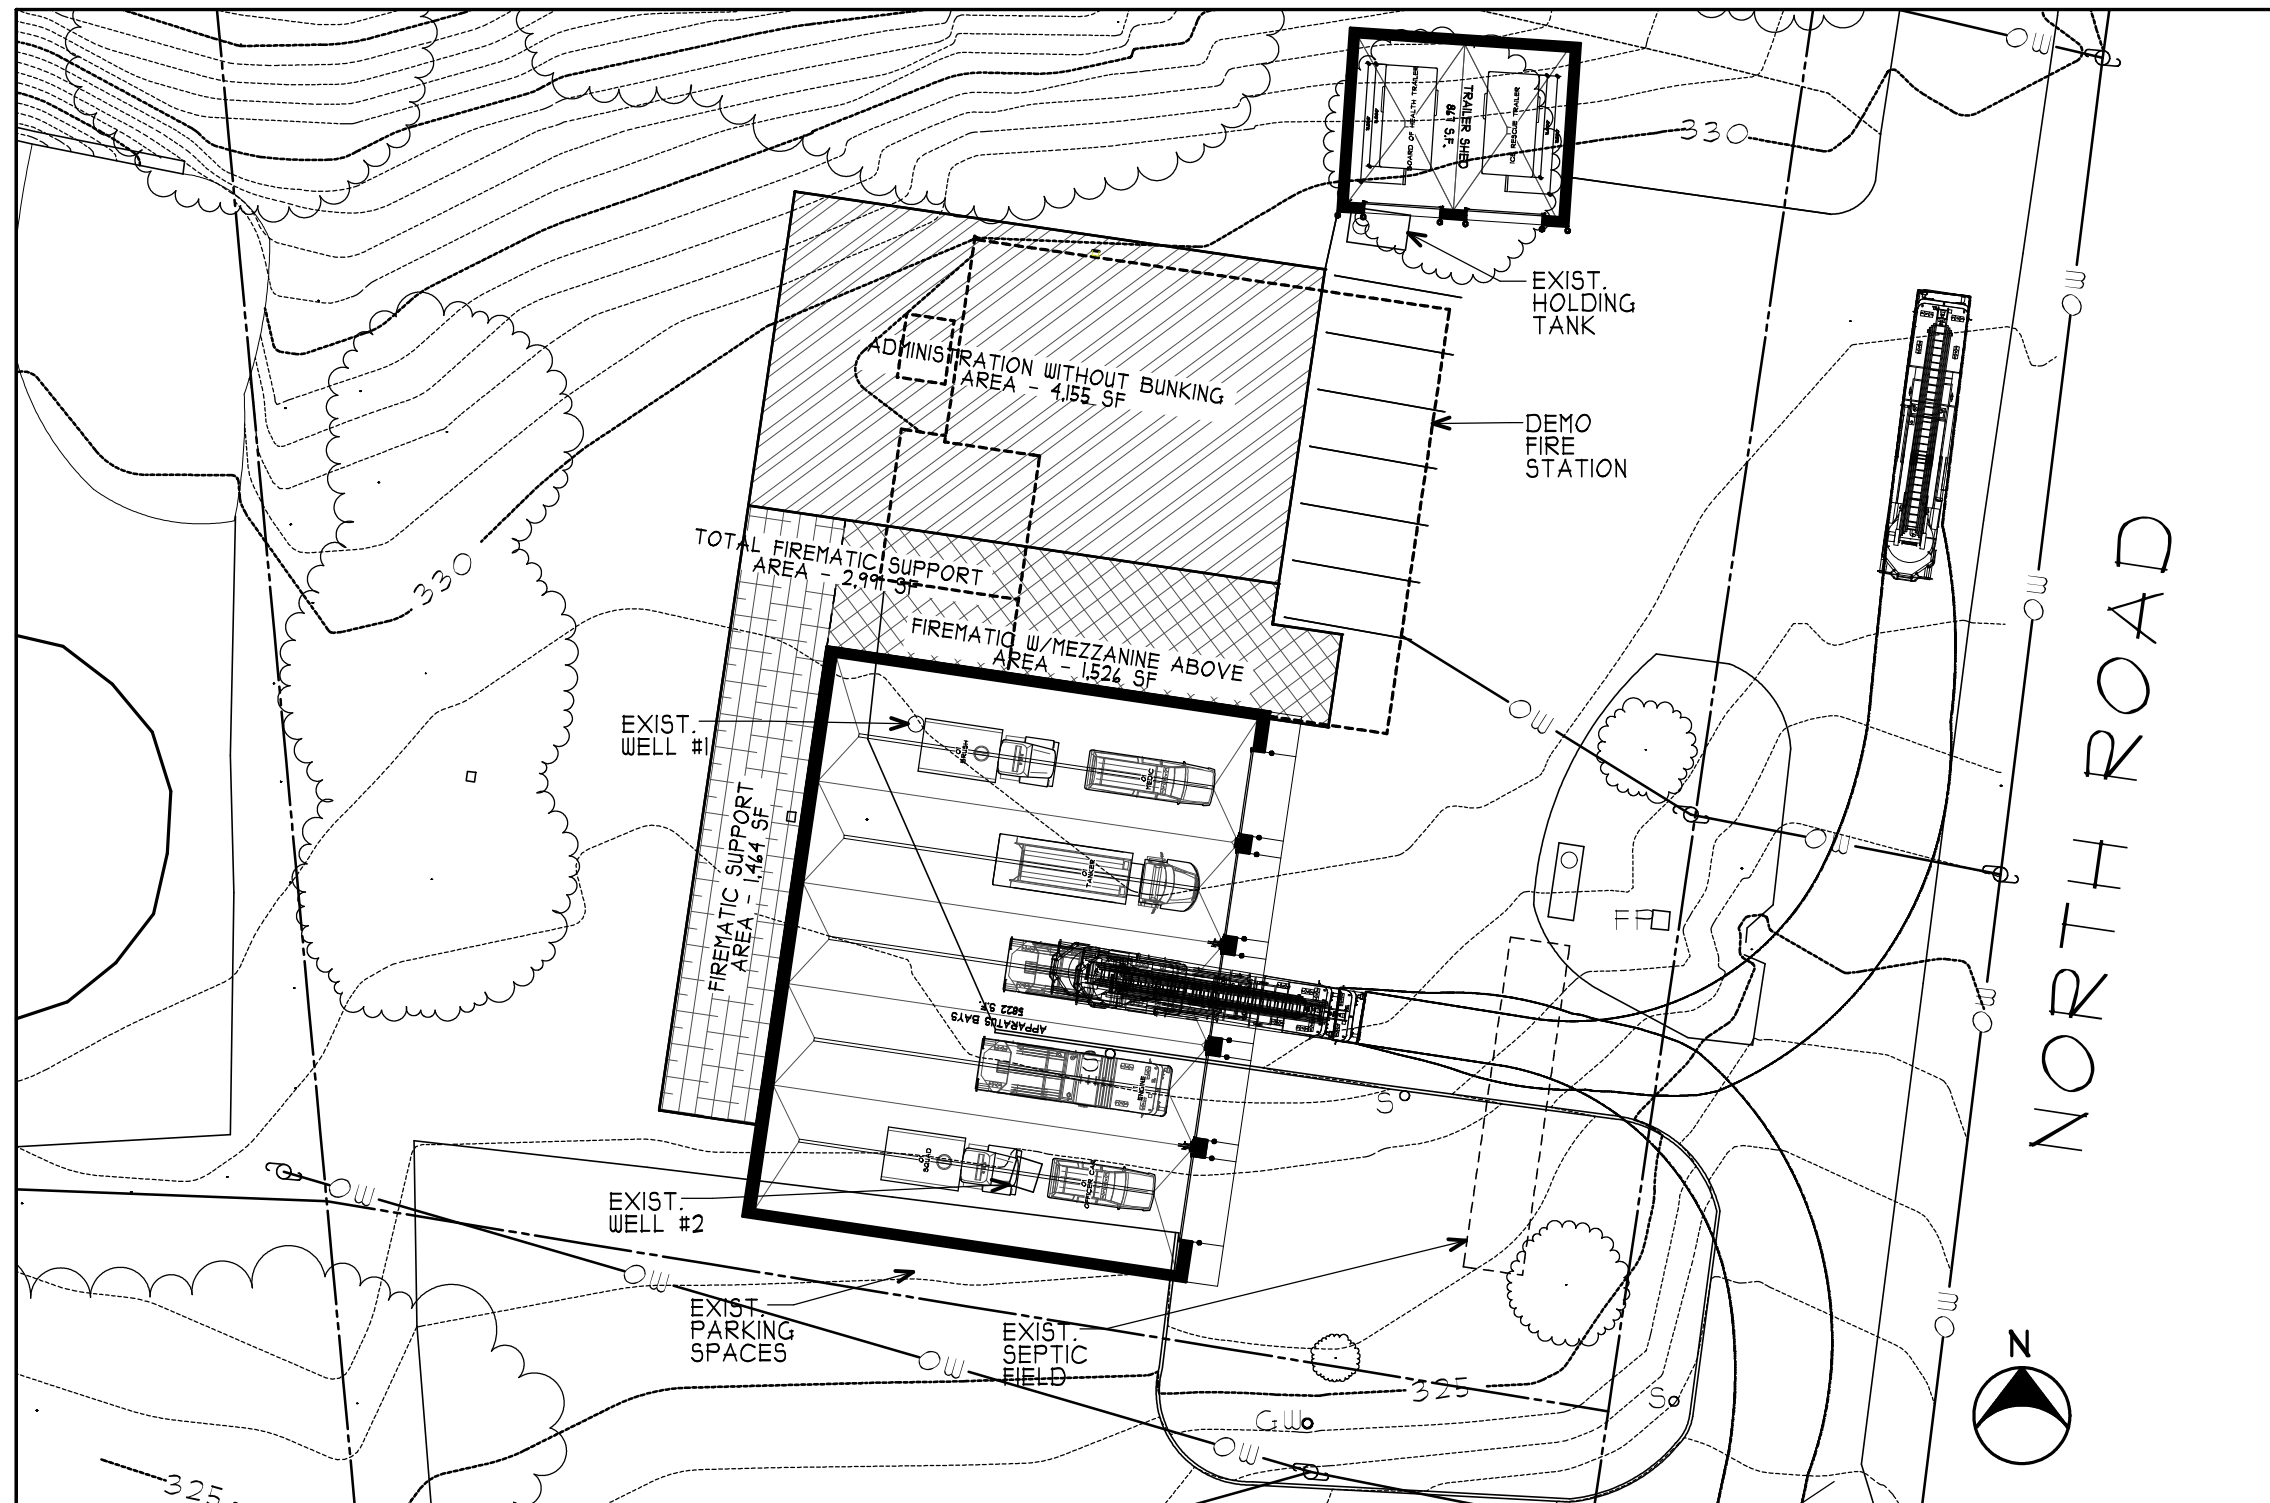
OPTION 3.2
SITE PLAN
 SCALE: 1" = 40'

THE TRAILER SHED CAN BE
 ADDED TO THE NORTH EDGE
 OF THE PARKING LOT

THERE IS NO SPACE ON THE
 SITE FOR THE REQUIRED
 PUBLIC PARKING

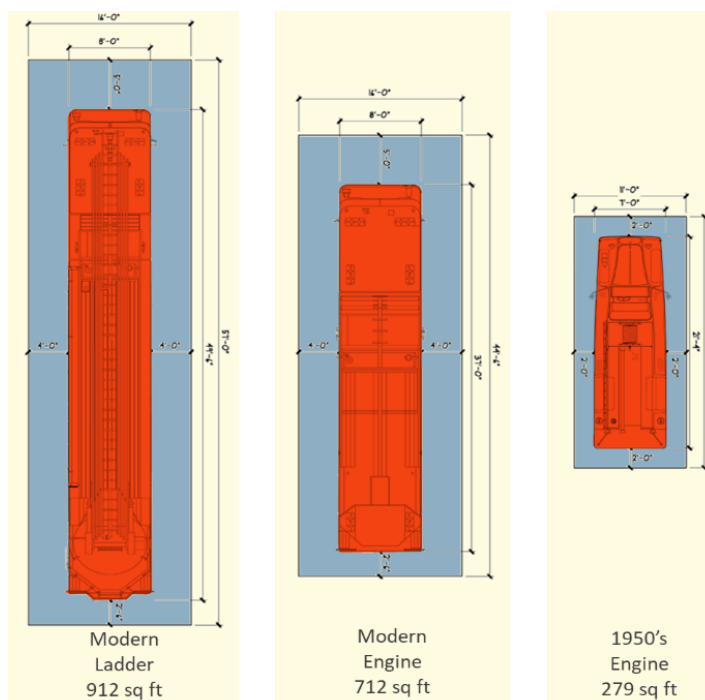
The existing station is nearly 60 years old and was designed and built based on late 1950's and early 1960's fire apparatus, firefighting gear, and equipment. While likely adequate at the time of construction, apparatus sizes have significantly increased over the last several decades as illustrated in the illustration below.

The significant increase in the past 70 years in the size of fire apparatus and the expected safe clearance around vehicles.
