Hampden Town Hall Capital Improvement And Accessibility Study

May 22, 2017

MAROIS CONSTRUCTION CO. INC.

Introduction

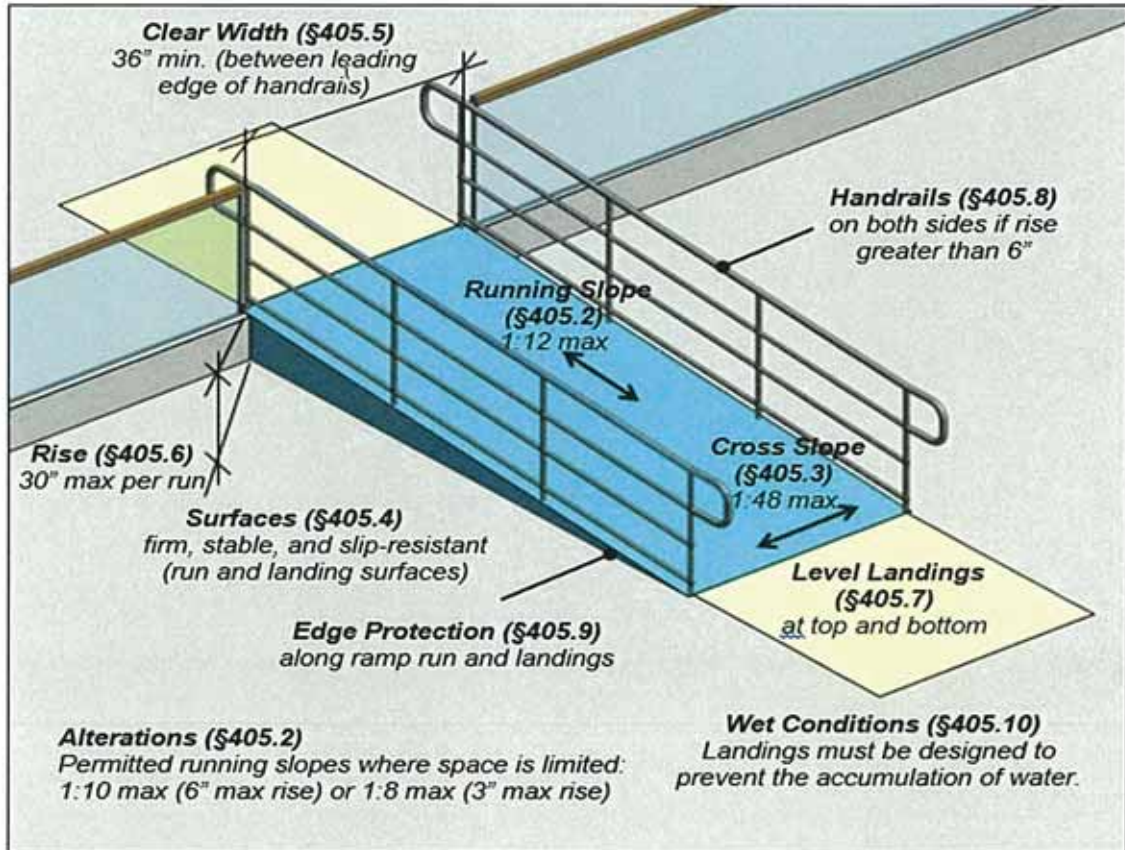
FIGURE 1: MA CODE REQUIRES 48" CLEAR WIDTH BETWEEN HANDRAILS

The handicap ramp located at the front of the building is not compliant with current code. The running slope of the ramp and the handrails do not meet code requirements as defined by CMR 521. The concrete structure is deteriorating as well.

- COMPLIANT RAMPS

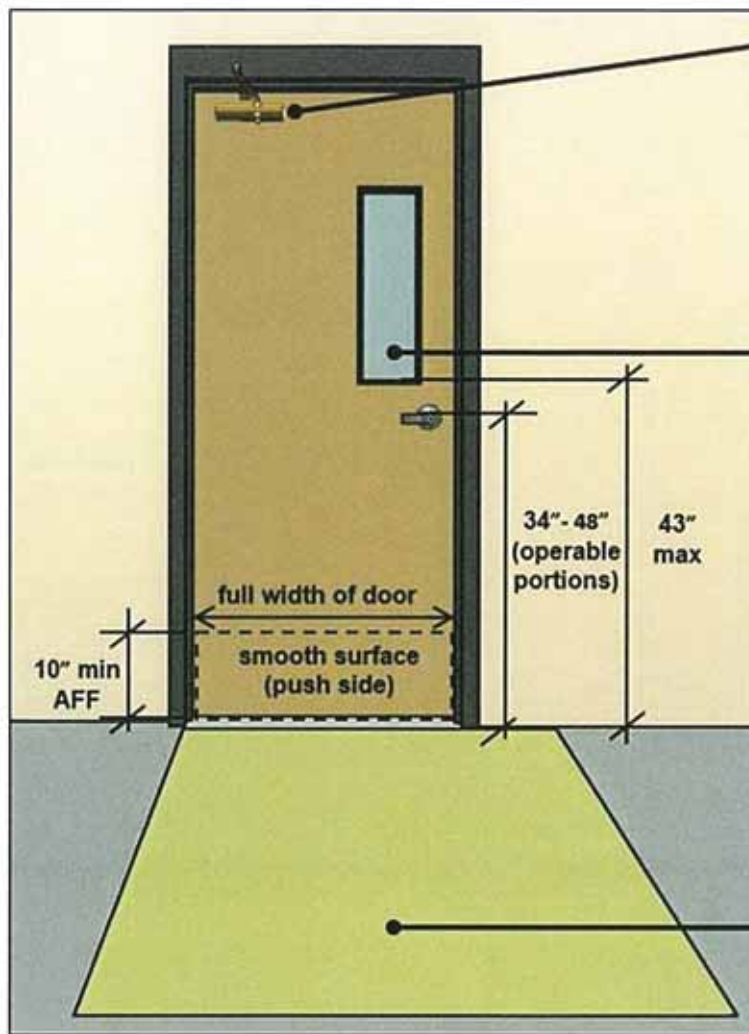
Most doors in the building do not meet both fire code/life safety requirements and the ADA requirements for accessibility. Specific concerns include AAB/ADA compliant handles, closers, and maneuvering clearances.

Closing Speed (§404.2.8)

Closers: 5 sec. min. from 90° to 12°
(spring hinges: 1.5 sec. min. from 70° to 0°)

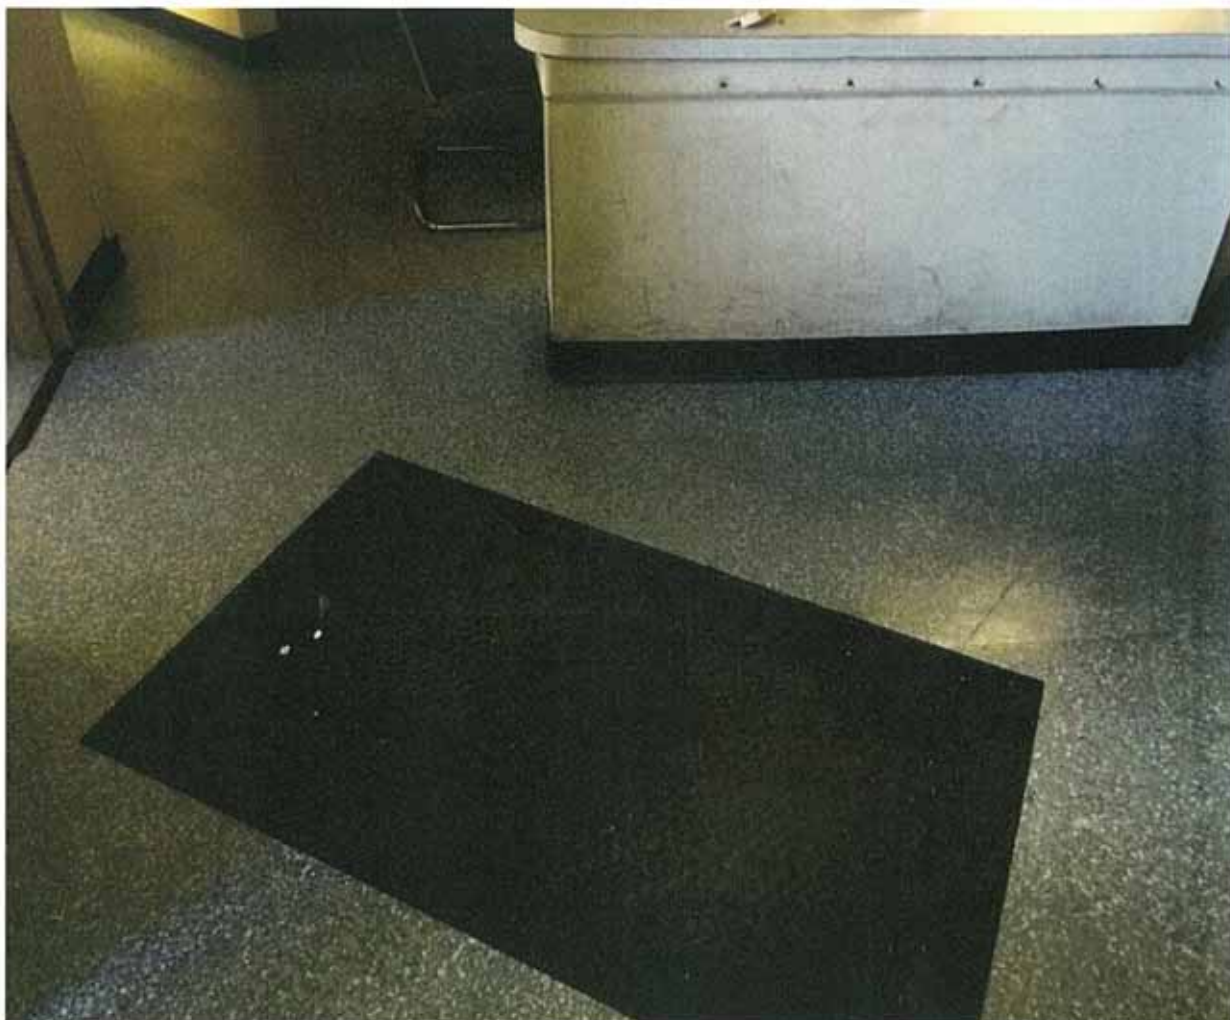
The Hamden Police Department formerly occupied a portion of the basement level of the Town Hall building. This space is located in the South East corner of the building and includes a jail cell, bathrooms, multiple offices, a kitchen, and reception desk area. The plan is to repurpose this portion of the building as general office space. The scope of work will include demolition of the holding cell and existing partition walls. The proposed design for this space includes three new offices that open directly to the main corridor, one of which would hold the access to the proposed IT closet. An additional office space and a meeting room would open to a secondary corridor that would also serve the two new accessible restrooms. This space would receive new heat and air conditioning via two new ductless mini split units. This entire portion of the building would receive new flooring and new acoustical ceiling tile.

The proposed design for this space includes three new offices that open directly to the main corridor, one of which would hold the access to the proposed IT closet. An additional office space and a meeting room would open to a secondary corridor that would also serve the two new accessible restrooms.
