Hampden Town Hall Capital Improvement And Accessibility Study

May 22, 2017

MAROIS CONSTRUCTION CO. INC.

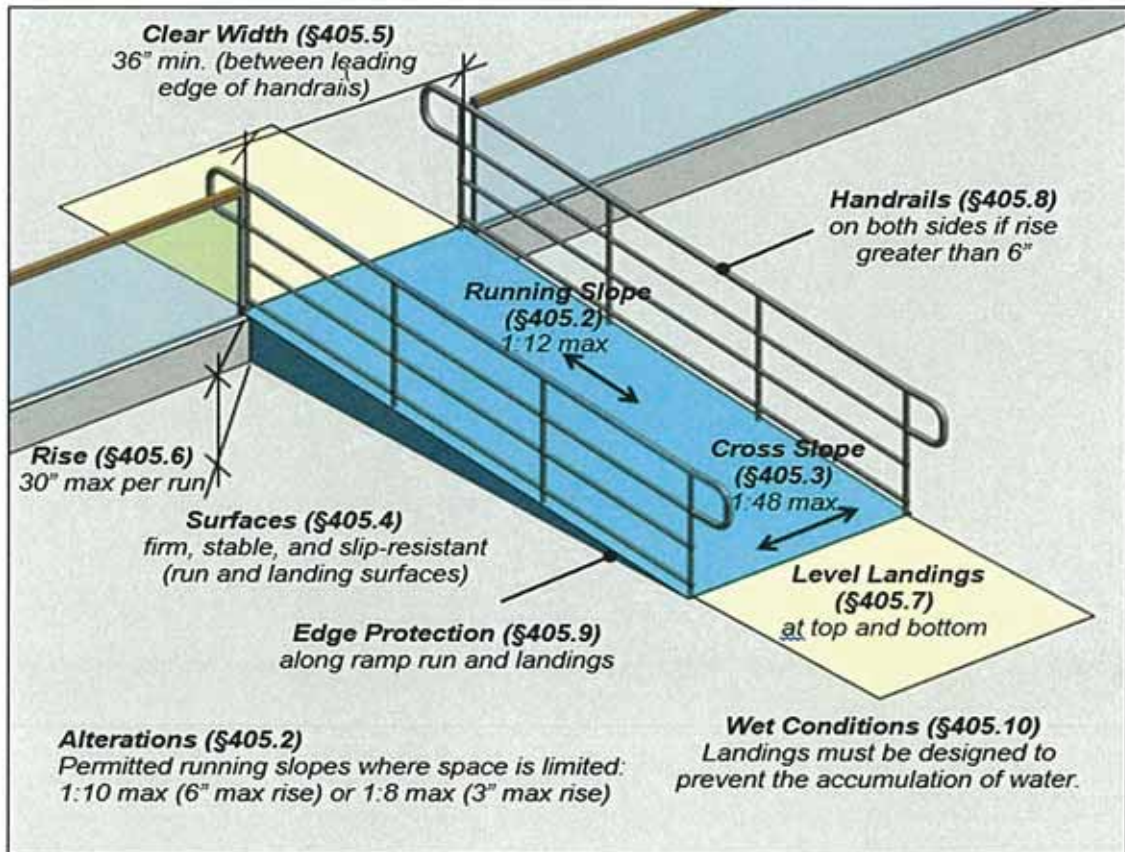
FIGURE 1: MA CODE REQUIRES 48" CLEAR WIDTH BETWEEN HANDRAILS

The handicap ramp located at the front of the building is not compliant with current code. The running slope of the ramp and the handrails do not meet code requirements as defined by CMR 521. The concrete structure is deteriorating as well.

| Deficiency | Proposed Resolution | Cost range | Estimated Cost |
|--|--|---|---|
| Front Handicap Ramp deterioration and non-compliant handrails | The ramp must be rebuilt to not exceed the maximum 8.3% slope and furnished with compliant handrails | \$58,000-68,000 | \$ 63,000.00 |

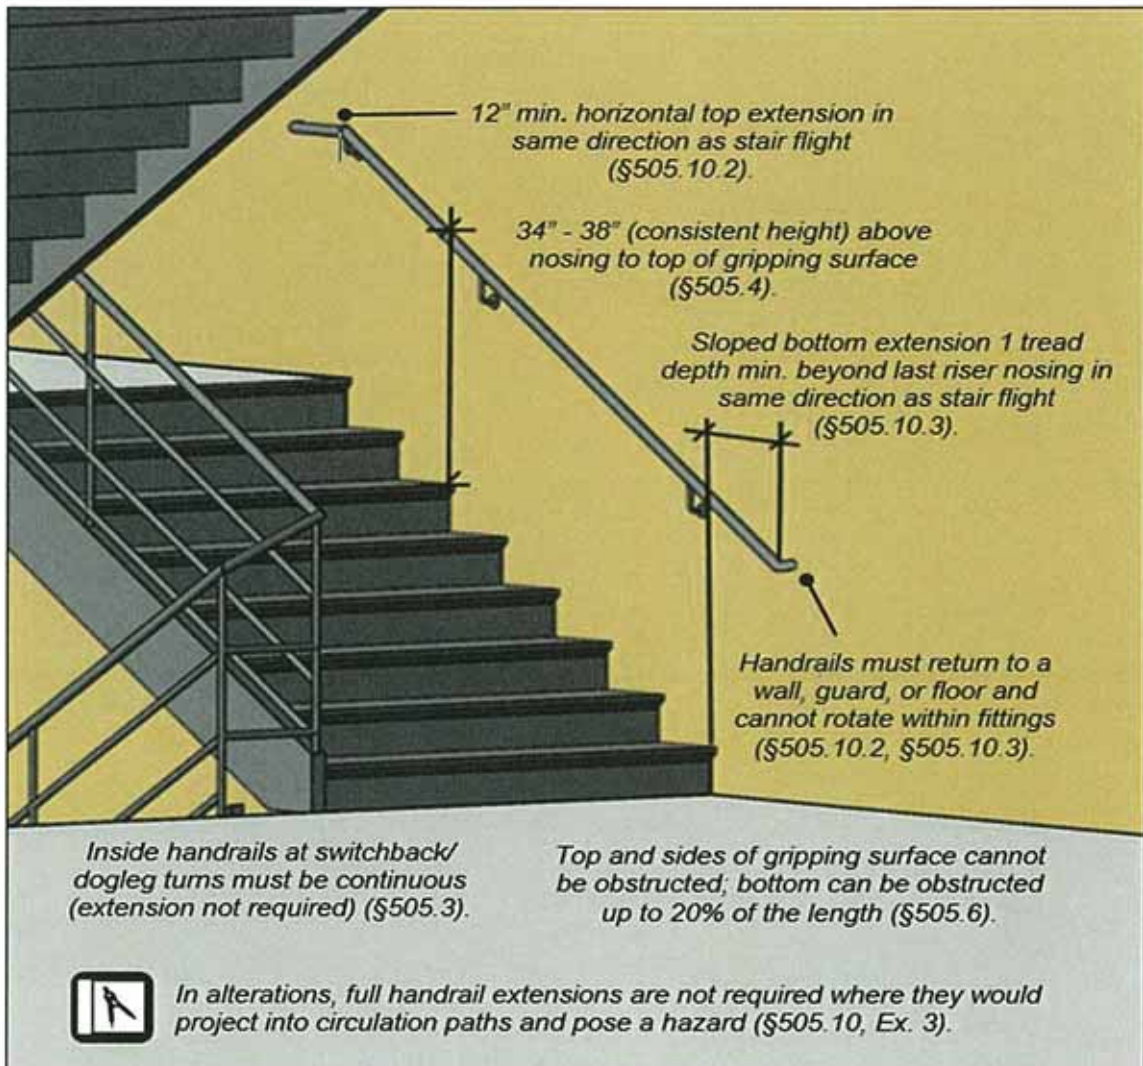
The handrails in stairways throughout the building are not code compliant and will need to be modified or replaced to comply with standards specified in 521 CMR 27.

In addition, existing tread nosing on stairs does not conform to 521 CMR 27.3 for angle and radius requirements.

| Deficiency | Proposed Resolution | Cost range | Estimated Cost |
|--|--|---|---|
| Stair treads/risers/handrails do not meet accessibility standards | Modify existing treads Replace/extend handrails to meet current standards | \$24,000-32,000 | \$ 28,000.00 |

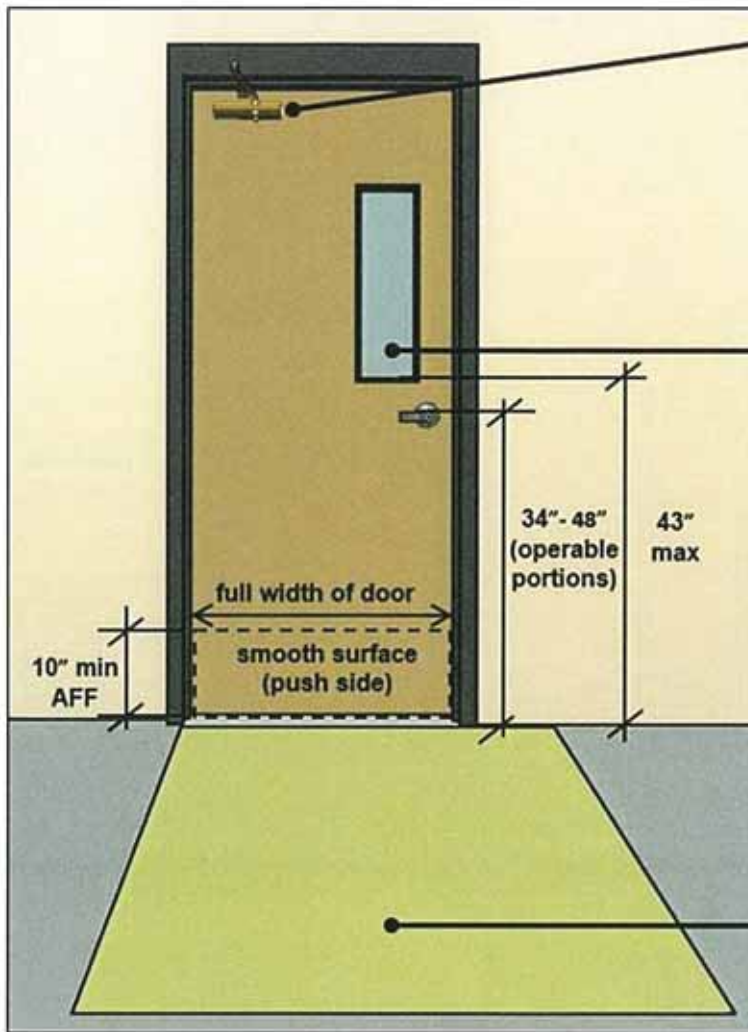
Most doors in the building do not meet both fire code/life safety requirements and the ADA requirements for accessibility. Specific concerns include AAB/ADA compliant handles, closers, and maneuvering clearances.

| Deficiency | Proposed Resolution | Cost range | Estimated Cost |
|--|--|---|---|
| Doors and hardware not accessible and/or fire rated | Install ADA compliant hardware, replace slabs and/or frames to as needed | \$50,000-70,000 | \$60,000.00 |

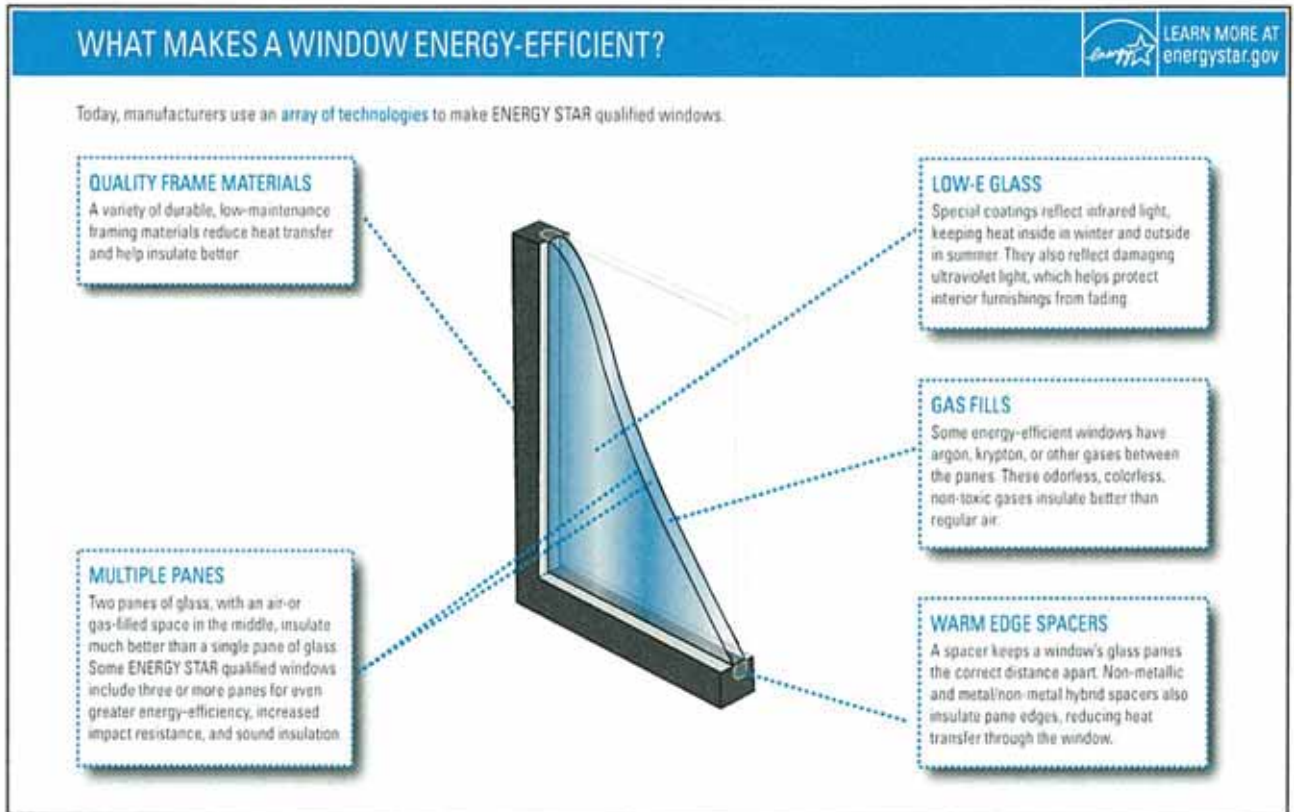
The windows are old, inefficient, and in some cases are deteriorating or not functioning properly.

New windows would offer increased comfort, lower maintenance costs, and should provide energy savings.

| Deficiency | Proposed Fix | Estimated Cost |
|---|---|---|
| Old windows | Replace with new more efficient windows | \$102,000.00 |
